REPORT ON THE COLLISION  
 THAT OCCURRED ON THE 2ND SEPTEMBER 1971  
 AT WENTWORTH JUNCTION  
 IN THE EASTERN REGION OF  
 BRITISH RAILWAYS

RI 2/3/0704.

31st. May 1972

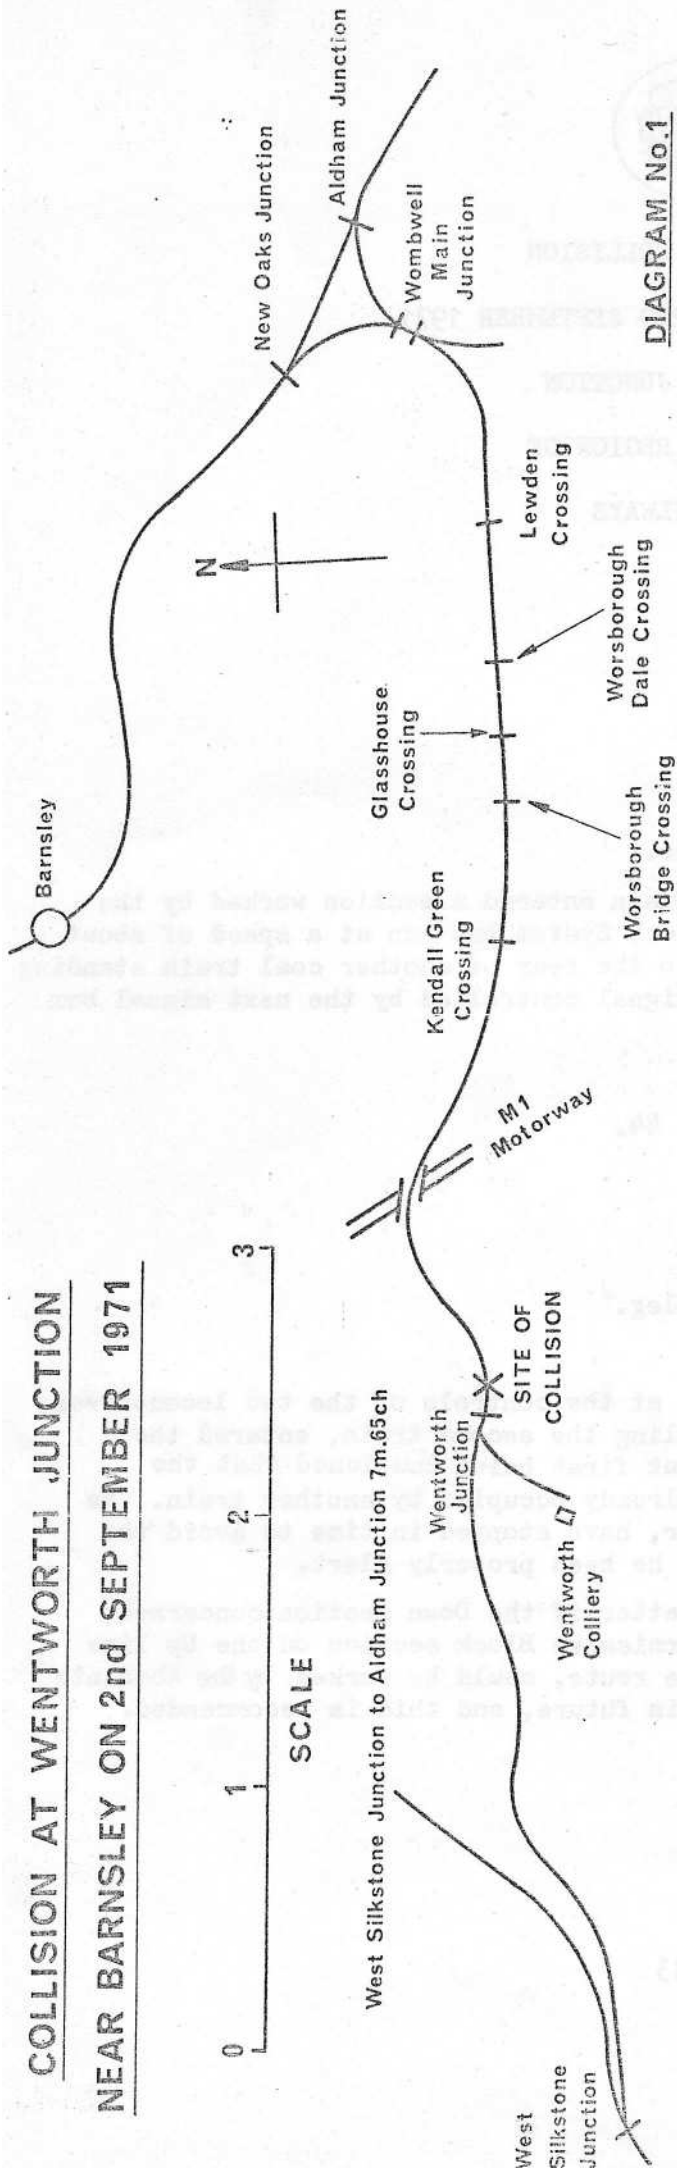
DIAGRAM No.1

4. The accident occurred on what is known locally as the "Worsborough Branch" but is, actually, a Barnsley avoiding line; the location is shown in Diagram No. 1. The "Branch", which is electrified on the 1,500 volts overhead system, extends from Aldham Junction to West Silkstone Junction, a distance of approximately eight miles; there are eight block sections between the two Junctions and the Down direction of trains is towards West Silkstone Junction. A single line branch half a mile in length leading to Wentworth Colliery joins the main line at Wentworth Junction. The traffic along the line consists, normally, of goods and mineral trains but the line is maintained to passenger train standards. The gradients are severe but it is not certain that the gradients diagram which I have reproduced is entirely correct; considerable mining subsidence has affected the line in places since the levels were last checked but the diagram depicts the gradients in general. I was told that there are no gradient boards along the line. Every block section is worked on the Absolute Block System, with two exceptions; on the Down line Permissive Block working operates between Kendall Green Crossing and Wentworth Junction, and also on the Up line between Worsborough Dale Crossing and Lewden Crossing. Kendall Green Crossing has two gates which can be placed either across the roadway or across the railway; their normal position is across the railway and the signaller has to go out onto the crossing in order to operate them.
