Appendix No. 31.  
—  
London and North  
Western Railway.

I HAVE the honour of laying before you the following report upon the accident which occurred on the Aylesbury branch of the London and North Western Railway on the 11th instant, in consequence of the 1.45 p.m. train from Aylesbury to Cheddington having run off the line.

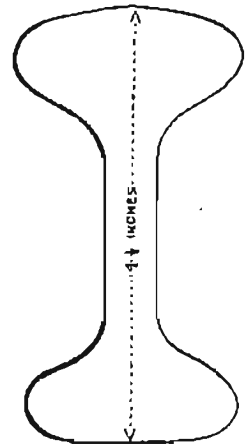
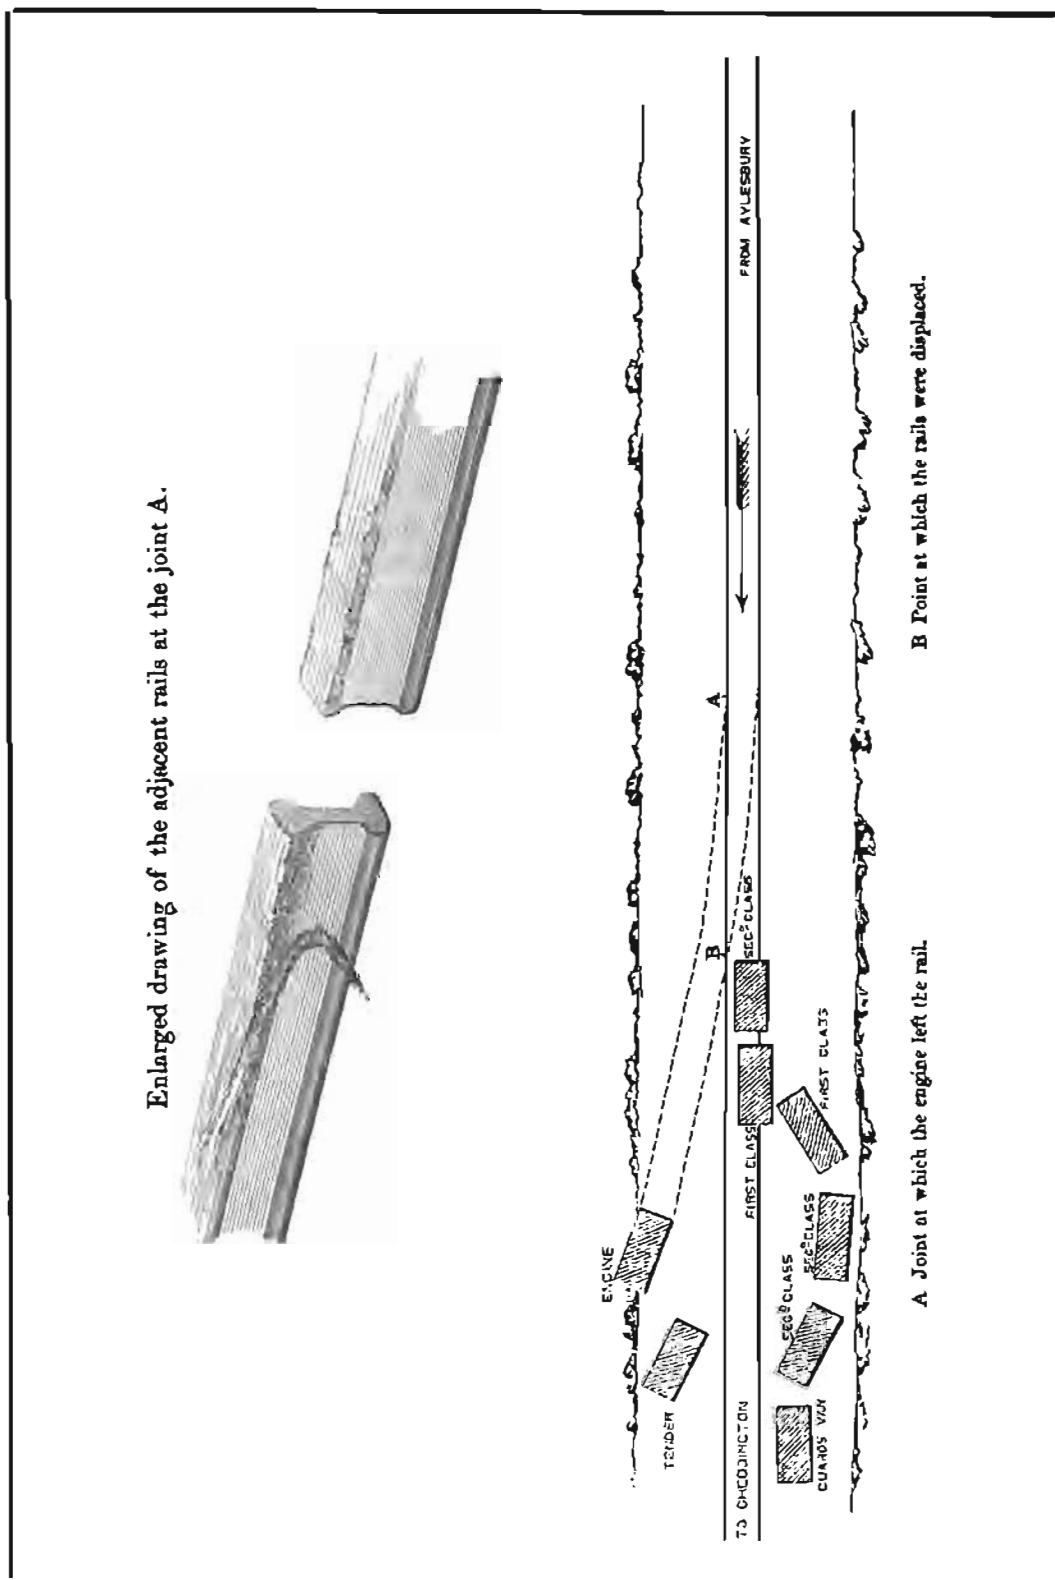
I have annexed a sketch showing the condition of the two rails adjacent to the joint at which the accident occurred.

The rail on the near side of the joint exhibited marks of abrasion for a foot or 18 inches from the joint, as if a piece had been cut off by the flange of the wheel (the opposite side of this rail had laminated); the other rail, the end of which met the wheel, was sheared in the manner shown in the sketch, and the sheared piece appeared to have guided the flange of the wheel off the rail. The off fore wheel of the engine exhibited marks of abrasion.

It appears to me that the accident has occurred from the gauge being tight, the leading wheel of the engine pressed off the edge of the first rail, but on meeting with the end of the second one, sheared it and went off the line.

It is therefore extremely desirable that the Company should cause a thorough examination of the road to be made with a view to the removal of any unsound sleepers, to the addition of ballast in those places where there is not at present a sufficiency, or where the ballast has become deteriorated from the admixture of clay, and to the improvement of the drainage where required.

It is also very undesirable that the gauge of a railway generally should be tighter than that of the wheels of the vehicles upon it on account of the increased traction, and the wear and tear it occasions, as well as on account of the tendency it has to cause an engine or carriage to leave the rails.
