LONDON AND SOUTH-WESTERN RAILWAY

*Railway Department, Board of Trade,
Whitehall, 11th April 1861.*

To accompany Report of Colonel Yolland, R.E., of 3d April 1861.

PLAN OF EPSOM JUNCTION.

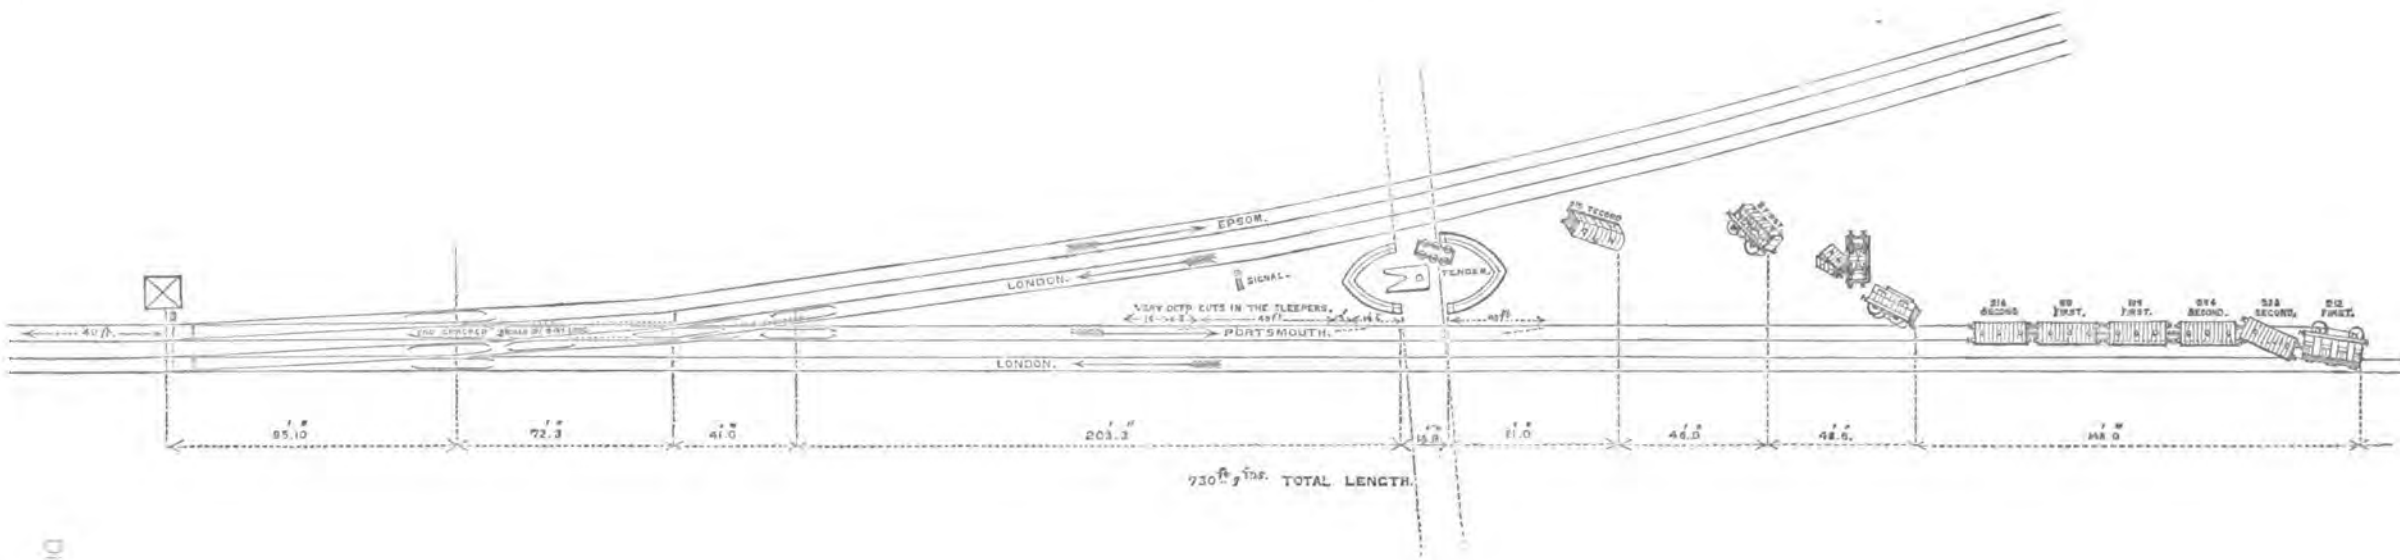
Note.—The dotted lines denote the positions and directions of marks on sleepers and rails.

This part of the line is laid with longitudinal sleepers and bridge rails, and the first marks which could be traced of a vehicle being off the line, walking towards the junction from London, were found on the longitudinal sleeper inside the right hand or north rail of the down line, about $5\frac{1}{2}$ inches from the rail, and about 40 feet from the tongue of the facing points or switches at the junction—40 feet east of the junction. This mark seems to have been made by the flange of a wheel running on the wooden sleeper, and there was also somewhat of the same kind of mark a few feet nearer to the junction, but I was told that this last was not a new mark. There was also an abrasion on the outside, at the top of the left hand or south rail, opposite to the first mark on the longitudinal sleeper, apparently made by the rubbing or grinding of the inside of the tire and rim of a left wheel against the top of the rail—and this abrasion could be traced further west, and the heads of sundry fang or screw bolts were also bruised or notched by the flange or tread of a wheel. Again, at 2 feet 11 inches east of the facing points, an iron plate fixed on the longitudinal sleeper inside the north rail and the head of a bolt on the outside of the south rail of the down line, immediately opposite to each other, were both notched by the flanges of a wheel, and the right hand or north facing point which was about $4\frac{1}{2}$ inches from the rail was struck, cracked, and bent down towards the north rail by the wheel or wheels of the vehicle which was off the rail, from the mark 40 feet east of the facing points, and which wheel must also have made the mark on the iron plate—while the opposite wheel on the same axle notched the head of the bolt outside the south rail. The blow on the facing point is a distinct confirmation of the pointsman's evidence.

detached. Other marks inside the north and outside the south rail of the down main line, keeping nearly at the same distance from the rails, could be traced to the crossing of the down main line with the up Epsom line, about 56 yards west of the facing points, and still farther down, there were distinct marks of more than a pair of wheels having been off the rails, and the transoms were cut, and the permanent way was much more injured.
