REPORT ON PERSONNEL ACCIDENT
THAT OCCURRED ON 7TH MARCH 1976
NEAR LOUGHBOROUGH
IN THE LONDON MIDLAND REGION OF
BRITISH RAILWAYS

ACCIDENT TO R. ANDERSON, M. MOUNTFORD AND D. HINTON
NEAR LOUGHBOROUGH ON 7th MARCH 1976
LOCOMOTIVE No.377 'KING HAAKON 7'

I have the honour to report for the information of the Secretary of State, in accordance with the Order of 22nd March 1976, the result of my Inquiry into the accident that occurred on 7th March 1976 to R Anderson, M Mountford and D Hinton of the Main Line Steam Trust near Loughborough in the London Midland Region of British Railways.

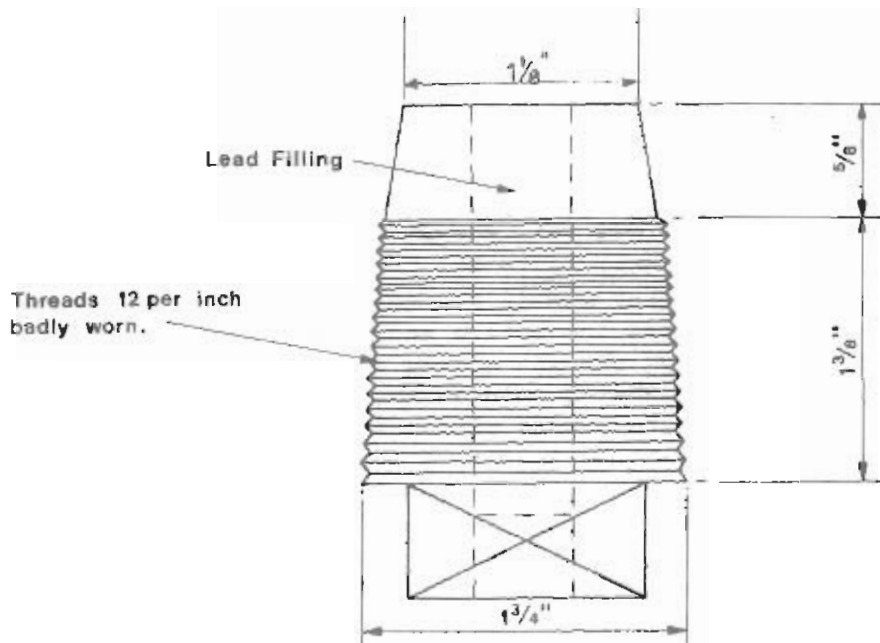
4. On 10th March 1976, in company with a British Railways chief boiler inspector, Mr J Williams, I examined the firebox of the locomotive. It is of steel welded construction. The steel crown plate, which is $\frac{3}{8}$ inch in thickness, had not been damaged; this was probably because the downward rush of steam and water more or less extinguished the fire before all the water on top of the firebox was lost. The crown plate has places for two brass fusible plugs; both along the centre line of the firebox. I found that the fore plug, which was the plug that had blown out, had been 12 inches from the tube plate and that the rear plug, which was still in place, was $7\frac{1}{2}$ inches from the back of the firebox, almost immediately above the firehole doorway. Sketch 'C', which gives the outline of the firebox and some of its dimensions is attached and shows the positions of the two plugs; the following sketch depicts the plug that was blown out and as it was found after the accident in the dead ashes of the fire.

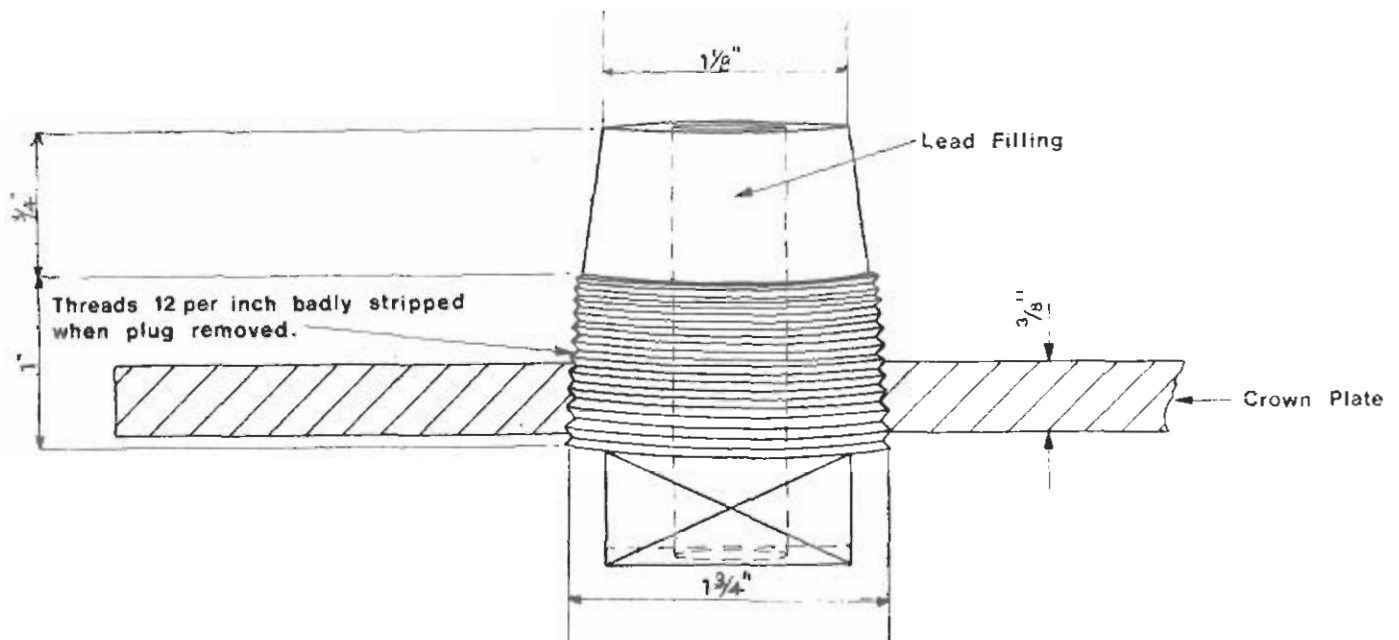
The crown plate, of nominal $\frac{3}{8}$ inch thickness, had wasted to $\frac{5}{16}$ inch around the fore plug hole which, at the best, would have allowed of only four threads of the plug being in contact. I found, however, that most of the plug's threads in the contact area were filled with rust and dirt, indicating that the plug had been fitting in its hole very badly and had, indeed, been loose. The back plug which, as previously stated, was in place when I went into the firebox, showed no signs of leaking around its threads and its lead filling was intact. It had the appearance of being cross-threaded in the hole, however, more or less as shown by the following sketch.

Mr Williams had this plug removed for me, when I then saw that many of its threads were badly stripped.
