TRAIN DERAILMENT AT HATFIELD, 17 OCTOBER 2000

First HSE interim report

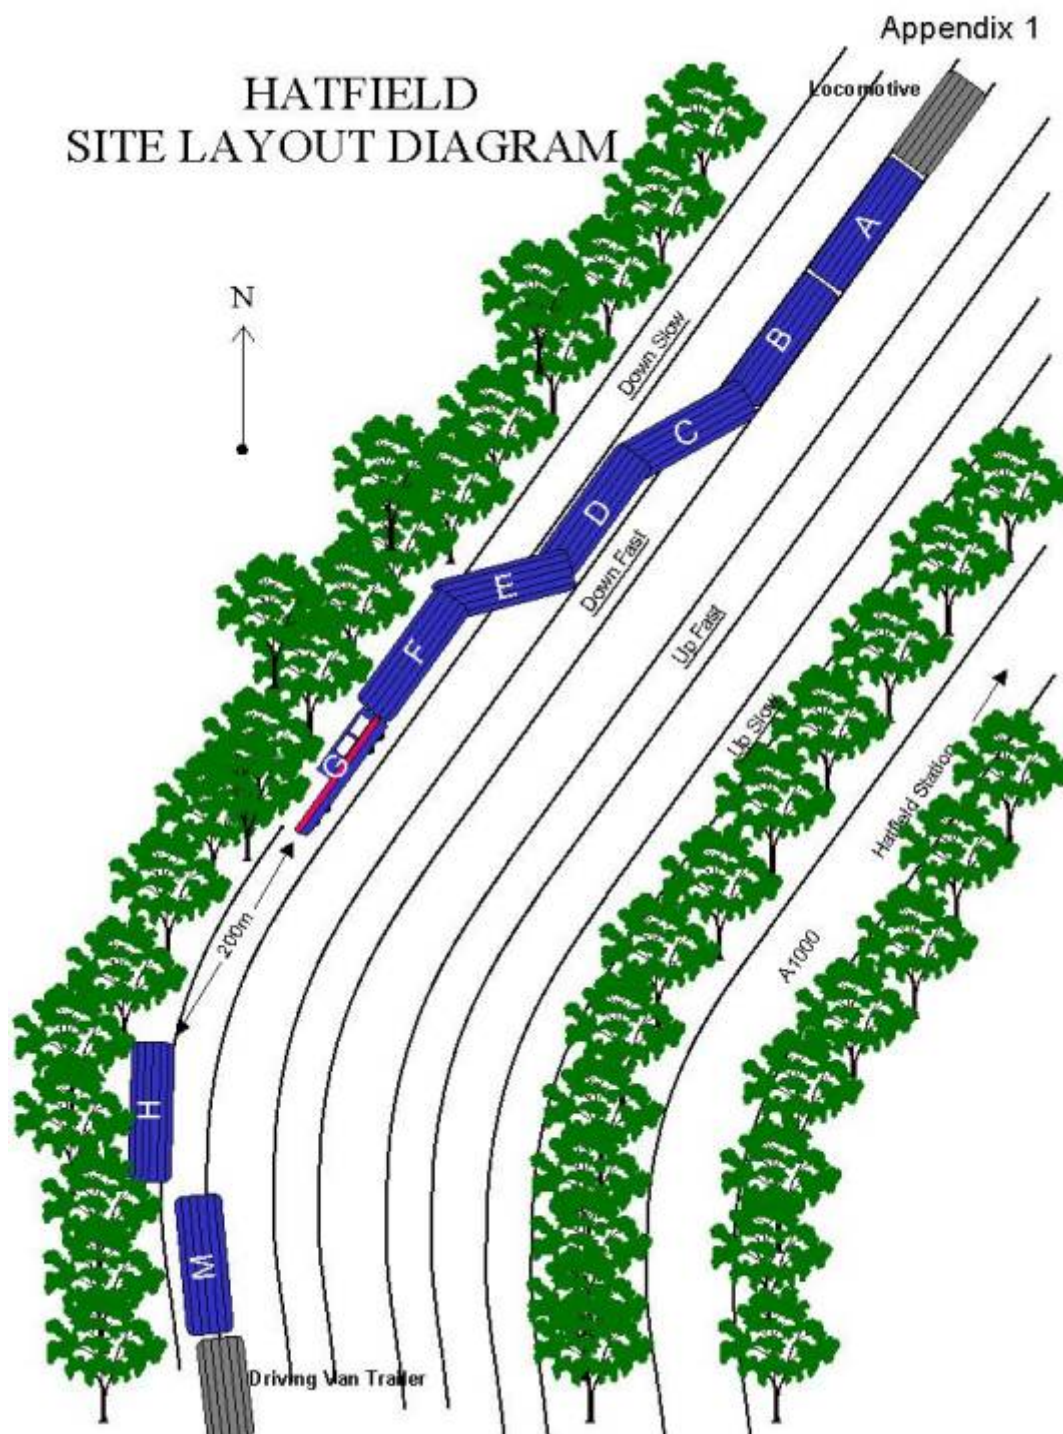
7. The derailment occurred approximately 16.8 miles (27 Kilometres) from Kings Cross station, on curved track between Welham Green and Hatfield in Hertfordshire. There are no points or signals nearby that are relevant to the derailment. Lines are electrified by the 25000 volts overhead line electrification alternating current system. The maximum permitted line speed is 115 mph on the fast line and there were no speed restrictions in place. A greatly simplified diagram at [Appendix 1](#) (for illustrative purposes only) shows the layout of the lines where the derailment occurred.
