HM RAILWAY INSPECTORATE

INTERNAL REPORT

A FIRE ON THE 18:30 PADDINGTON TO SWANSEA TRAIN

NEAR MAIDENHEAD ON FRIDAY 8 SEPT. 1995

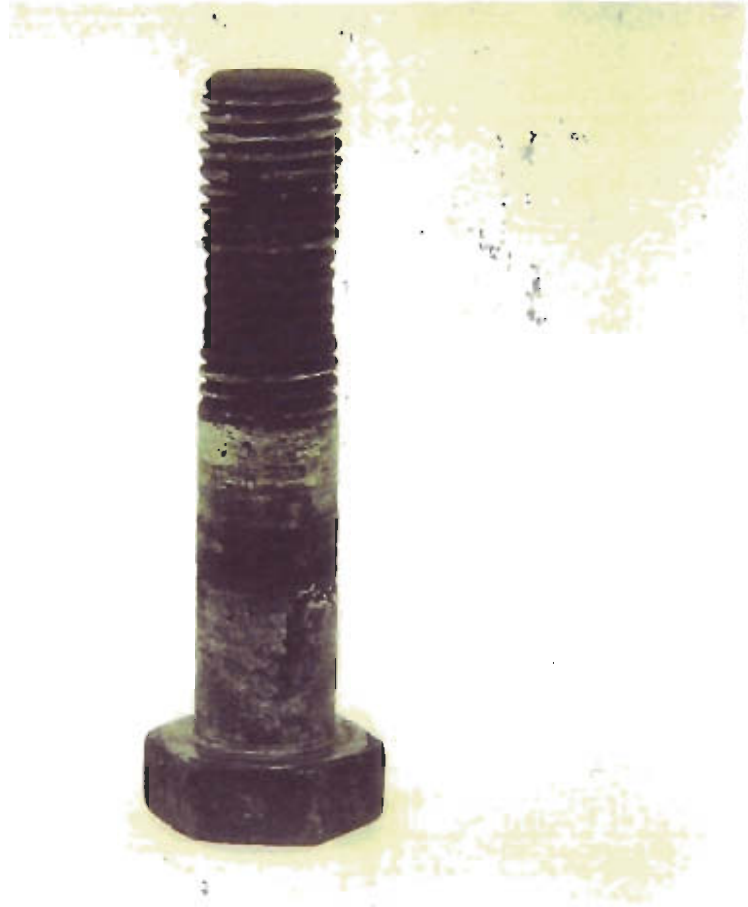
The bolt from the rear right-hand (RR) position was in relatively poor condition. The lower half of the plain shank had suffered from significant pitting corrosion ⁹. The threaded portion had suffered from considerable mechanical damage. Threads in the upper part had been worn away by a combination of corrosion and abrasive wear, parts of the thread in the lower part had been broken off and the remainder had been plastically deformed around the full circumference. The plastic deformation was therefore consistent with the nut having been forced off the bolt under load.

The rear right hand M24 bolt from the rear fuel tank

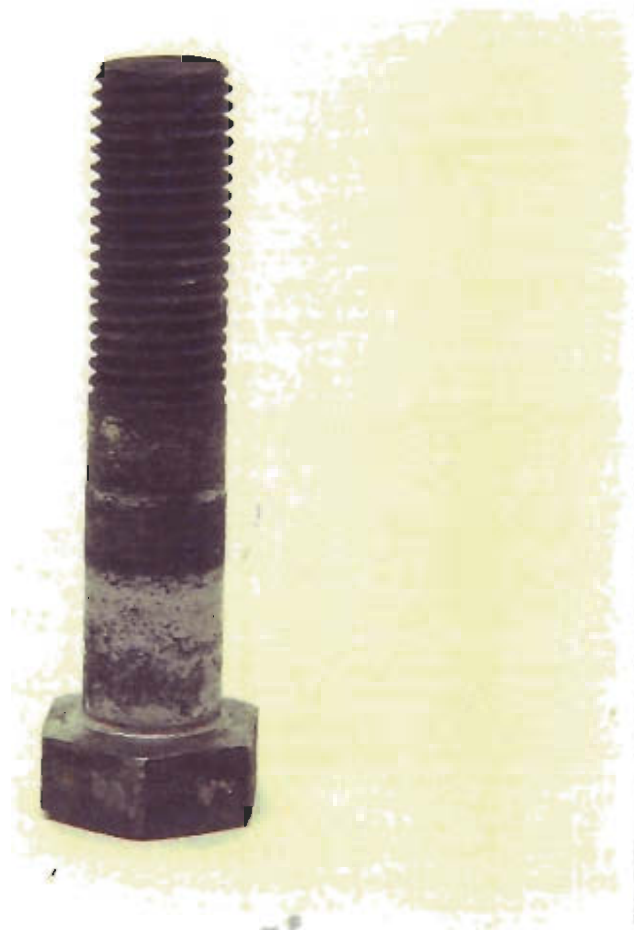
The bolt from the rear left-hand (RL) position was in relatively good condition. It had suffered minor corrosion over the lower part of the plain shank and some minor thread crown damage over the upper half of the threaded part ¹⁰. This latter damage could have arisen as a result of abrasive contact between the bolt and the side of the bolt hole in the cradle.

Fig 17 The rear left hand M24 bolt from the rear fuel tank

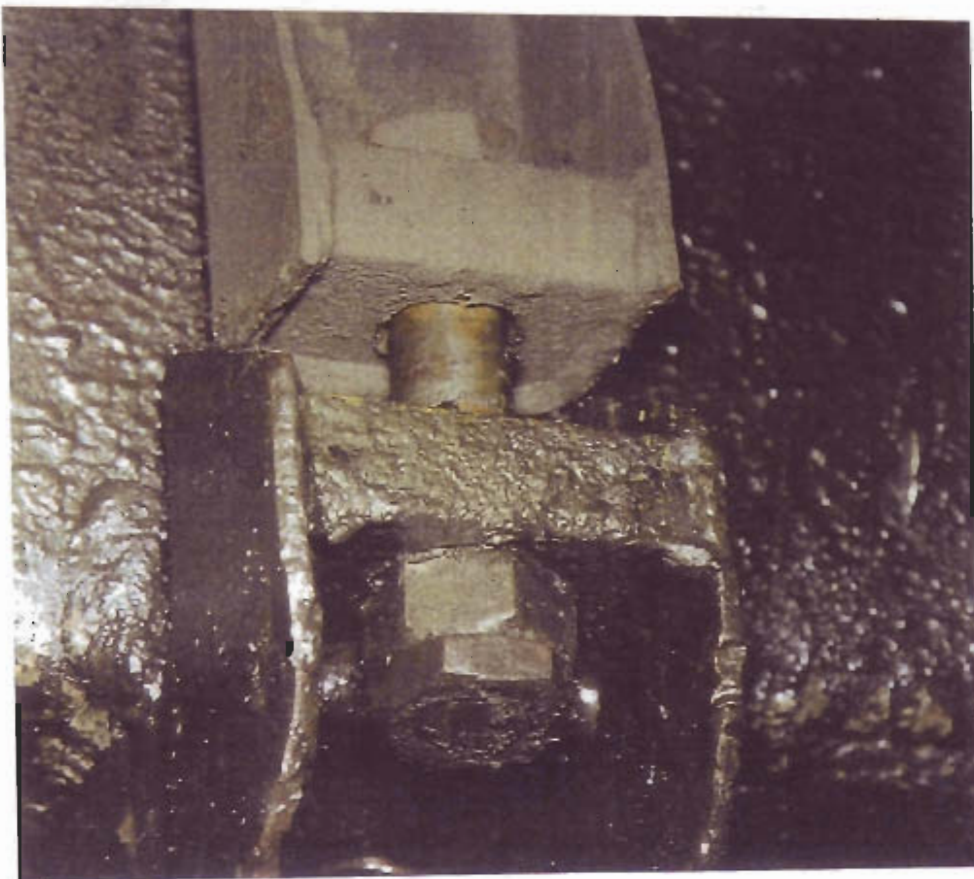
Fig 12 The front left hand M24 bolt on the rear fuel tank

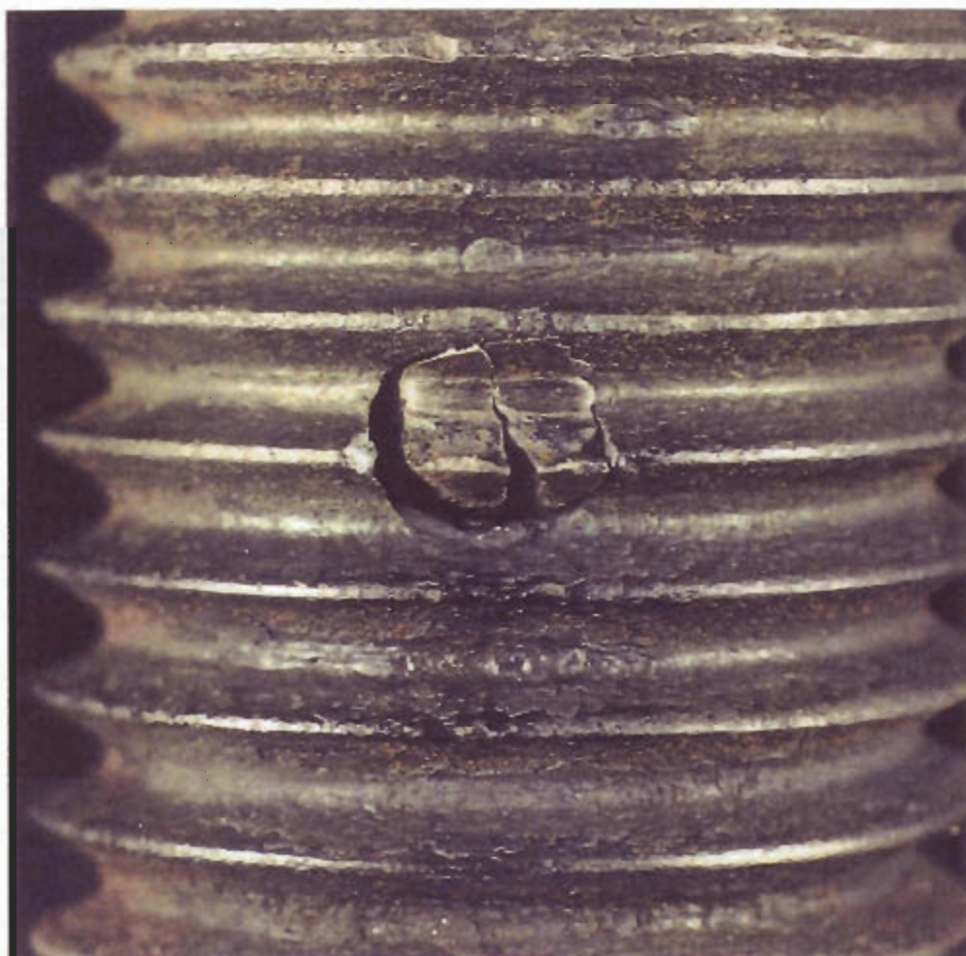
The thread profile in the end of the split pin in the front left hand M24 bolt

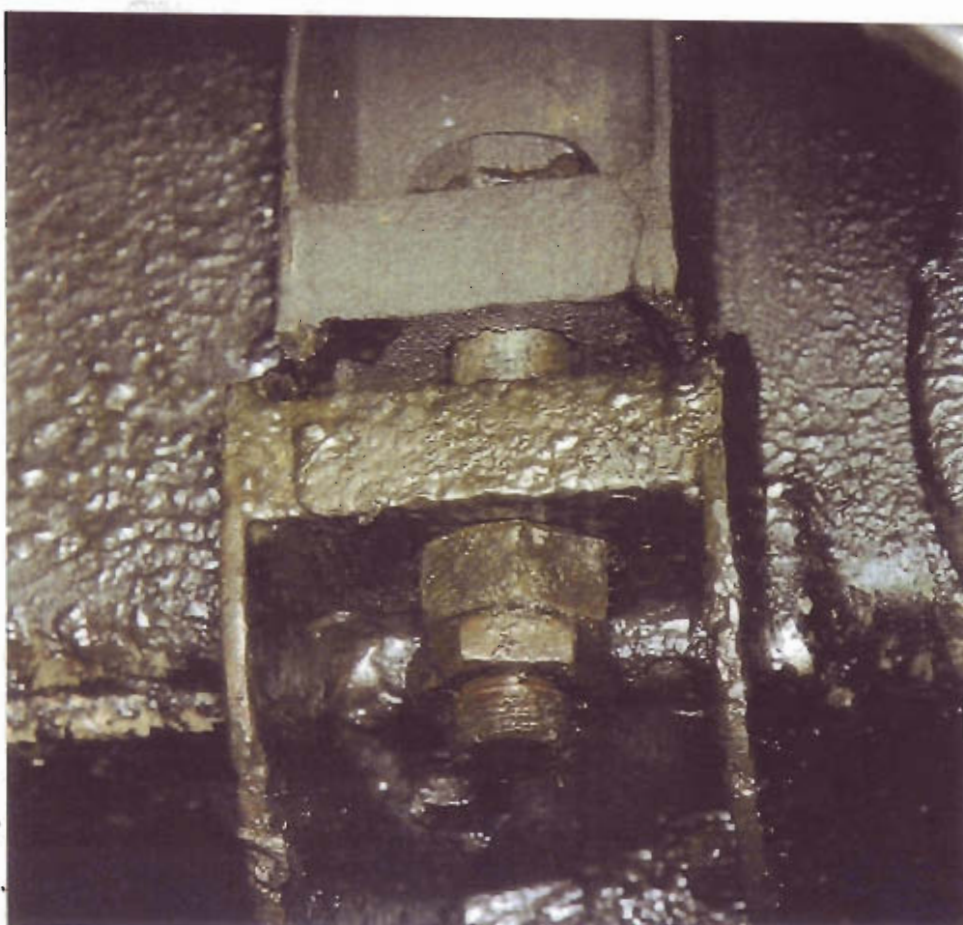
Fig 13 The front right hand M24 bolt on the rear fuel tank

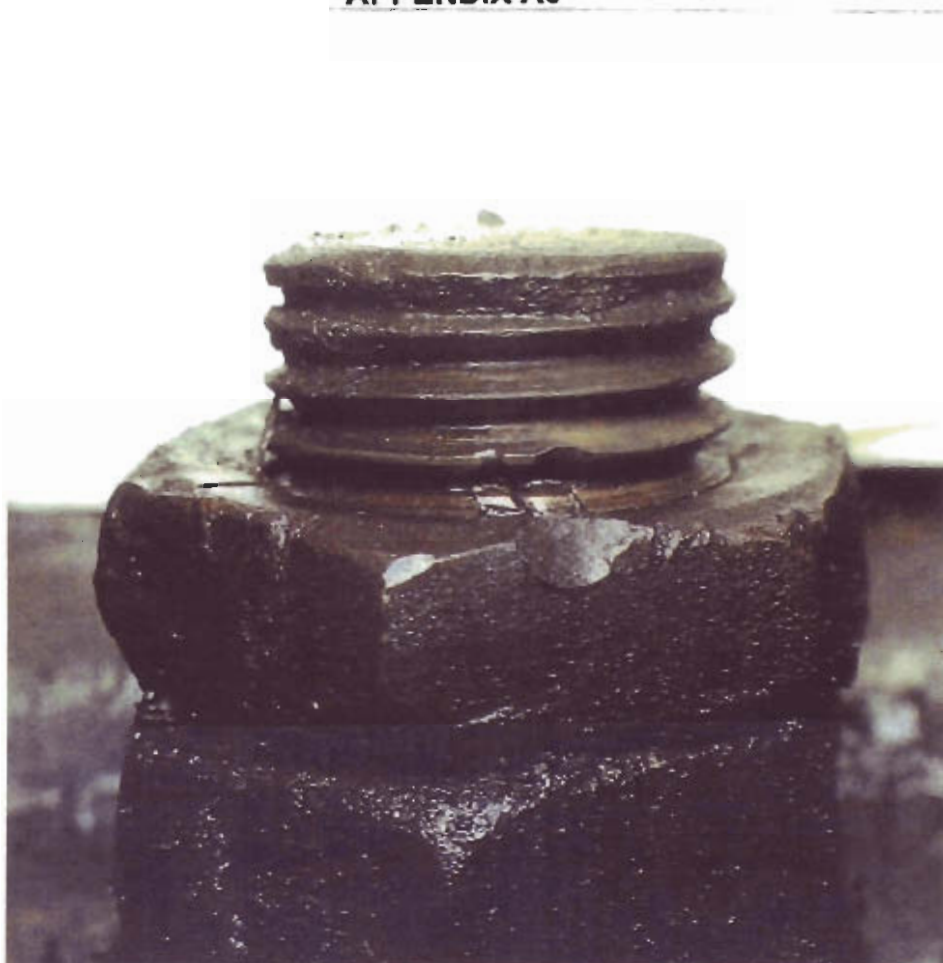
Fig 15 The end of the split pin and damage to the thread on the front right hand M24 bolt of the rear fuel tank

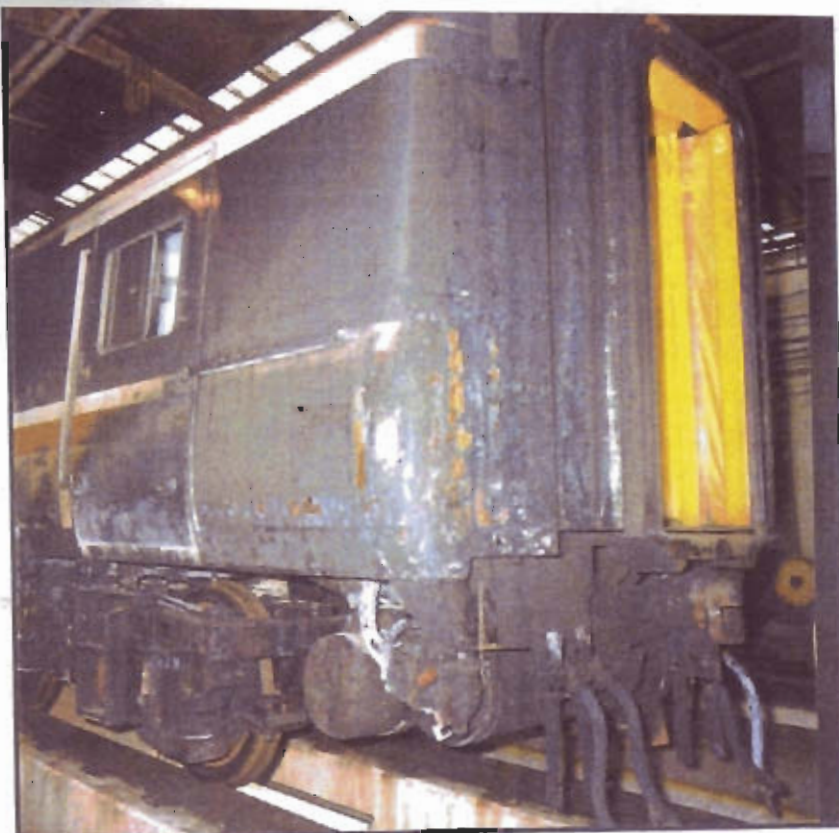
**Fig.3a - Rear view of tractor unit
after separation
APPENDIX A11**

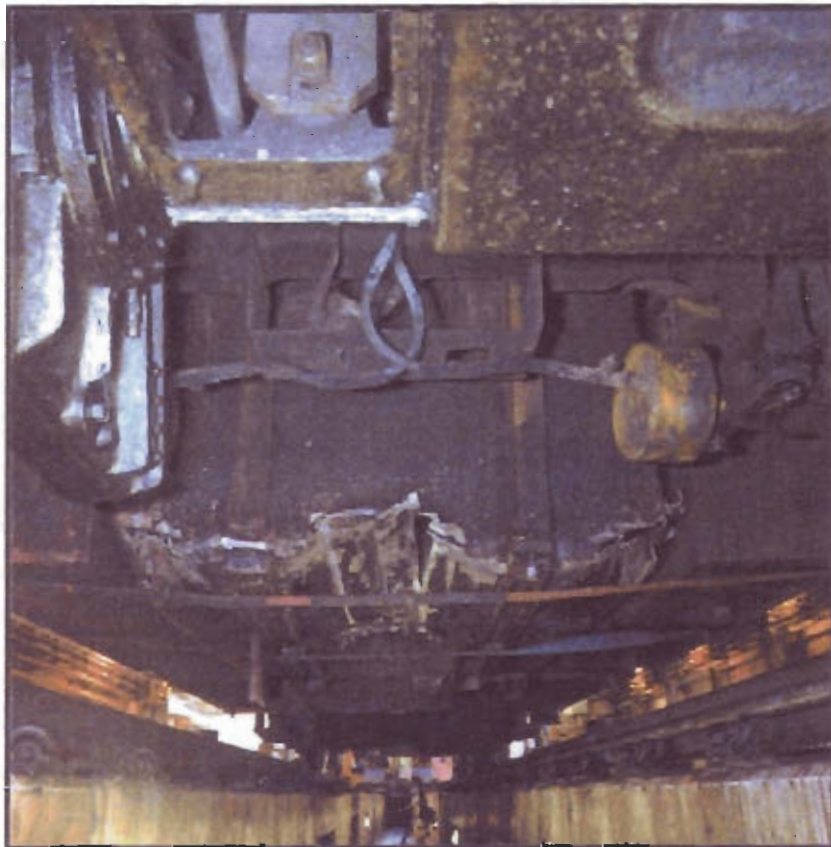
Fig.6a - Damage to rear of fuel tank

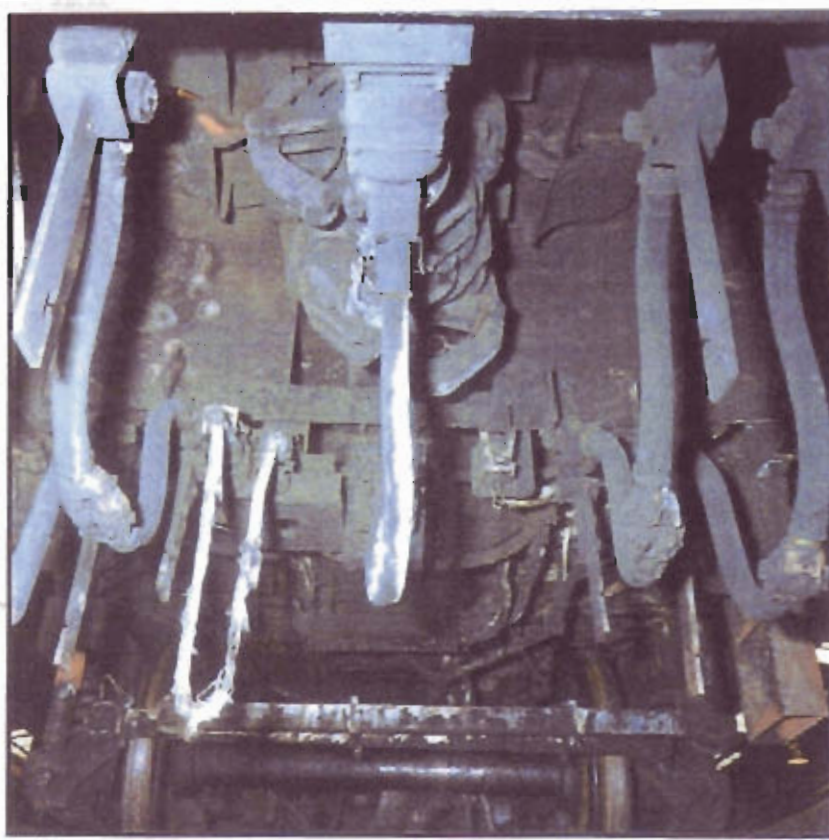
Underneath the first coach (coach H), the flexible pneumatic connections were all severely fire damaged, one connection on the RHS had parted. The electrical cables in this region were also burnt through, in places down to the bare wires¹⁹. There were a number of cables and fittings in this area underneath the coach that had also been burnt. Underneath the two wooden door steps there was considerable charring of the wood, more so on the LHS. There was also fire damage to the various fittings in this area and to the underfloor panels where what appeared to be a tar based protective material had melted and flowed. Underneath the front bogie of the lead coach were the remains of the plastic exit pipe from the toilet and a plastic vent pipe, which was from the overflow from the roof tank²⁰.

Fig.10a - Fire damage to connections between tractor unit and first coach

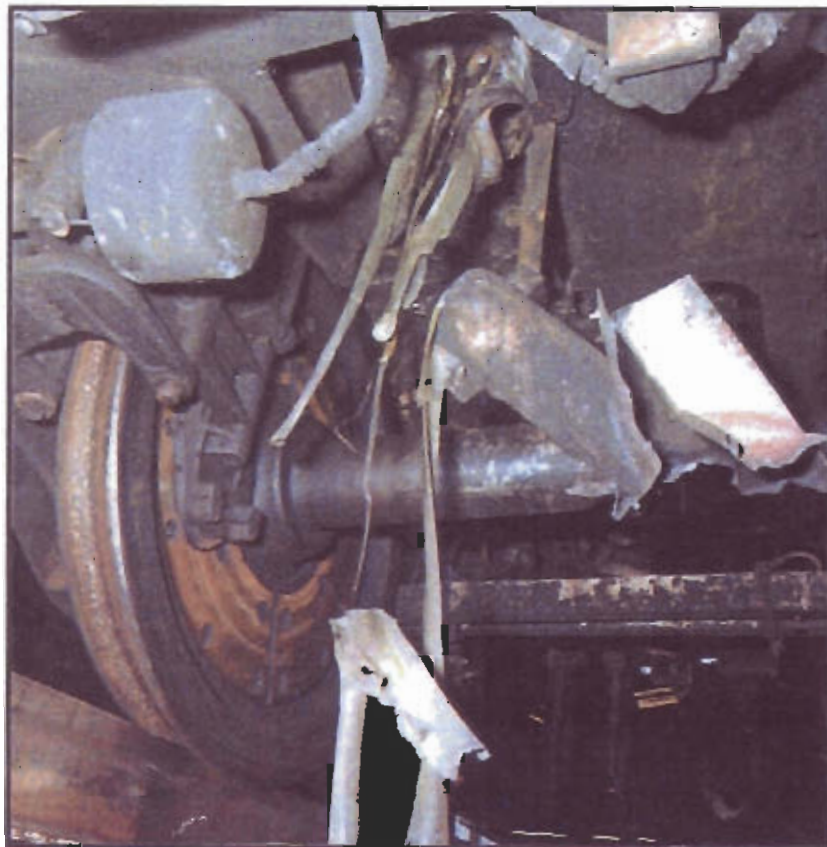
Fig.11b - Close up of fire damage from behind wheel

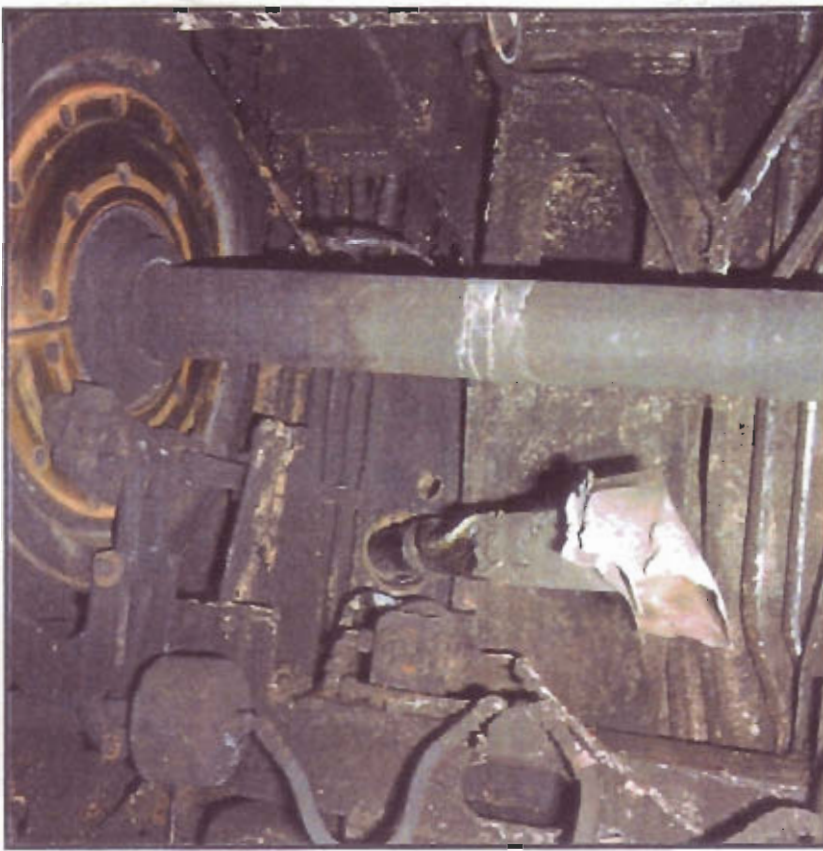
Fig.14 - Fire damage to WC outlet and overflow pipe towards front of coach G

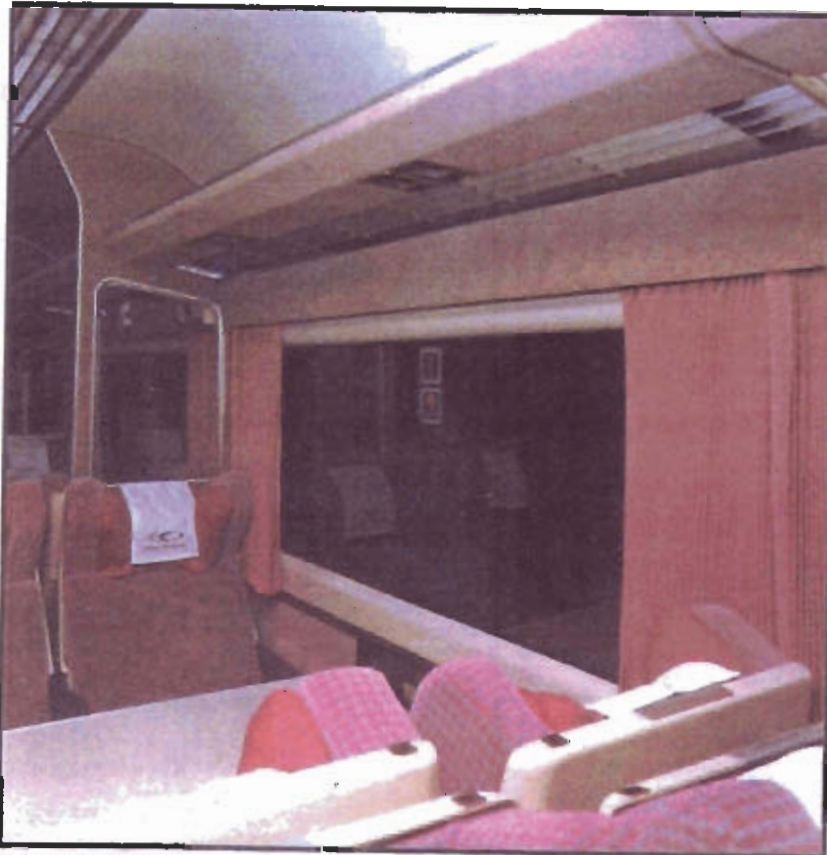
A general inspection of the condition of the interior of the coaches revealed little damage. In the compartments there was some evidence of very light sooting of horizontal surfaces and some traces of soot around the air conditioning grills in the ceilings of the first three coaches H, G and F. Beyond that there was little evidence of soot damage²². The sooting around the ceiling vents was probably due to ingress of smoke during the incident from the external fire and also from consumption of the air-conditioning paper filters in the forward coaches.

Fig.21 - A general view of the post fire first class accommodation

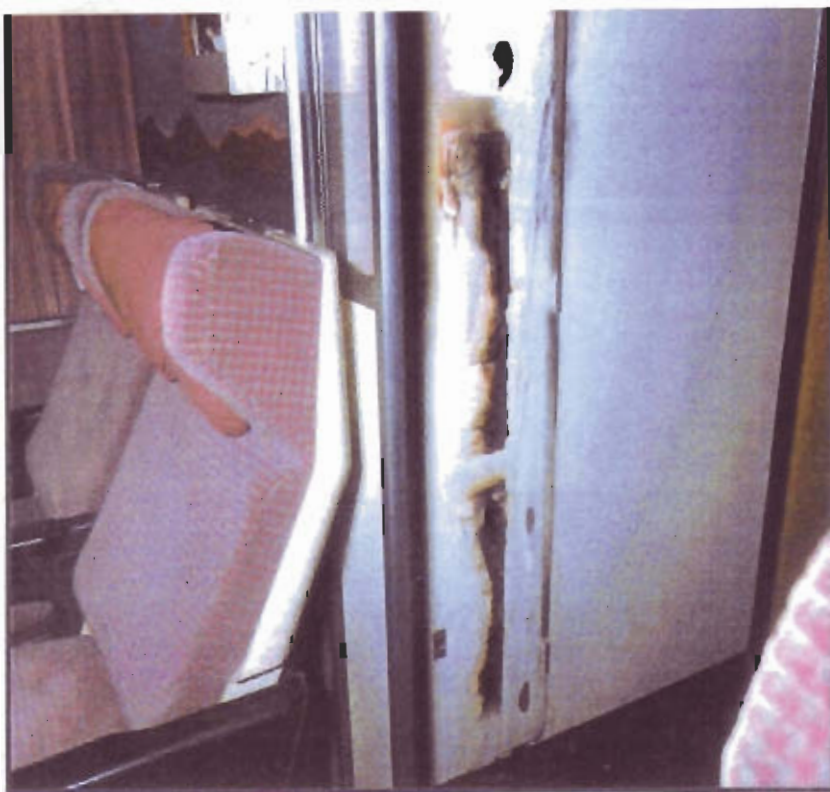
Fig.23 - The service duct access door adjacent to the toilet area of coach H

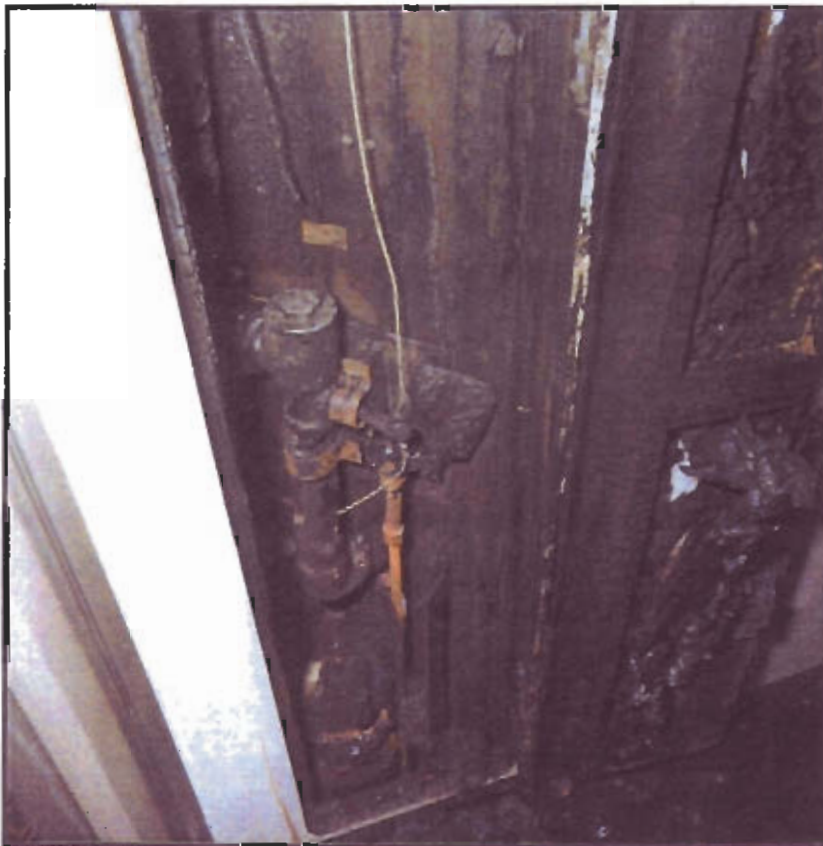
Fig.24b

In coach H the melamine panel had just been penetrated in two places²³ when it was extinguished by external action. The plastic items had been largely consumed and the plastic overflow pipe had disappeared completely. As a result the fire had spread to the access door. Such damage is indicative of a substantial fire within the duct²⁴. The adjacent toilet area showed significant soot deposition on horizontal

Fig.24 - A view of the fire damage in the service duct at the front of coach H

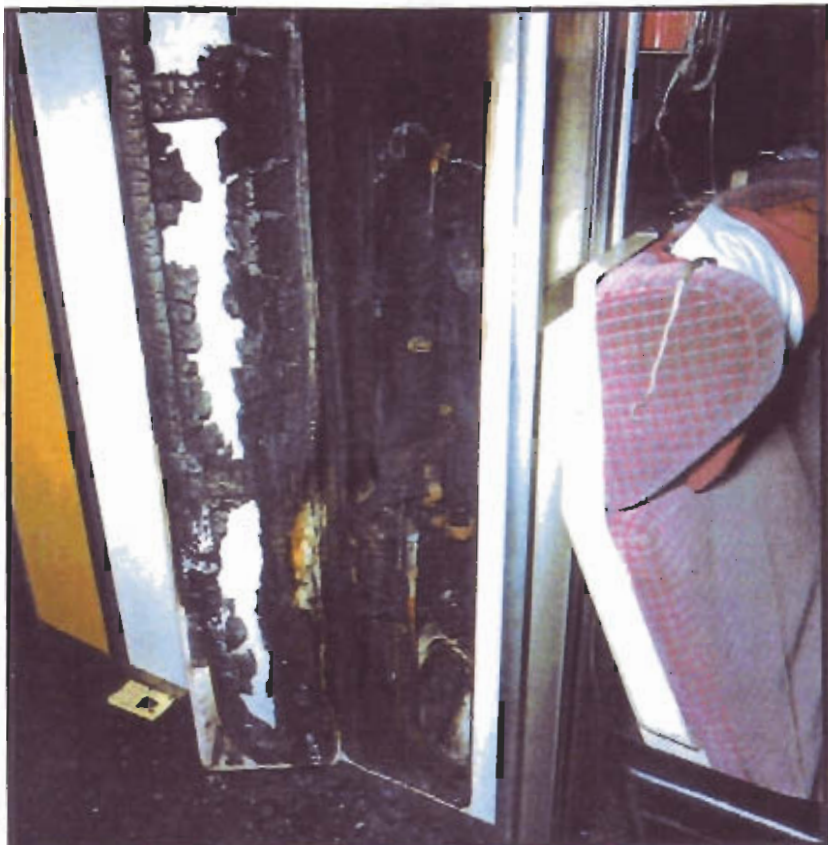
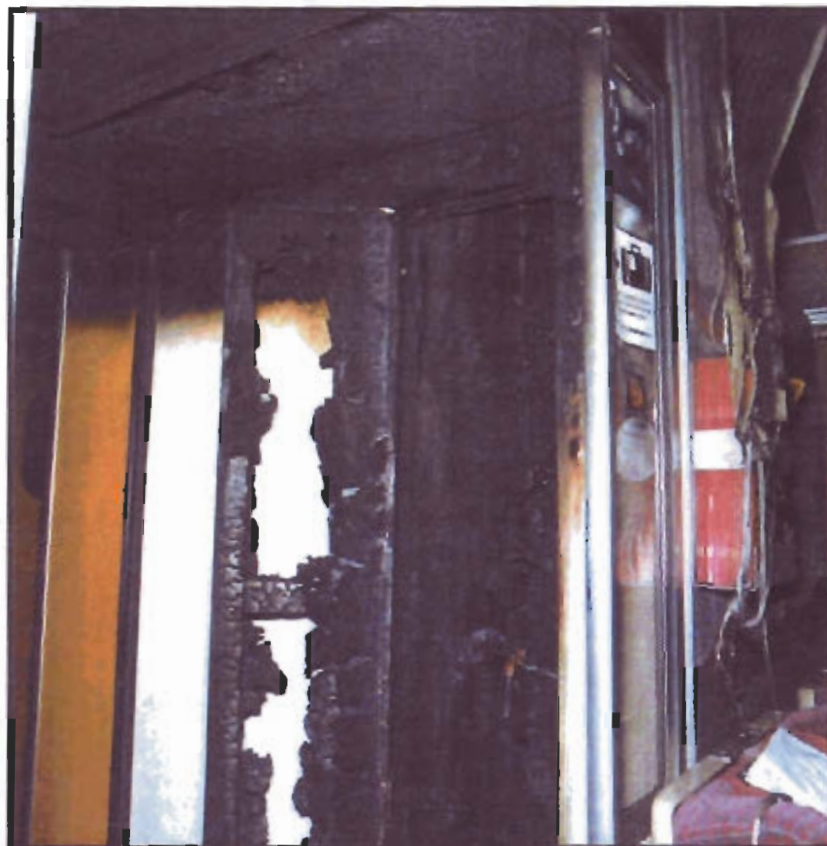
In the forward vestibule area of coach G the damage was much more severe since the fire had grown to a significantly larger size before being extinguished as a greater proportion of the fuels inside the duct had been consumed in the fire. The plastic overflow pipe was again burnt completely away²⁵. There had been significantly greater consumption of the access door, in particular the melamine panel, allowing the fire to spread into the vestibule area.

Fig.26 - The damage to the service duct due to the internal fire in coach G

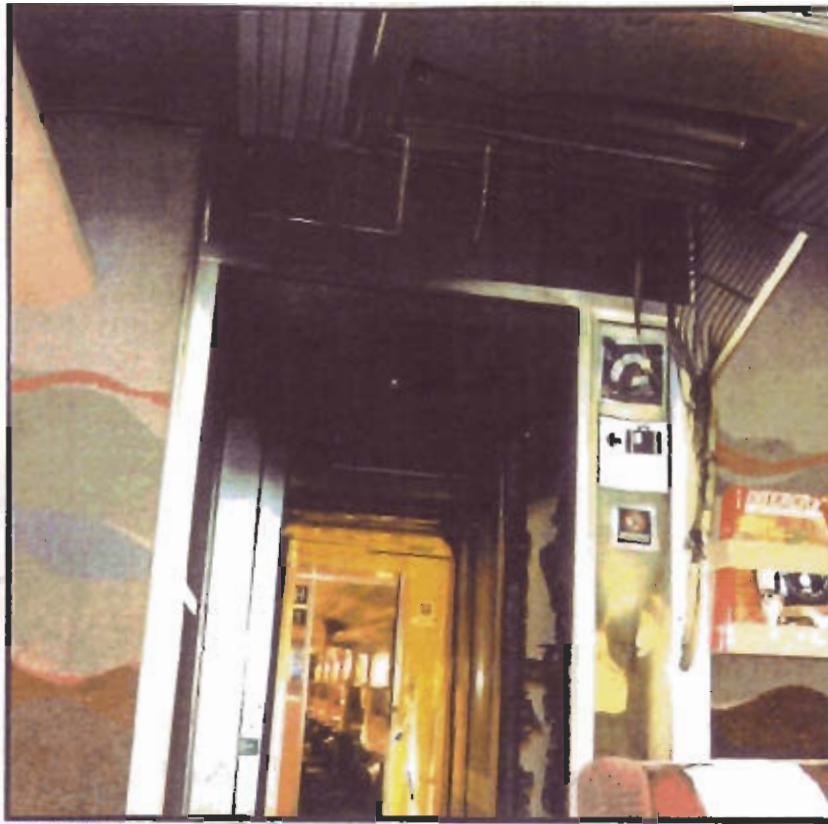
The damage pattern indicates that it had grown to such an extent that flames played on the ceiling and ignited the GRP ceiling panel. As a result flames and hot gases had penetrated into the compartment and distorted a fluorescent light cover and a ceiling panel²⁶. The polycarbonate dividing panel had also been severely distorted indicating temperatures there in excess of 200°C. Flames had also extended along the ceiling into the door area of the vestibule. The upper parts of the melamine panels had been consumed and the metallic ceiling panels showed heat and smoke damage. Again the toilet area was severely coated with soot²⁷, but in this case, was not just confined to the horizontal surfaces and was more severe than in coach H.

Fig.28 - A view from the front of the compartment of coach G showing damage in the compartment due to the fire in the vestibule

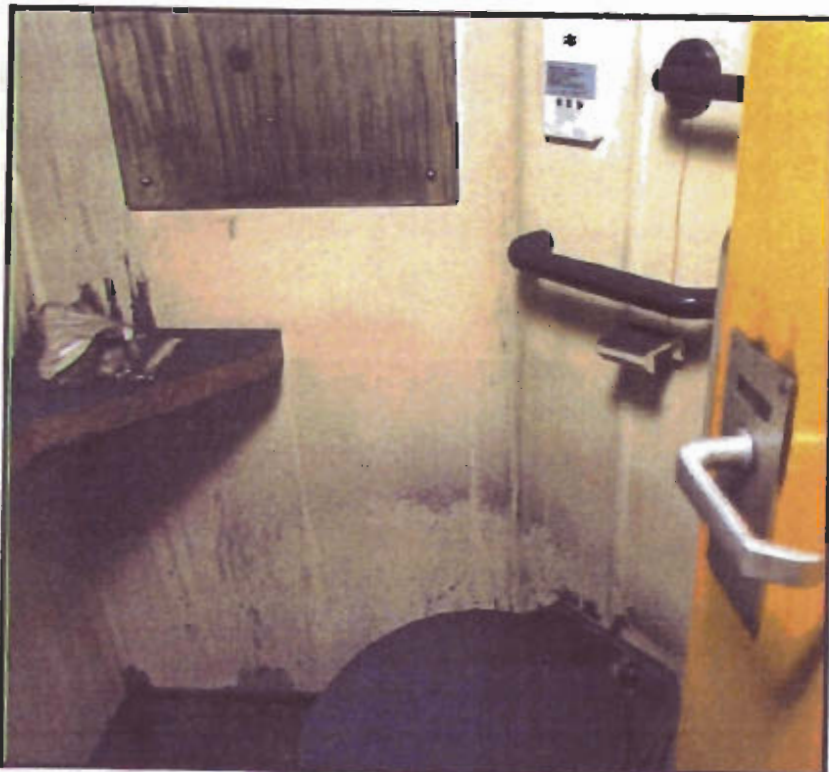
Fig.30 - Soot deposits in the forward toilet area of coach G

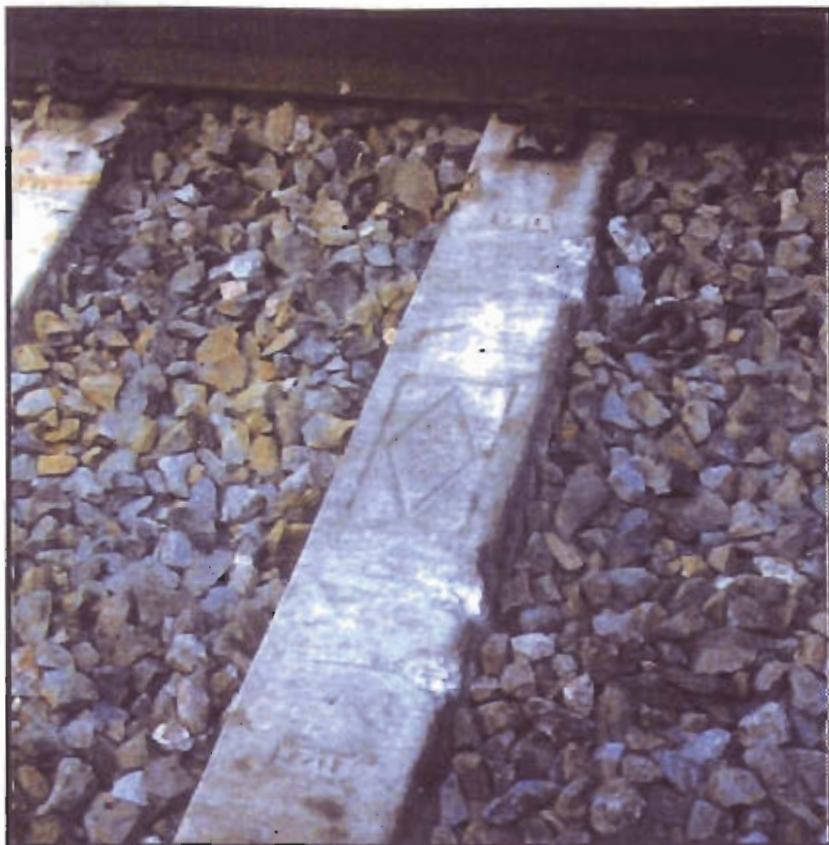
Contact, with either the centre of a sleeper or both it and the rail clips simultaneously, probably indicated that the fuel tank was leaking, because of the degree of tank wear or distortion inferred. Such damage was observed East of Taplow³¹ and within the station. This is consistent with the witness statements suggesting that ignition occurred within seconds of the tank dropping.

Fig.33 - Further damaged sleeper observed east of Taplow Station

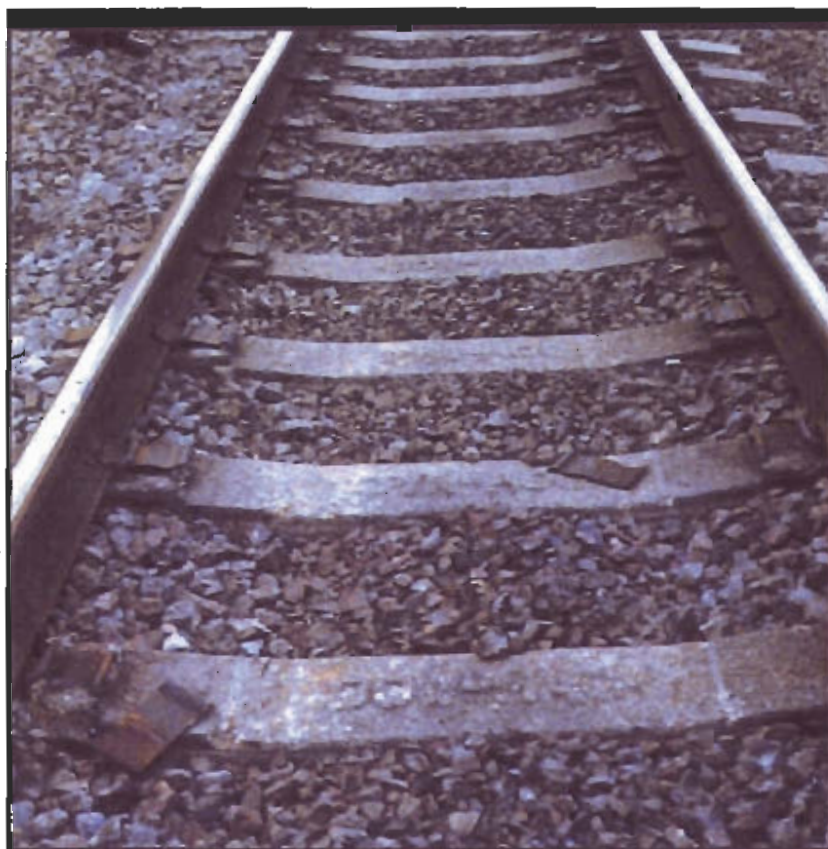
Of these the most likely was the first. The tank was constructed of aluminium, and any moving contact with the rusted metal clips holding the rails in place could cause a thermite reaction to occur in which the temperatures could be of the order of 3000°C.

Fig.35 - Disturbed rail fixing clips observed east of Taplow Station
