**A report of a train accident
that occurred on 27 February 1989
at Warrington
in the London Midland Region of British Railways**

**Letter to the Permanent Under Secretary of State
Department of Transport**

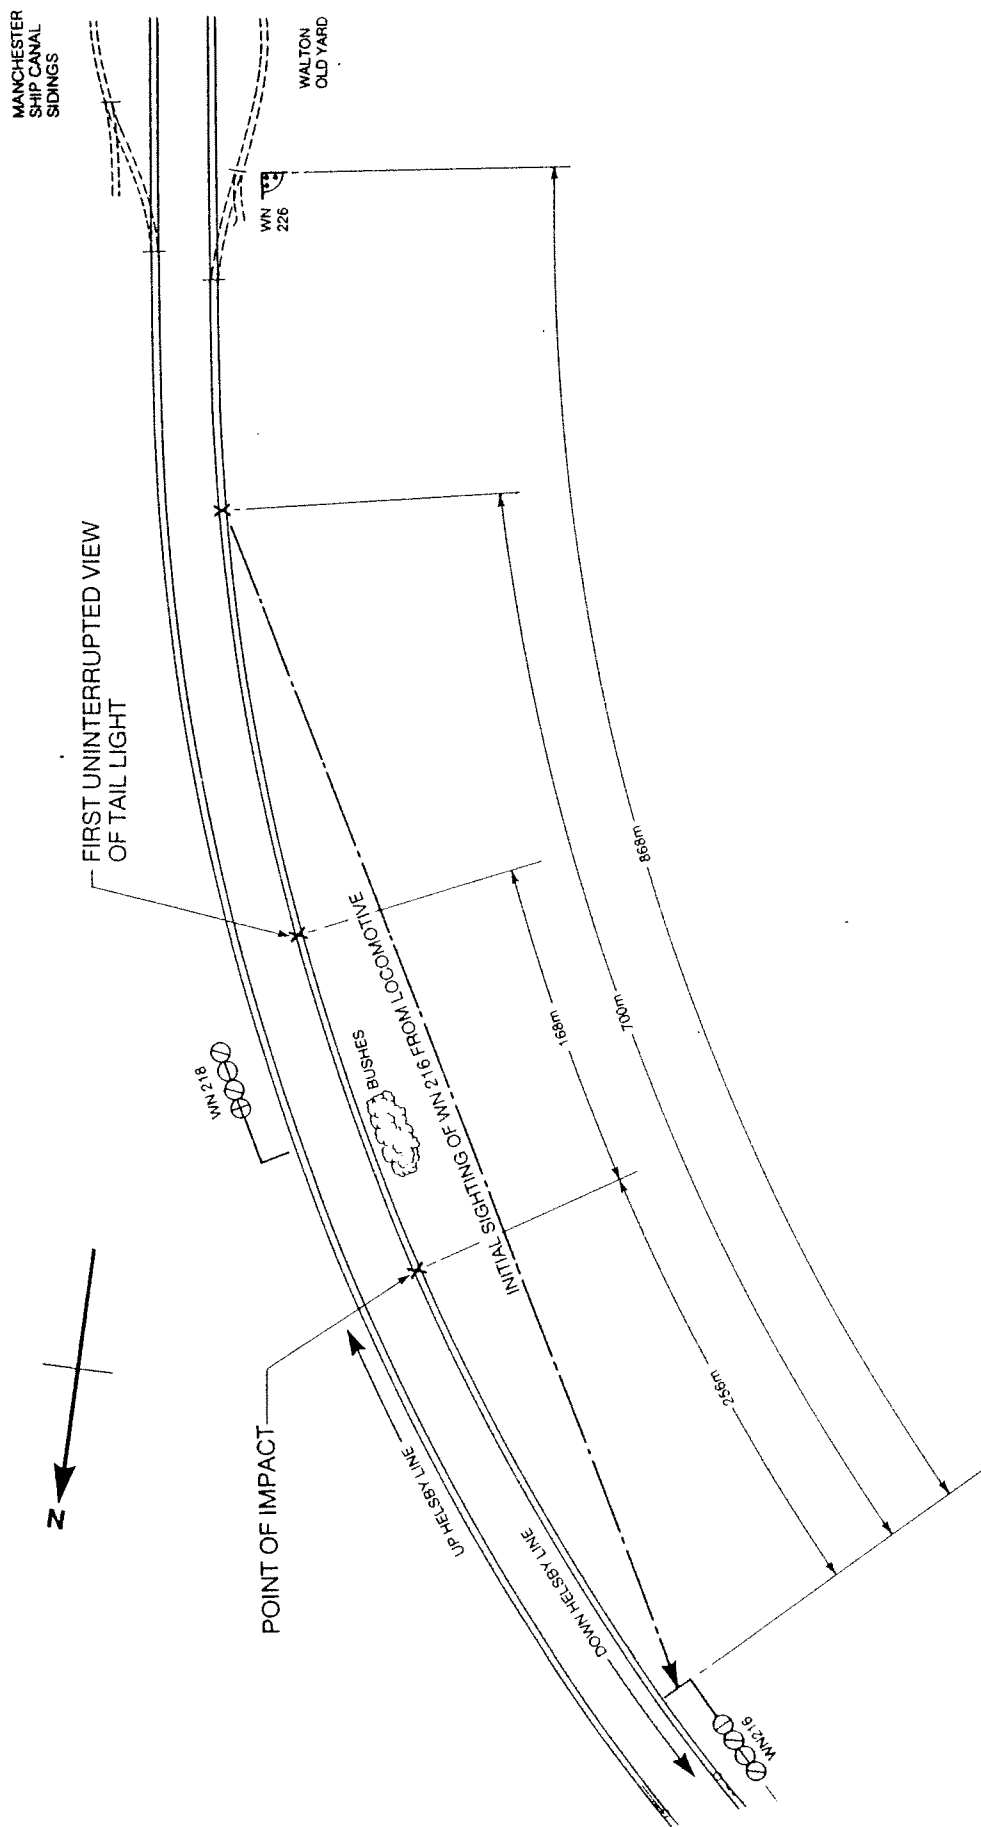
Figure 1 Collision at Warrington, 27 February 1989 (Not to scale)

A freight train travelling along a line on which 'permissive' working was allowed struck the rear of another freight train that was standing at a signal that had just changed to a clear aspect.

1 The collision occurred at 21.30 hours when 6S73, the 11.00 Dover to Mossend freight train, collided with the rearmost vehicle of 6E26, the 21.25 Walton Old Junction to Doncaster freight train, resulting in the deaths of the two men who were in the leading cab of locomotive No 85020 hauling 6S73.

2 The incident occurred on the Down Helsby line, which is a northbound passenger line on which 'permissive' working is allowed for freight trains; that is, freight trains are permitted to follow each other into the same section when drivers must be prepared to stop short of any train ahead. The location is about one mile south of Warrington Bank Quay Station and the Up and Down Helsby lines are part of the West Coast Main Line which is electrified by the 25 kV ac system. Sidings known as Walton Old Yard and Manchester Ship Canal lie respectively to the West and East of the Helsby lines. Entry to the Down Helsby from Walton Old Yard is by controlled ground position light signal WN226; this signal permits trains to proceed only as far as the line is clear. The departure, some 950 yards northwards, is controlled by WN216, a four aspect signal. A main line signal WN218 located close to the accident site controls movements on the Up Helsby line and into the Manchester Ship Canal sidings.
