RAILWAY ACCIDENTS

REPORT ON THE COLLAPSE OF  
CLIFTON HALL TUNNEL

which occurred on  
28th April 1953 at  
SWINTON

LONDON MIDLAND REGION  
BRITISH RAILWAYS

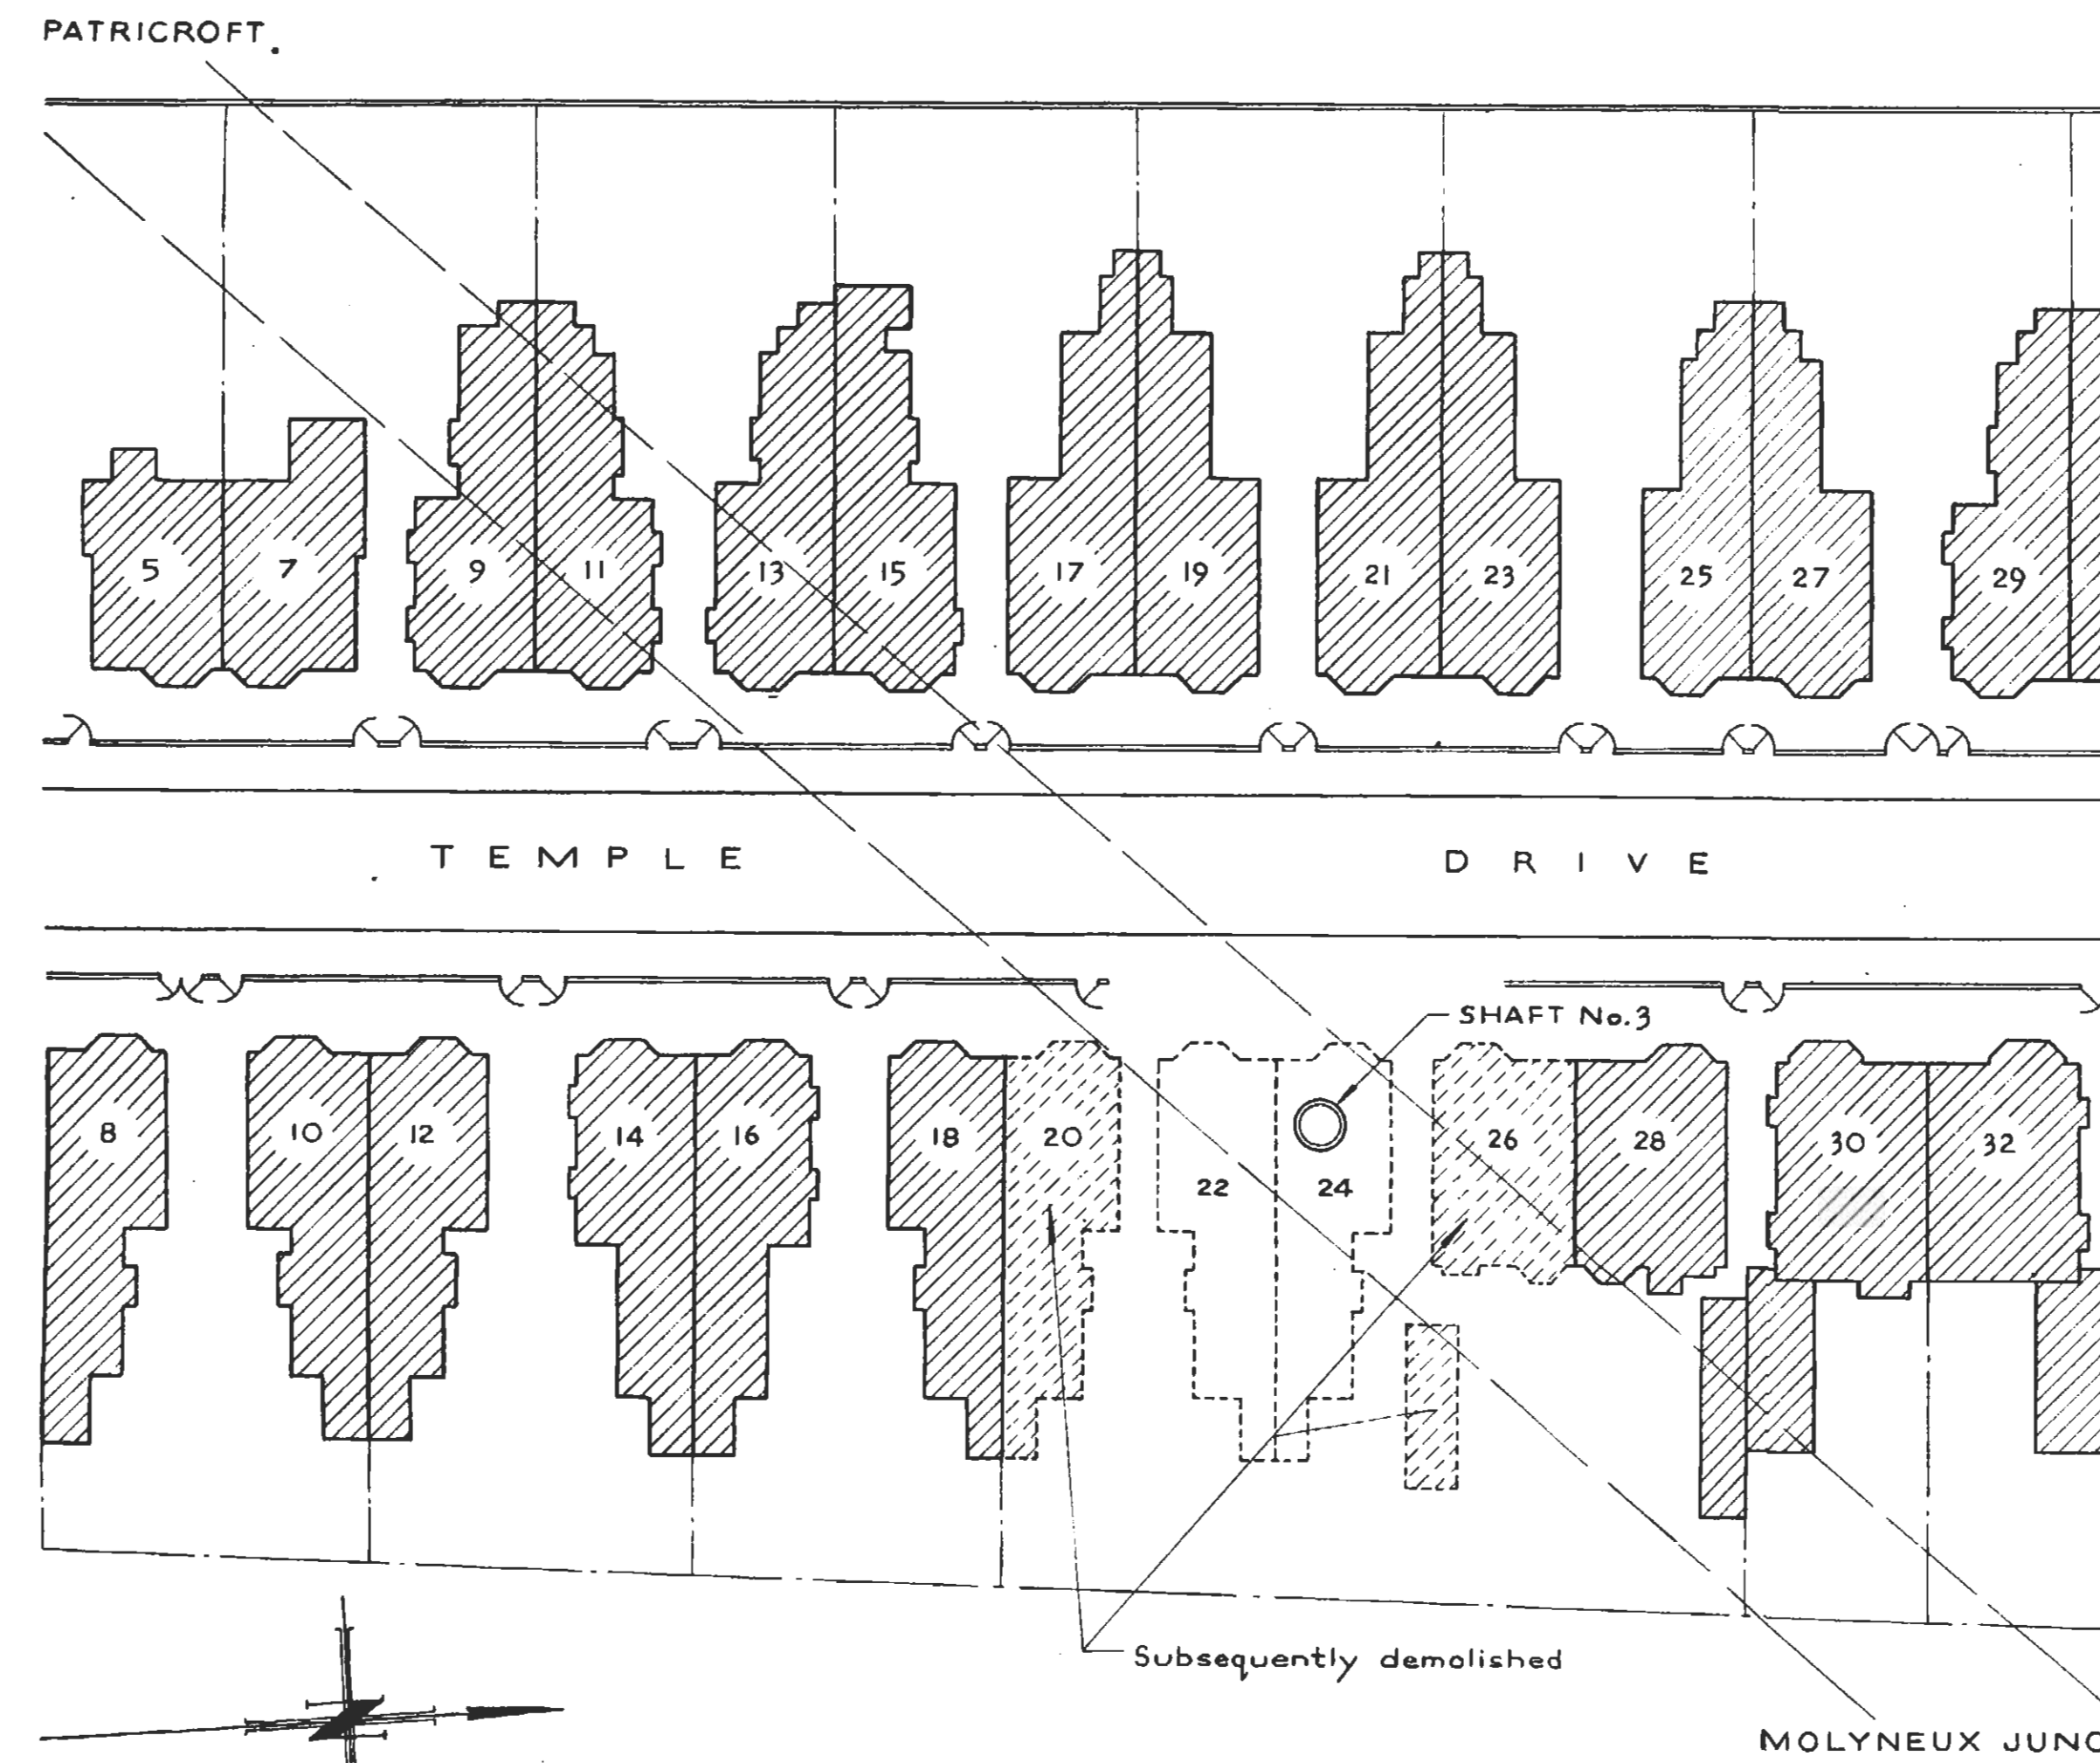
7. Extensive exploratory work was carried out after the accident in an endeavour to find the actual shafts. The ground under the collapsed houses in Temple Drive was excavated to a depth of 32 feet before the brick lining of No. 3 shaft was uncovered. It was approximately 8 feet in diameter and 9 inches thick, and traces were found of timber curbs such as were used in this type of construction when the tunnel was built over 100 years ago. Nos. 1, 4, 5 and 6 shafts were also located at varying depths from 3 feet to 14 feet below ground level. They were brick lined and varied from 9 feet to 10 feet in diameter. Nos. 2 and 5a shafts are apparently underneath existing buildings, and No. 1a, which is under a playing field, could not be found.

12. The next day on his return Mr. Owen, with Mr. Boivie and several members of their staff made a detailed examination from the top of an inspection wagon. Two blocks of brickwork had fallen from the roof of the tunnel directly over the Up line and had left gaps in the face ring each about 3 feet 6 inches long, with a length of about 4 feet 6 inches of brickwork between them (see Fig. 6). There were signs of butt joints across the crown of the arch at the ends of the damaged section and there was an area of patched brickwork at one end. The crown of the arch between the butt joints was about 2 inches lower than the general level of the tunnel.

The gaps were about 9 inches deep and 10 inches wide and they exposed to view a partly rotted timber. After scraping away some of the decayed pieces it was seen that the timber was about 9 inches deep by 6 inches wide and that there was more brickwork behind it. It would seem, therefore, that behind the face ring of the arch there was a piece of timber 11 to 12 feet long lying longitudinally in the second ring and extending from one butt joint to another.

FIG. 5 POSITION OF SHAFT No.3 AND OF THE HOUSES IN TEMPLE DRIVE  
SCALE: 40 FEET TO 1 INCH

FIG. 6 SKETCH SHOWING DAMAGE TO TUNNEL ROOF UNDER SHAFT No.3

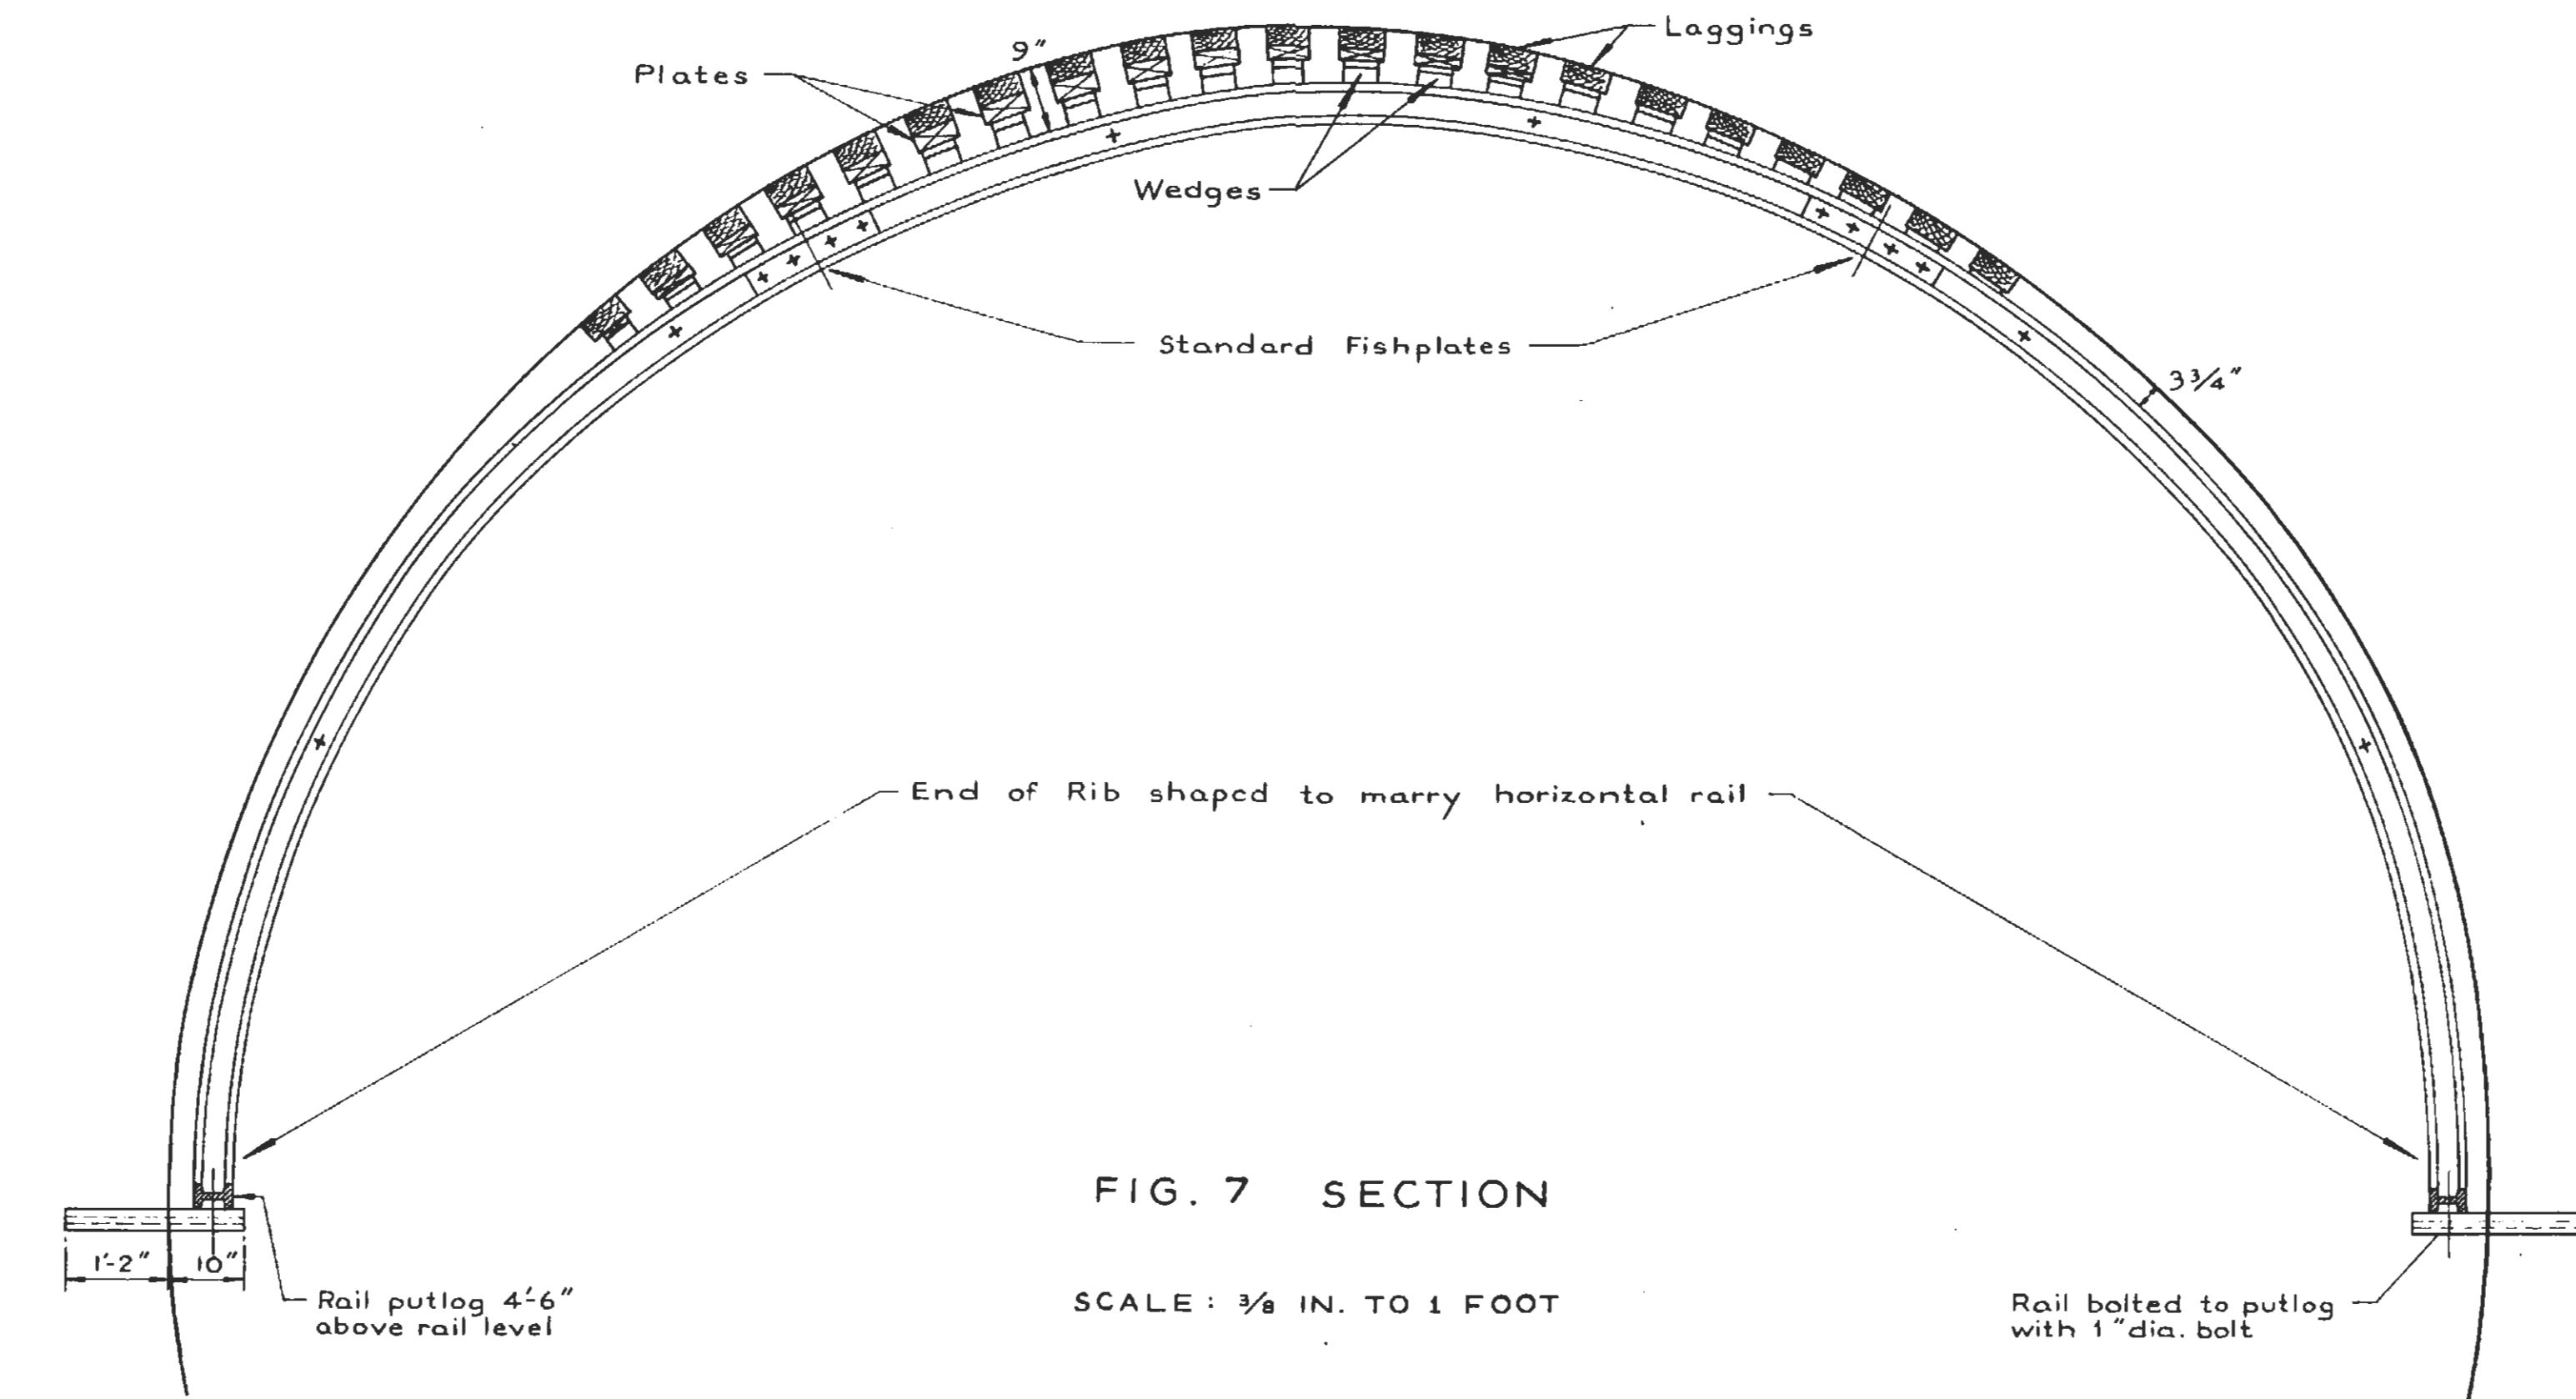
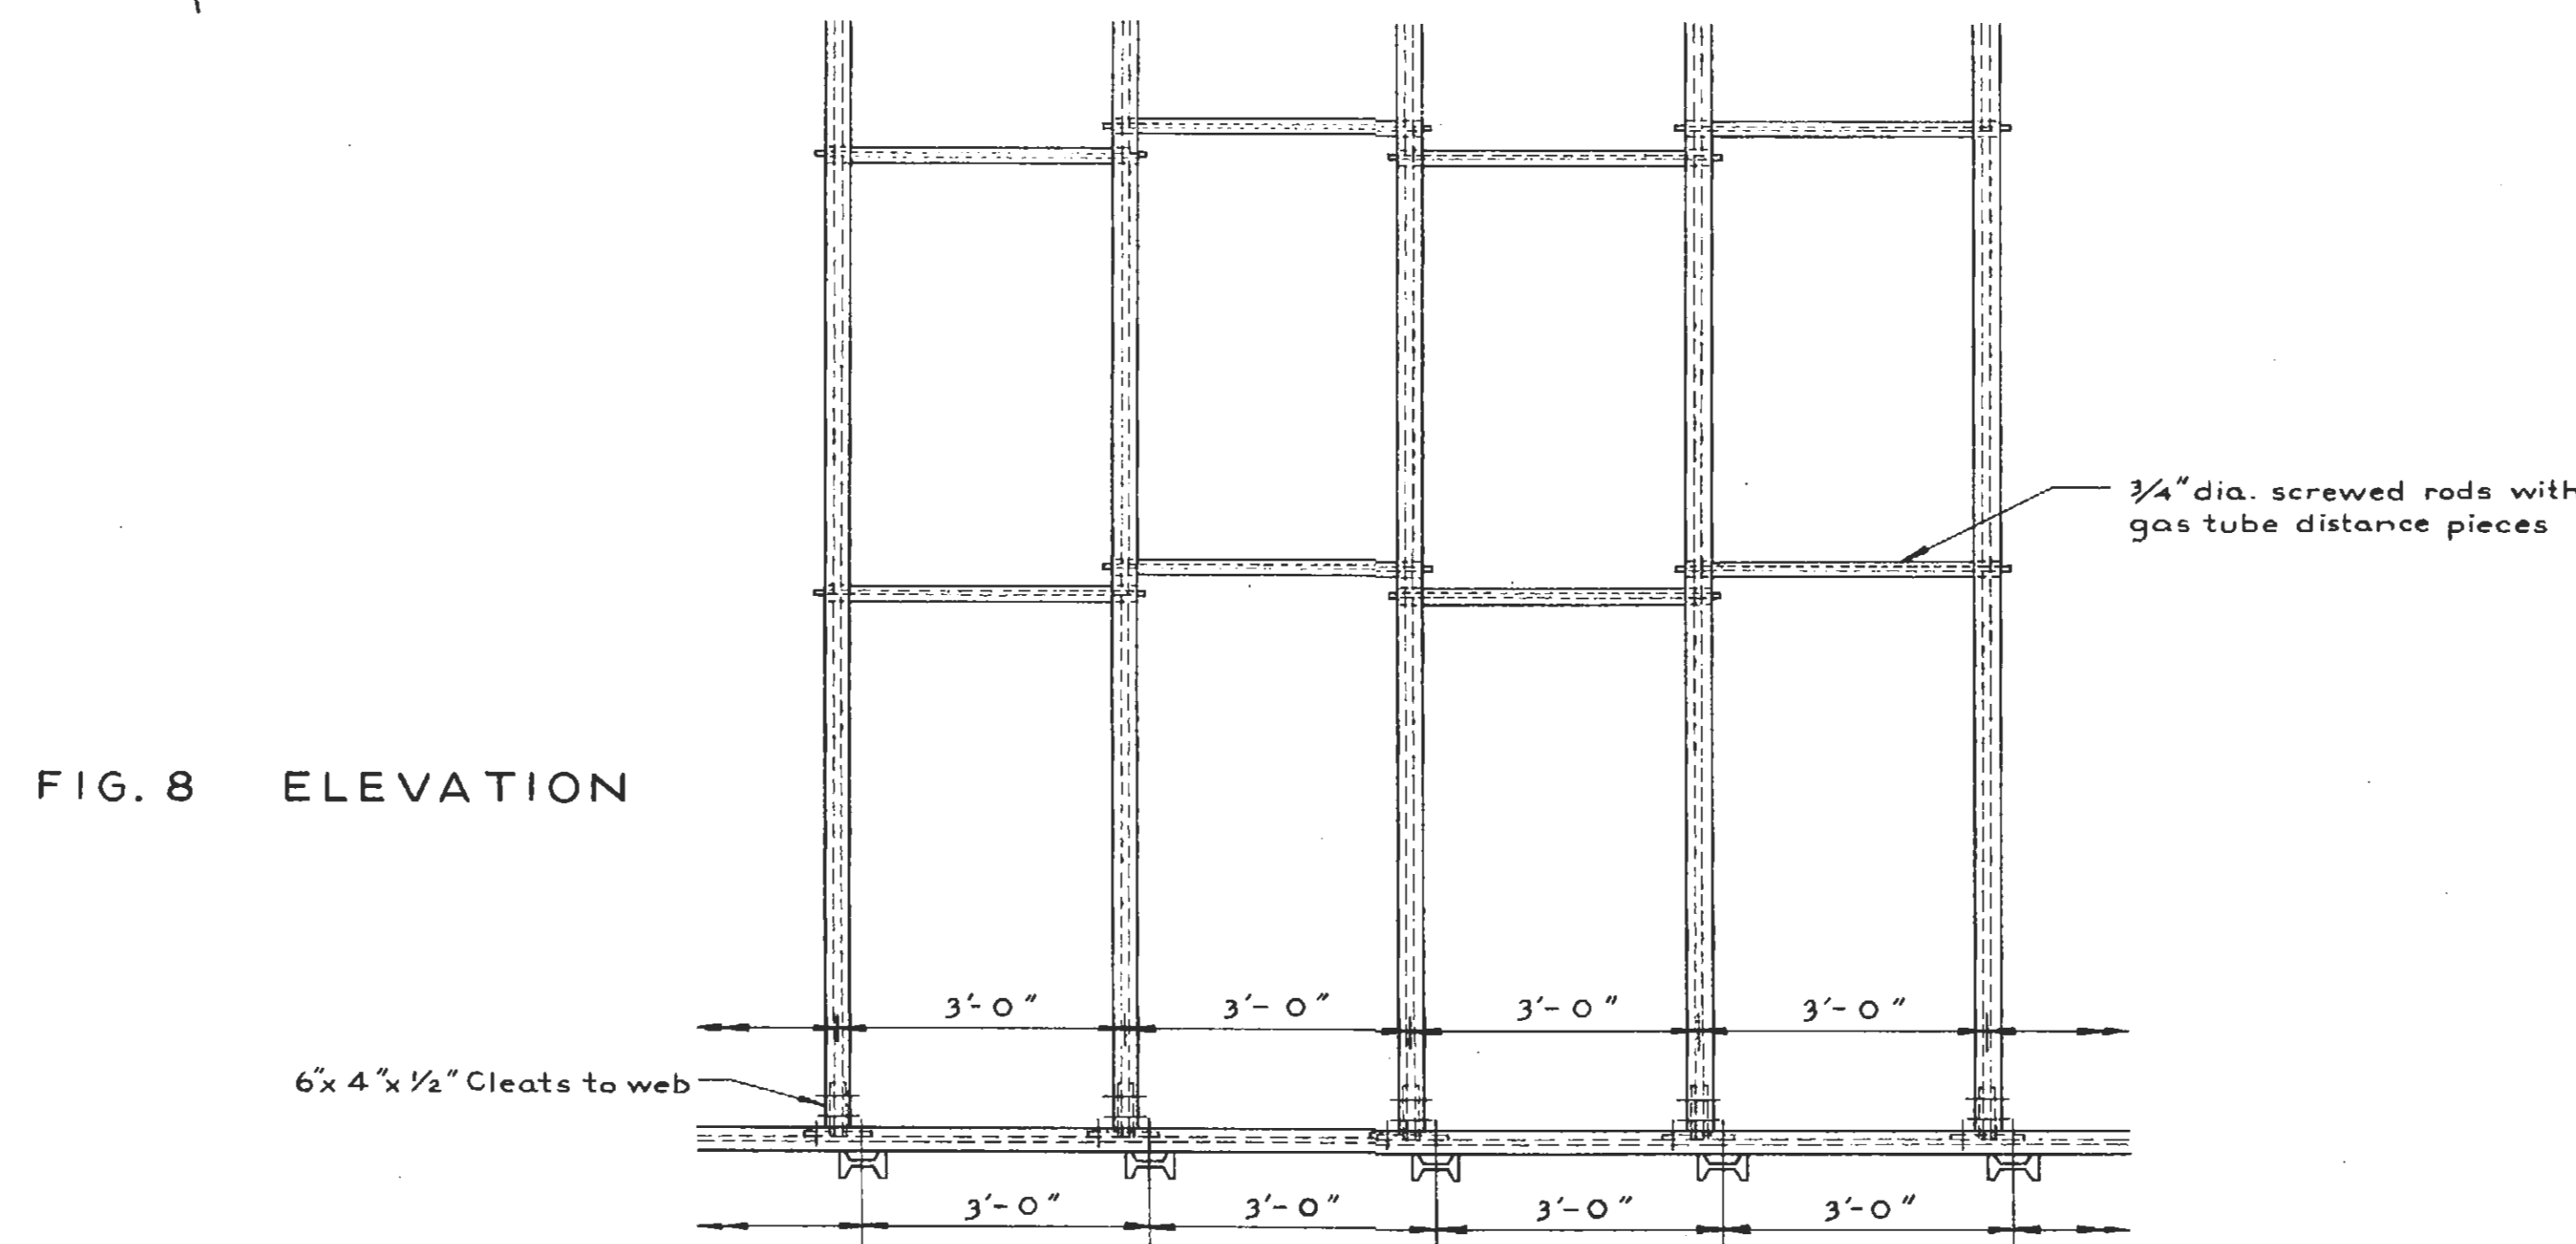
FIGS. 7 & 8 DETAILS OF STEEL RIBS DESIGNED FOR REINFORCING THE TUNNEL AT SHAFT No.3

13. As a result of this examination it was decided that the tunnel at this place should be strengthened with rail ribs in a manner similar to the existing reinforcement but of a better design. Whereas previously the rails forming the ribs had been curved on their minor axis, it was proposed now to curve them on their major axis, thereby giving them greater resistance to buckling. They were to rest on longitudinal rails supported by "putlogs", which were short lengths of rail cemented into the tunnel ring, the design being generally as shown in Figs. 7 and 8.

21. The possibility of timbers having been left in the arch rings under the other construction shafts cannot be discounted and steps have been taken to strengthen the tunnel roof where considered necessary. At No. 4 shaft where there was no reinforcement, eleven pairs of steel ribs made of rails bent on the major axis have now been placed on putlogs at 3 feet intervals and they have been packed tightly with wooden lagging to the sides and roof of the tunnel. At Nos. 5 and 5a shafts, where the existing rail reinforcement was over 50 years old, the brick lining has been further supported by placing pairs of the improved type of rib between the existing rails.

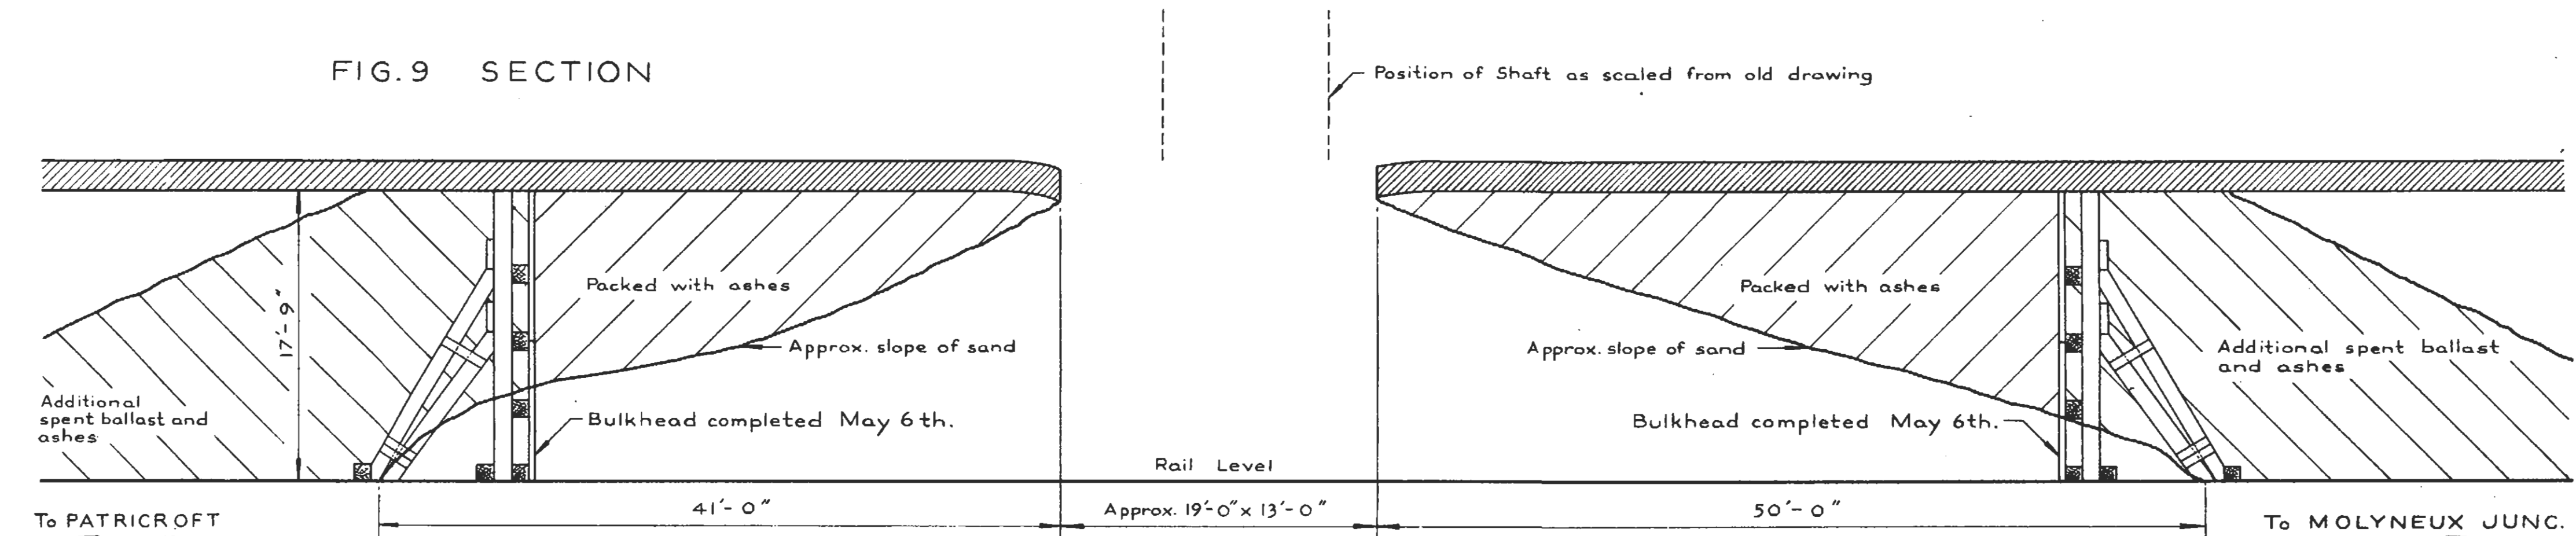
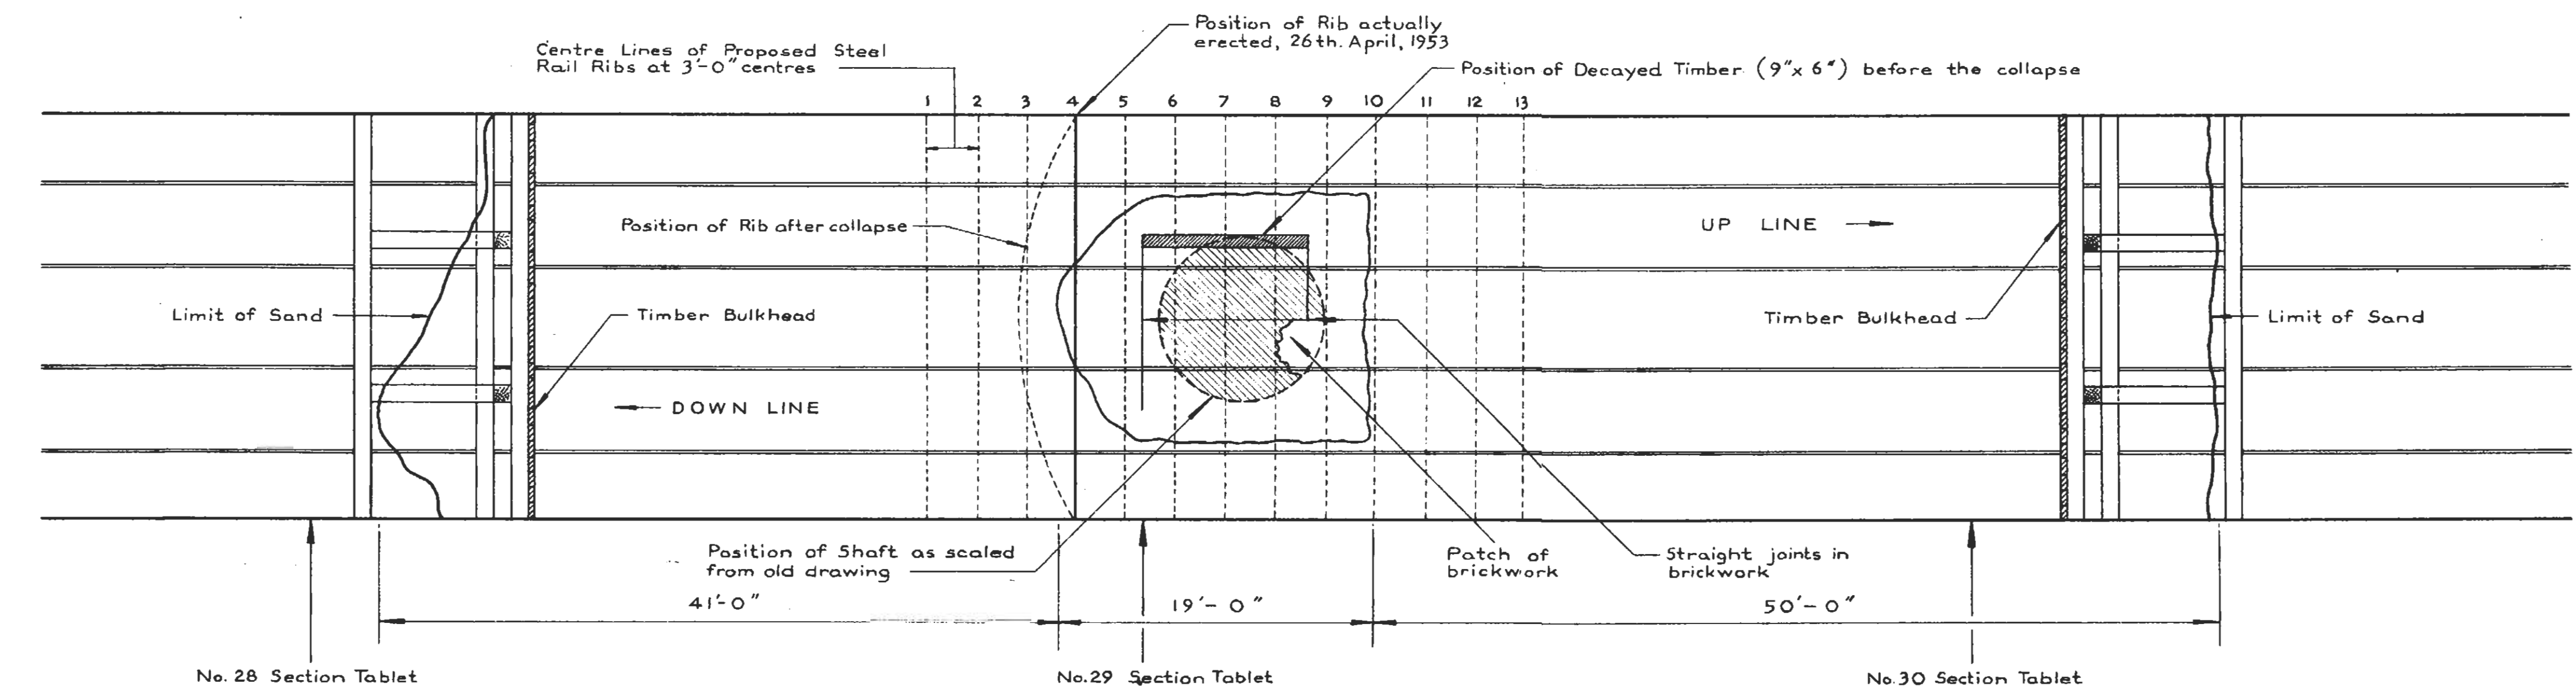
FIGS. 9 & 10 PLAN AND SECTION OF THE TUNNEL AT SHAFT No.3 AFTER THE ACCIDENT SHOWING TIMBER BULKHEADS

17. Mr. Owen was advised immediately, and he arrived on the scene 40 minutes after the occurrence. He found the tunnel completely blocked with sand, and loosened brickwork was still falling from the hole in the roof. The sand at the bottom was very wet and was mixed with lumps of clay; the rest of it was fairly dry. Mr. Owen arranged for the tunnel on either side of the fall to be packed solidly with ashes and for stout timber bulkheads to be erected as shown in Figs. 9 and 10. This work was completed by 6th May and since then the bulkheads have been further strengthened with additional filling as shown on the drawing.

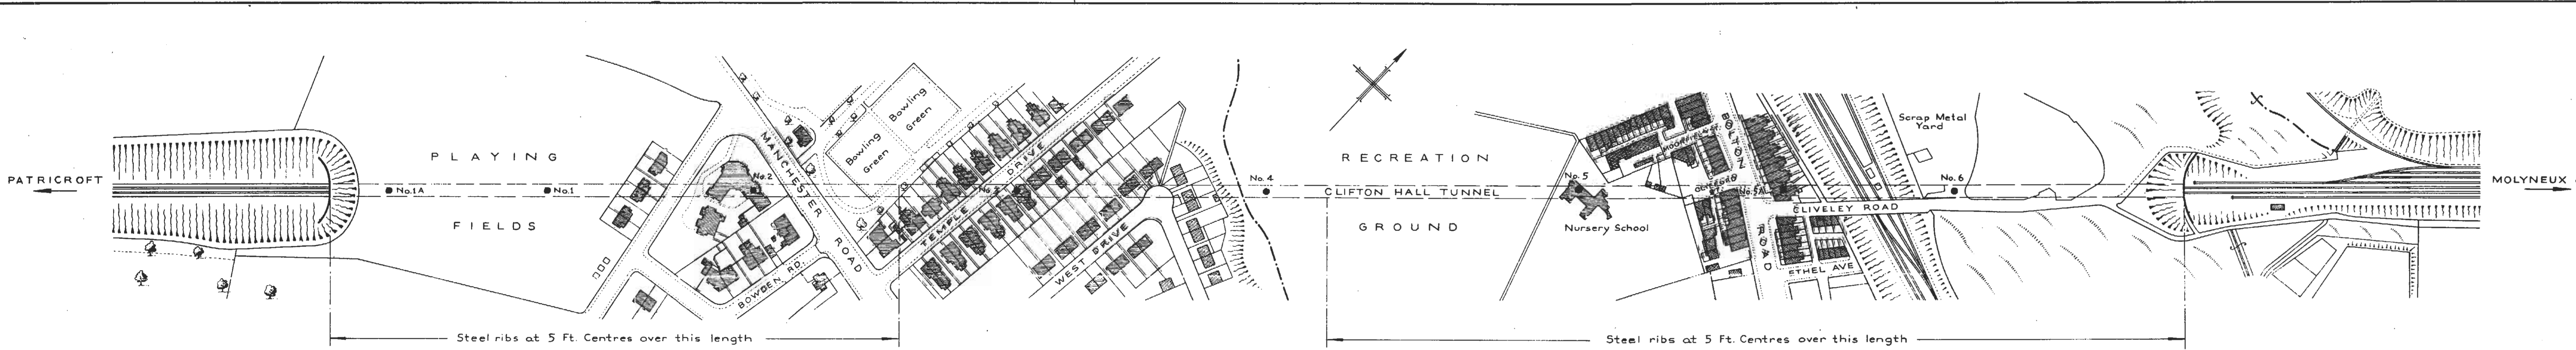
FIG. 2 PLAN OF SITE — 1953

2. When the tunnel was first opened the ground above it was pasture land crossed by two roads only as shown in Fig. 1 which has been compiled from the Parliamentary plan dated November 1844. This land has gradually been developed as illustrated in Fig. 2 and now forms part of the town of Swinton. Temple Drive crosses the tunnel diagonally and the positions of the houses directly over it are indicated in Fig. 5. Nos. 22 and 24 collapsed when the accident occurred, and the wall of No. 26 fell out. No. 20 and the remainder of No. 26 were subsequently demolished.

Eight shafts were sunk at the sites shown in Figs. 2 and 3 but they were filled in on completion of the tunnel. The ground above them has been built over in the course of urban development and as the position of the shafts was not marked on the sides of the tunnel, all traces of them were lost. The information about them was obtained from an old progress plan in the Civil Engineer's office and their positions were located by referring to the tablet numbers which were marked on the sides of the tunnel at 50 feet intervals. No. 3 shaft was directly under the place where No. 24, Temple Drive was afterwards built and it was here that the collapse of the tunnel roof occurred.

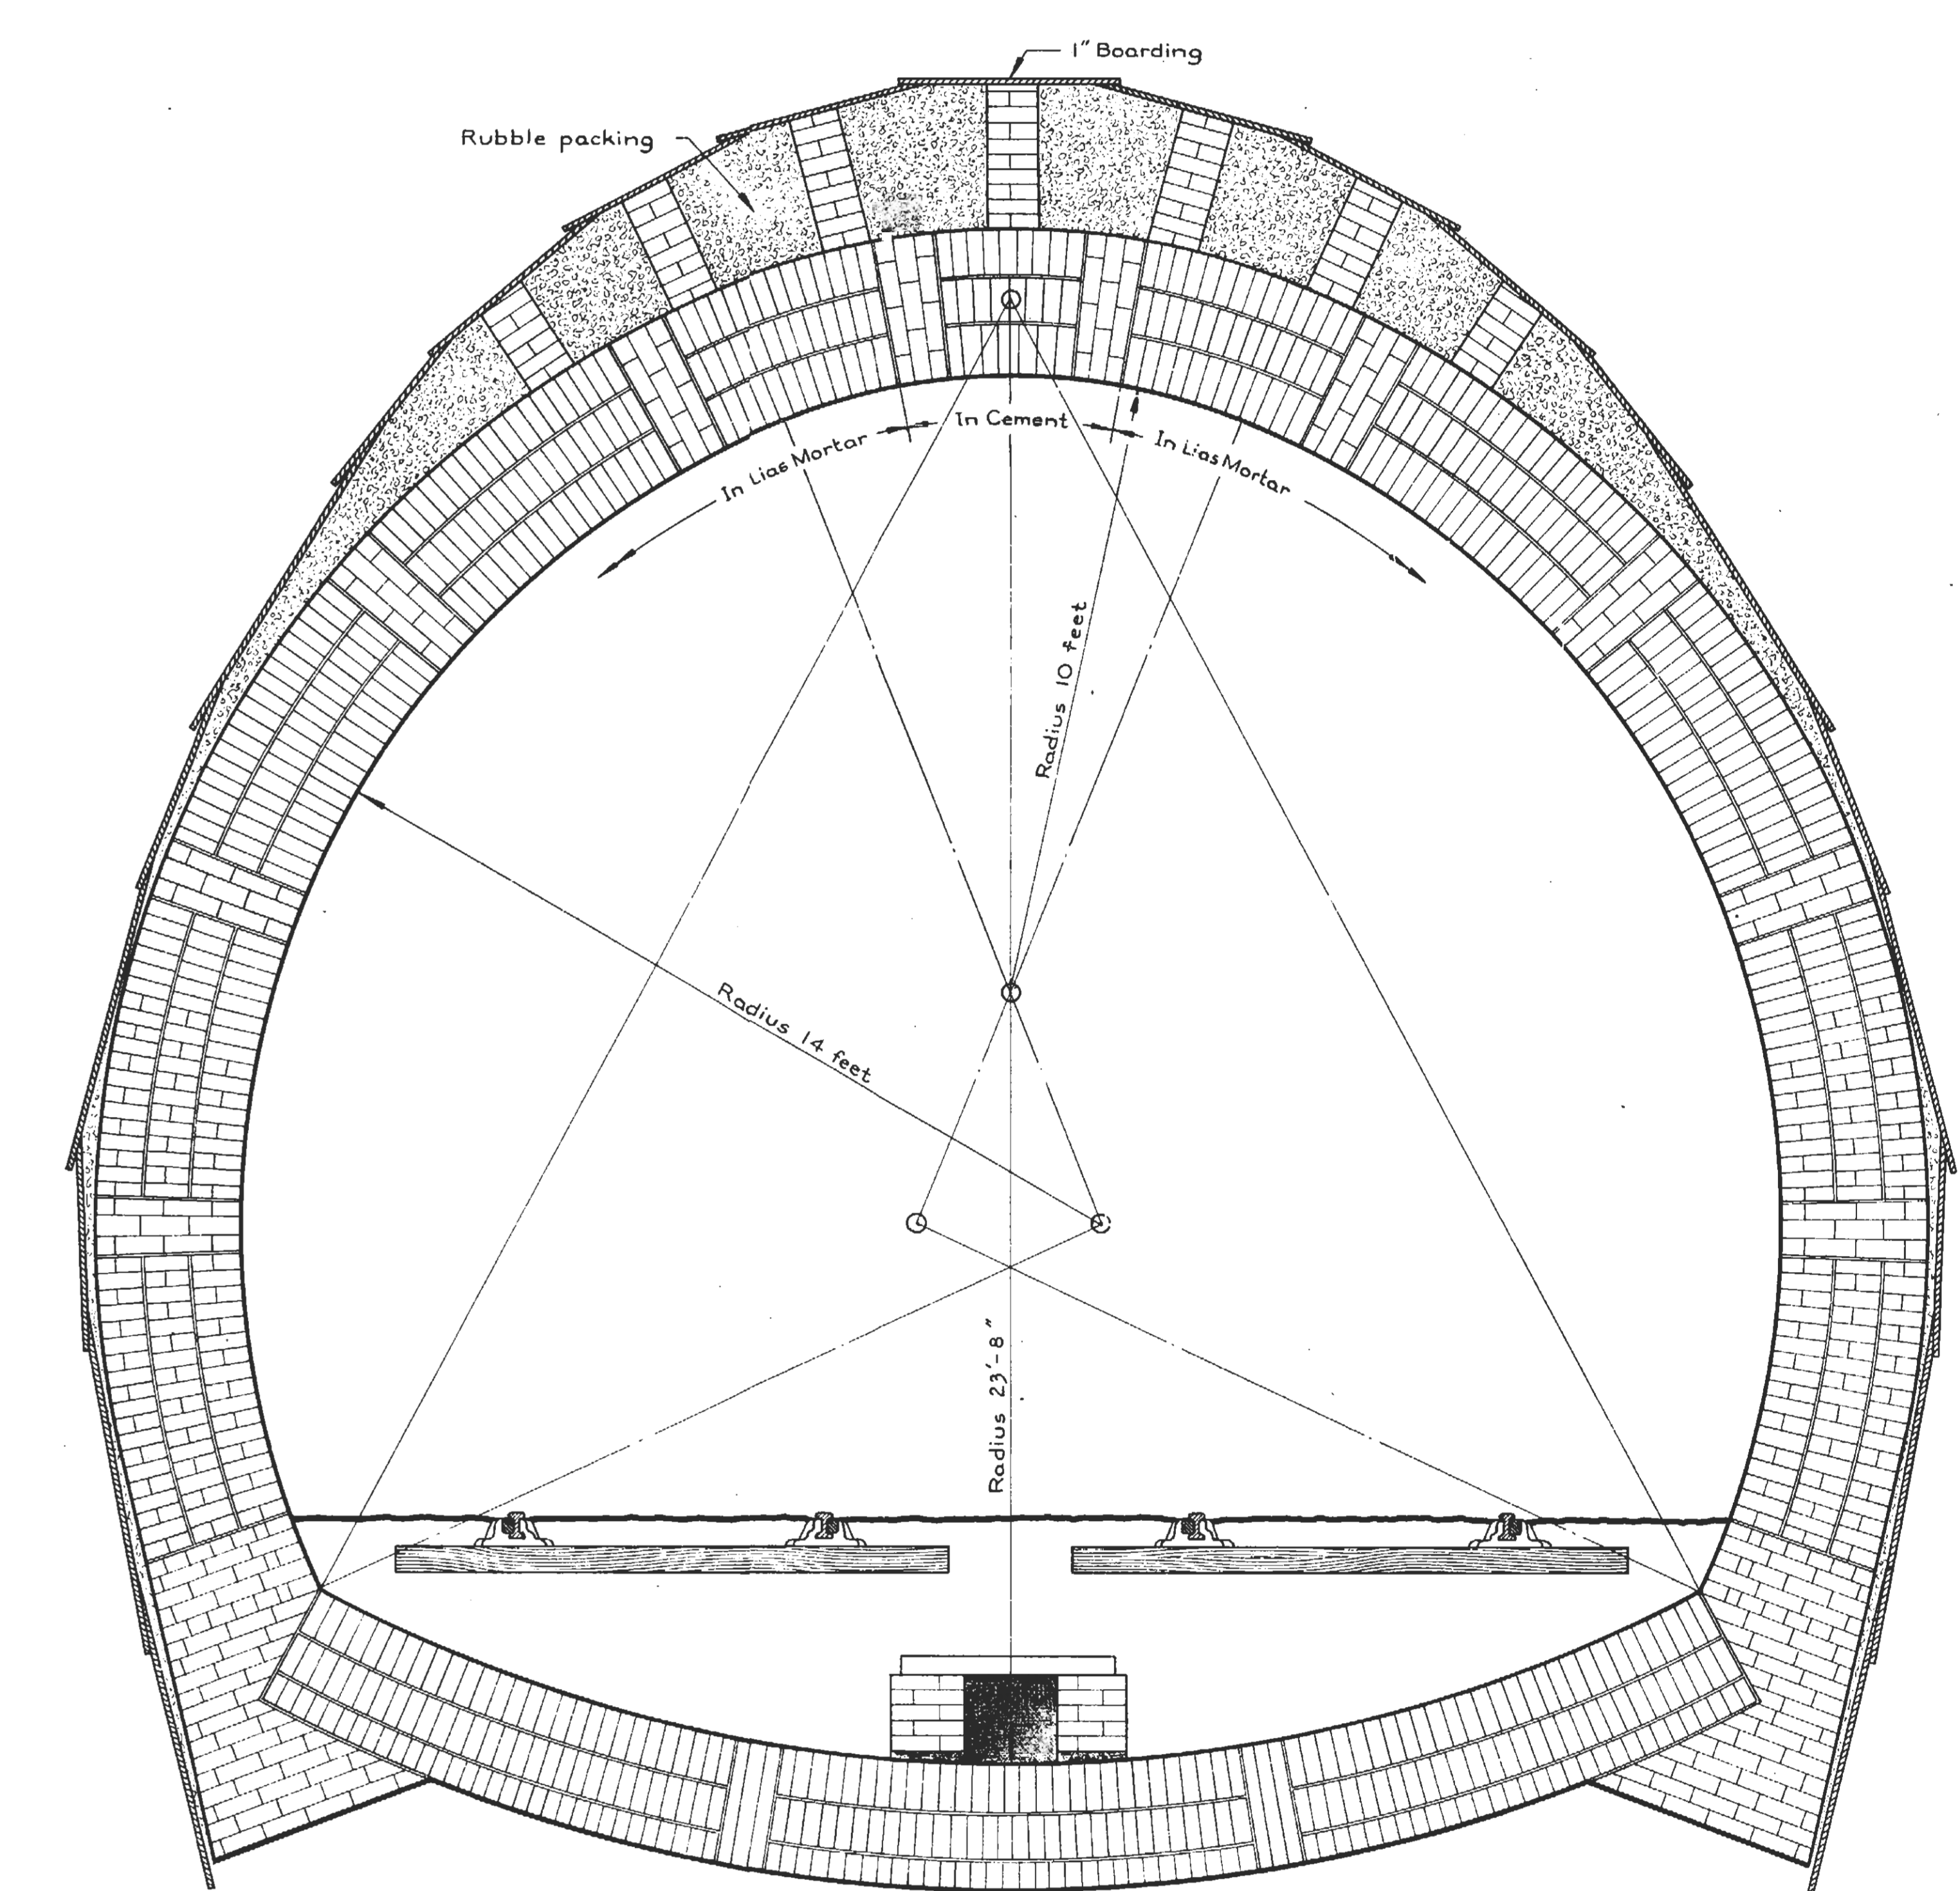
FIG. 4 TYPICAL CROSS-SECTION OF TUNNEL TAKEN FROM THE PARLIAMENTARY PLAN SCALE: 1/3 INCH TO 1 FOOT

4. The tunnel, which is 1,298 yards long, is straight throughout its length, and there are no ventilation shafts. It is lined with brick resting on a brick invert, as shown in the cross section in Fig. 4. The greatest width is 24 feet 9 inches and the height from the invert to the top of the arch is 22 feet 3 inches.
