REPORT ON THE DOUBLE COLLISION

8th October 1952

HARROW AND WEALDSTONE

LONDON MIDLAND REGION

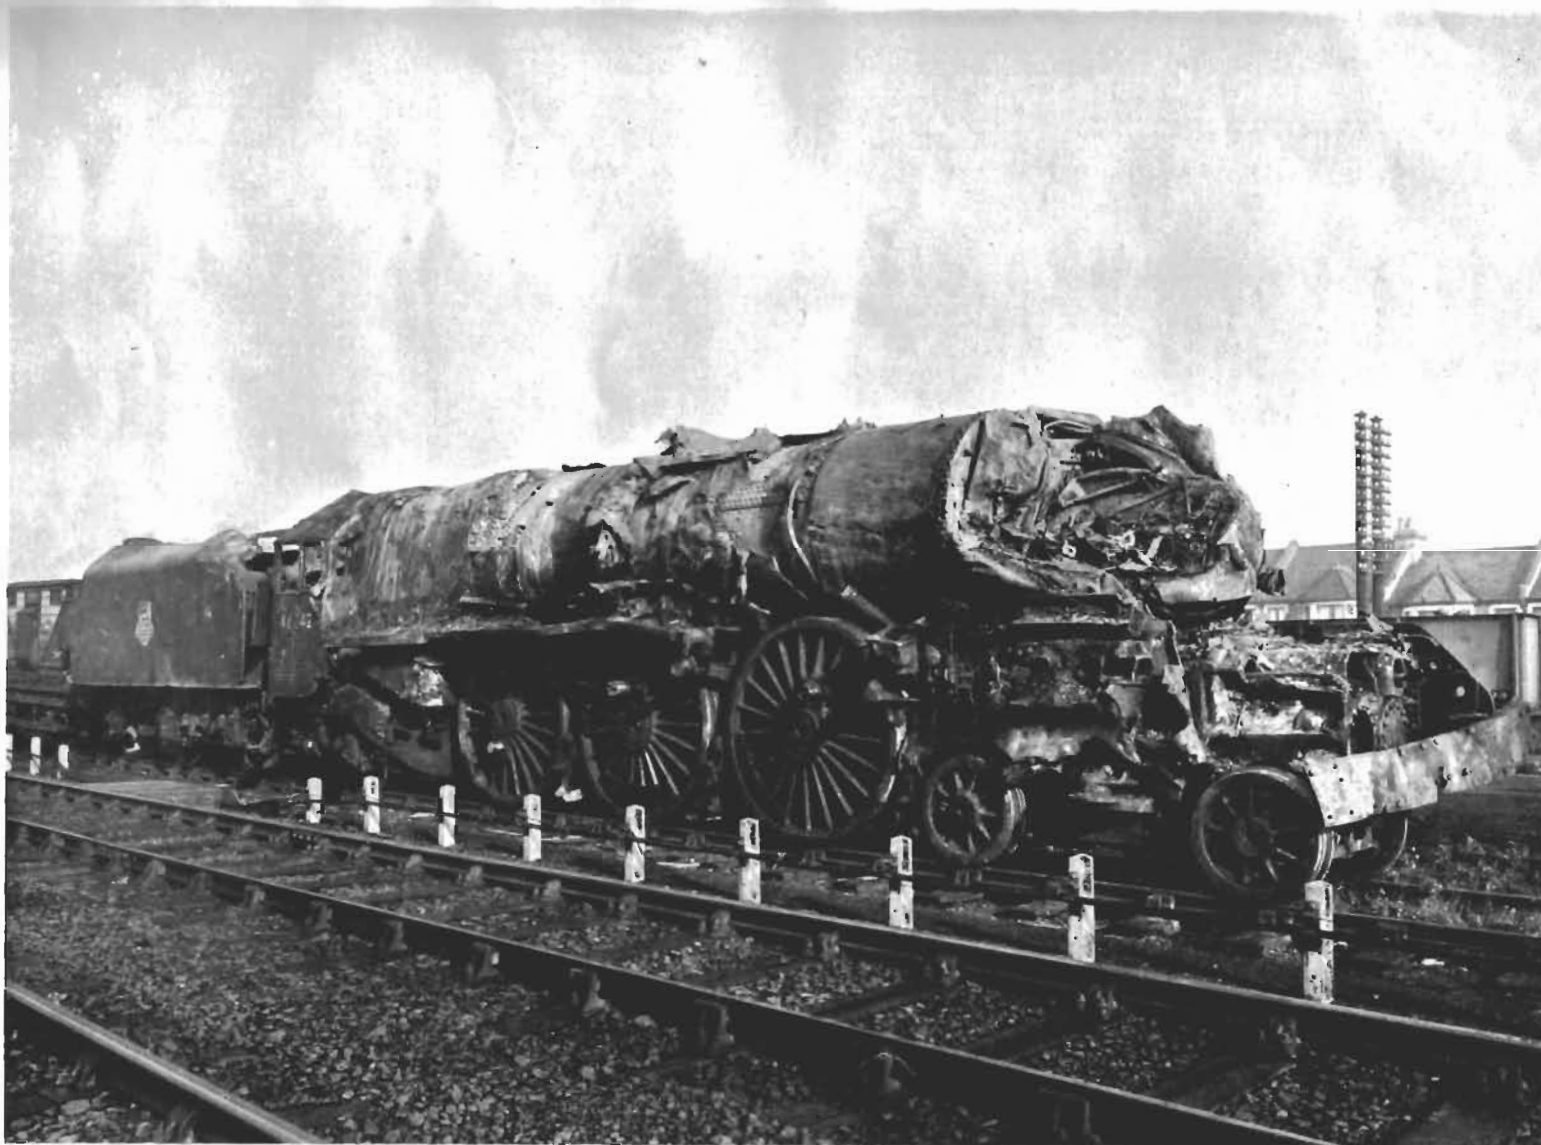
1. ENGINE NO. 46242. Class 8.P. 8.15 p.m. Train from Perth (para. 5)

Photograph 1 shows the right hand side of engine No. 46242 after it had been rerailed and placed in a siding; nothing more than the twisted rods and other motion parts had been cut away. The main frames were severely buckled, and it will be noted that the front end of the right hand frame plate was torn away from the inside cylinder casting and that the right hand outside cylinder and steam chest were smashed. The crushing of the comparatively light smoke box plating had saved the boiler from serious structural damage, though the front tube plate was bent. Three of the main steam pipes in the smoke box were broken. Pressure in the boiler must have been released when one of the safety valves and a top feed clack box casting were broken off, and the water had been blown away through a displaced mud hole door on the firebox, with the result that the crown sheet was burnt. The brick arch was undamaged.

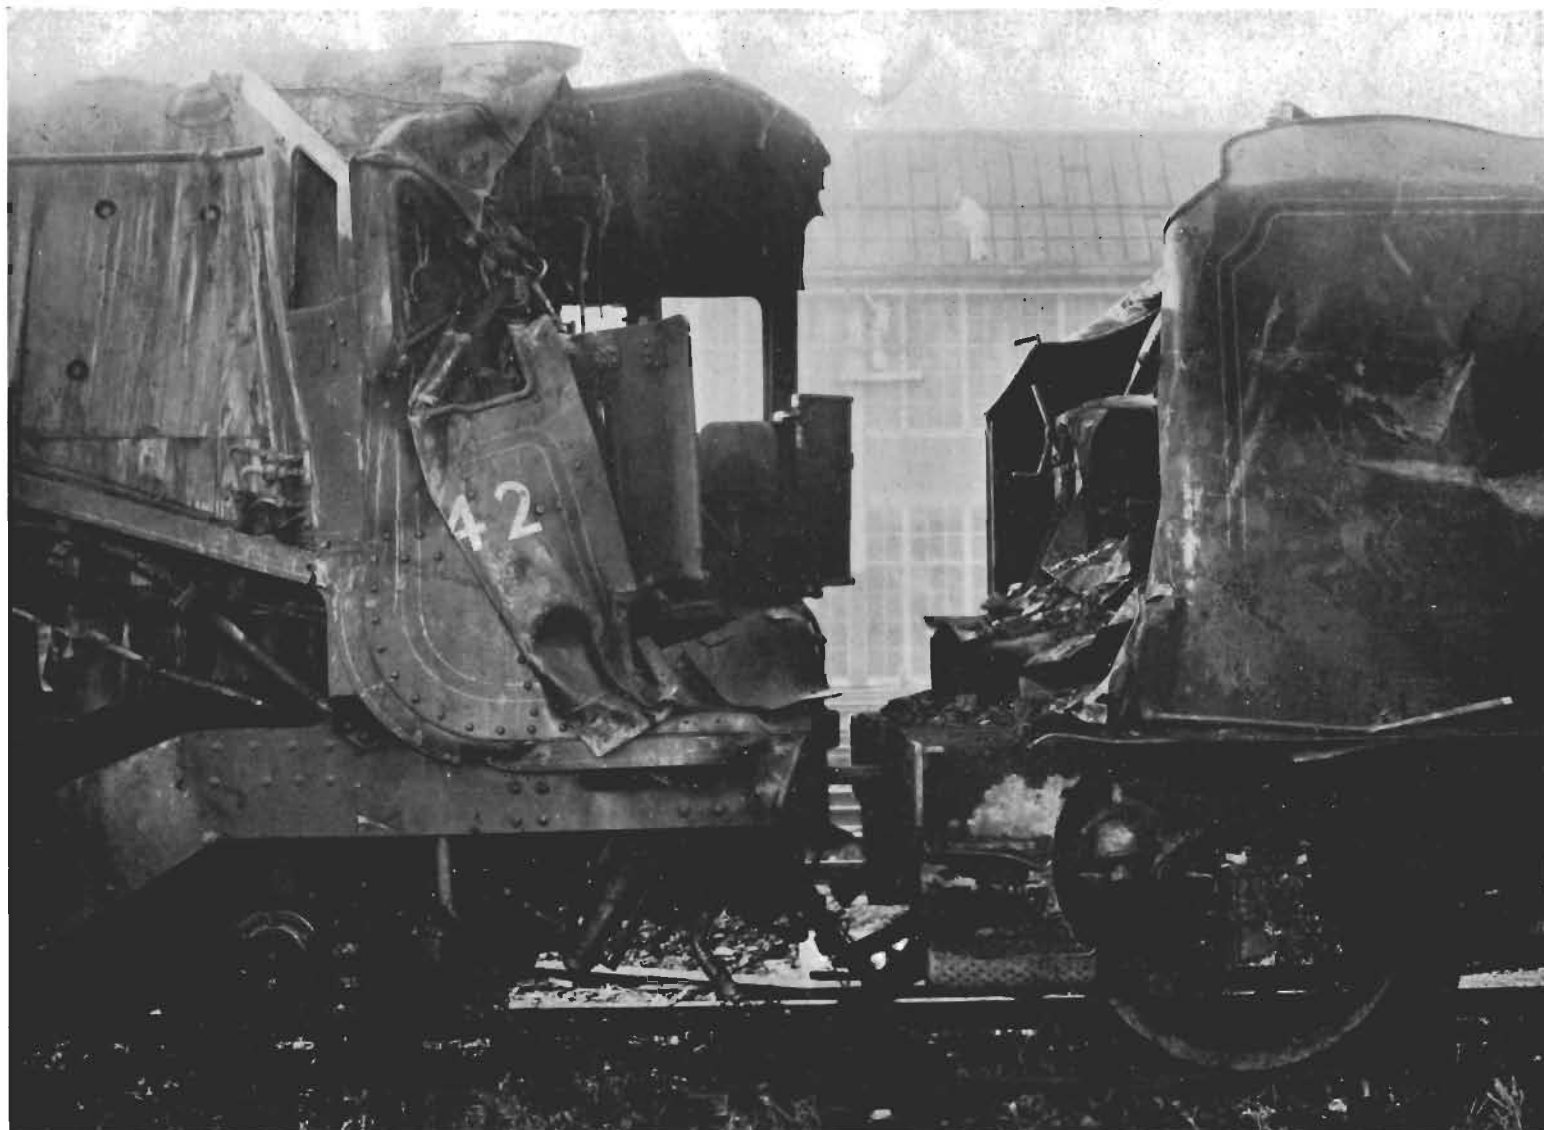
2. ENGINE No. 46242. Class 8.P. 8.15 p.m. Train from Perth (para. 5)

Photograph 2 illustrates the damage which occurred between the engine and the tender which was probably responsible for the fatal injuries to both the enginemen, and photograph 3 shows the cab fittings; none of their steam joints was broken and the two water gauge glasses were intact, but the drain pipe and cock of the left hand water gauge had been torn away and must have released some steam and hot water into the cab. The extensive damage to the tender included the buckling of both the main frames and the bursting of the tank, and all the water was lost. I refer later to the position in which the engine controls were found.

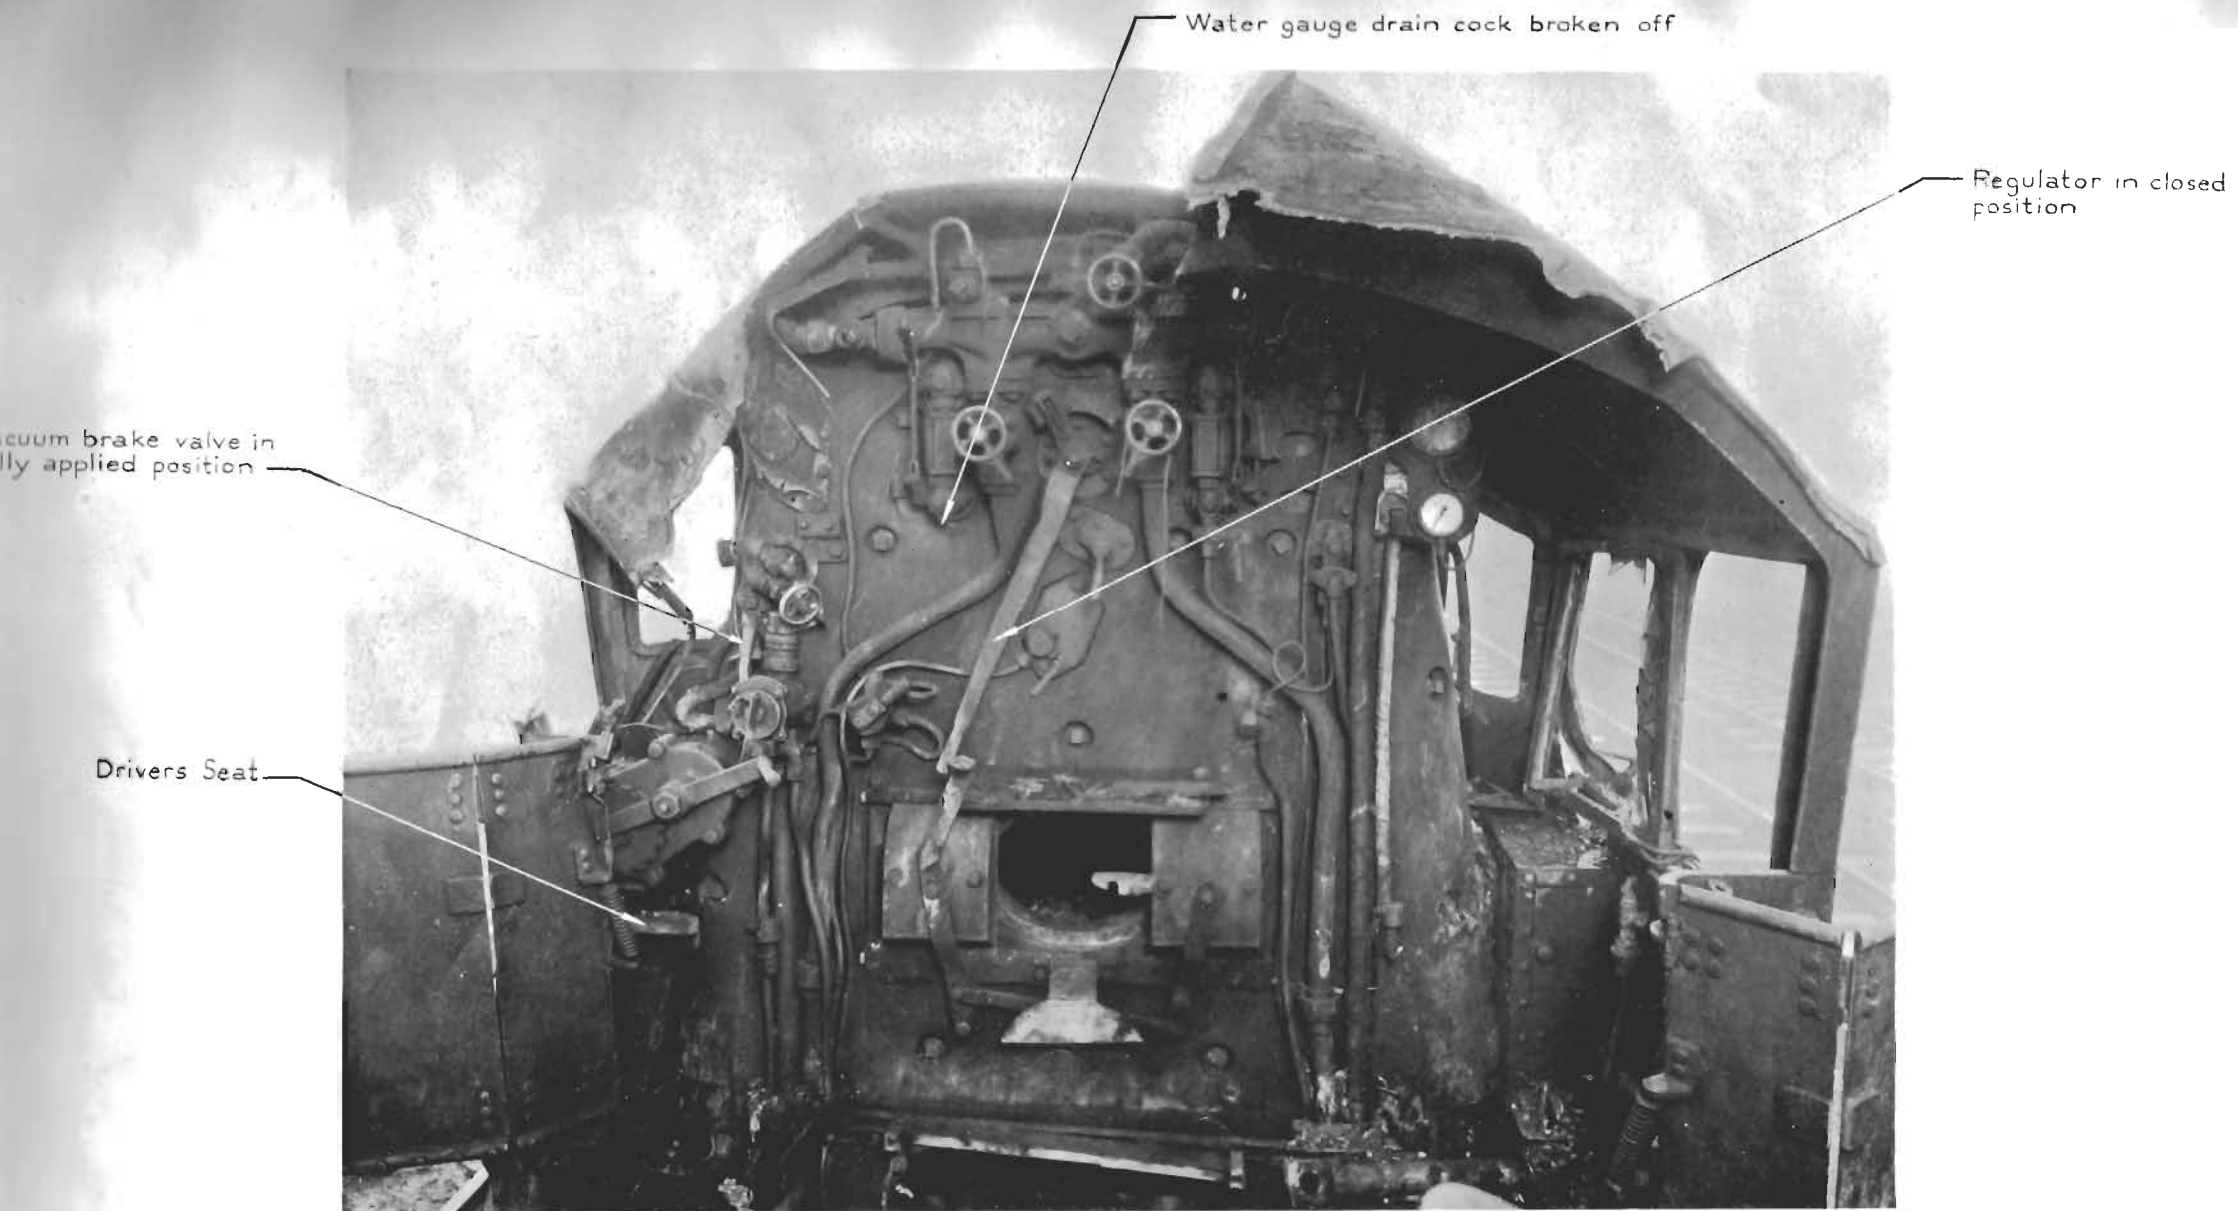
3. ENGINE No. 46242. Class 8.P. 8.15 p.m. Train from Perth (para. 5)

53. When the engine was recovered, the regulator was found fully closed (photograph 3). The reversing screw was in forward gear at 60 per cent. cut off, which is the normal coasting or "drifting" position, and the blower was open by one turn of the screw valve. Driver Jones' hand was on the vacuum brake valve handle in its fully applied position, hard over to the left.

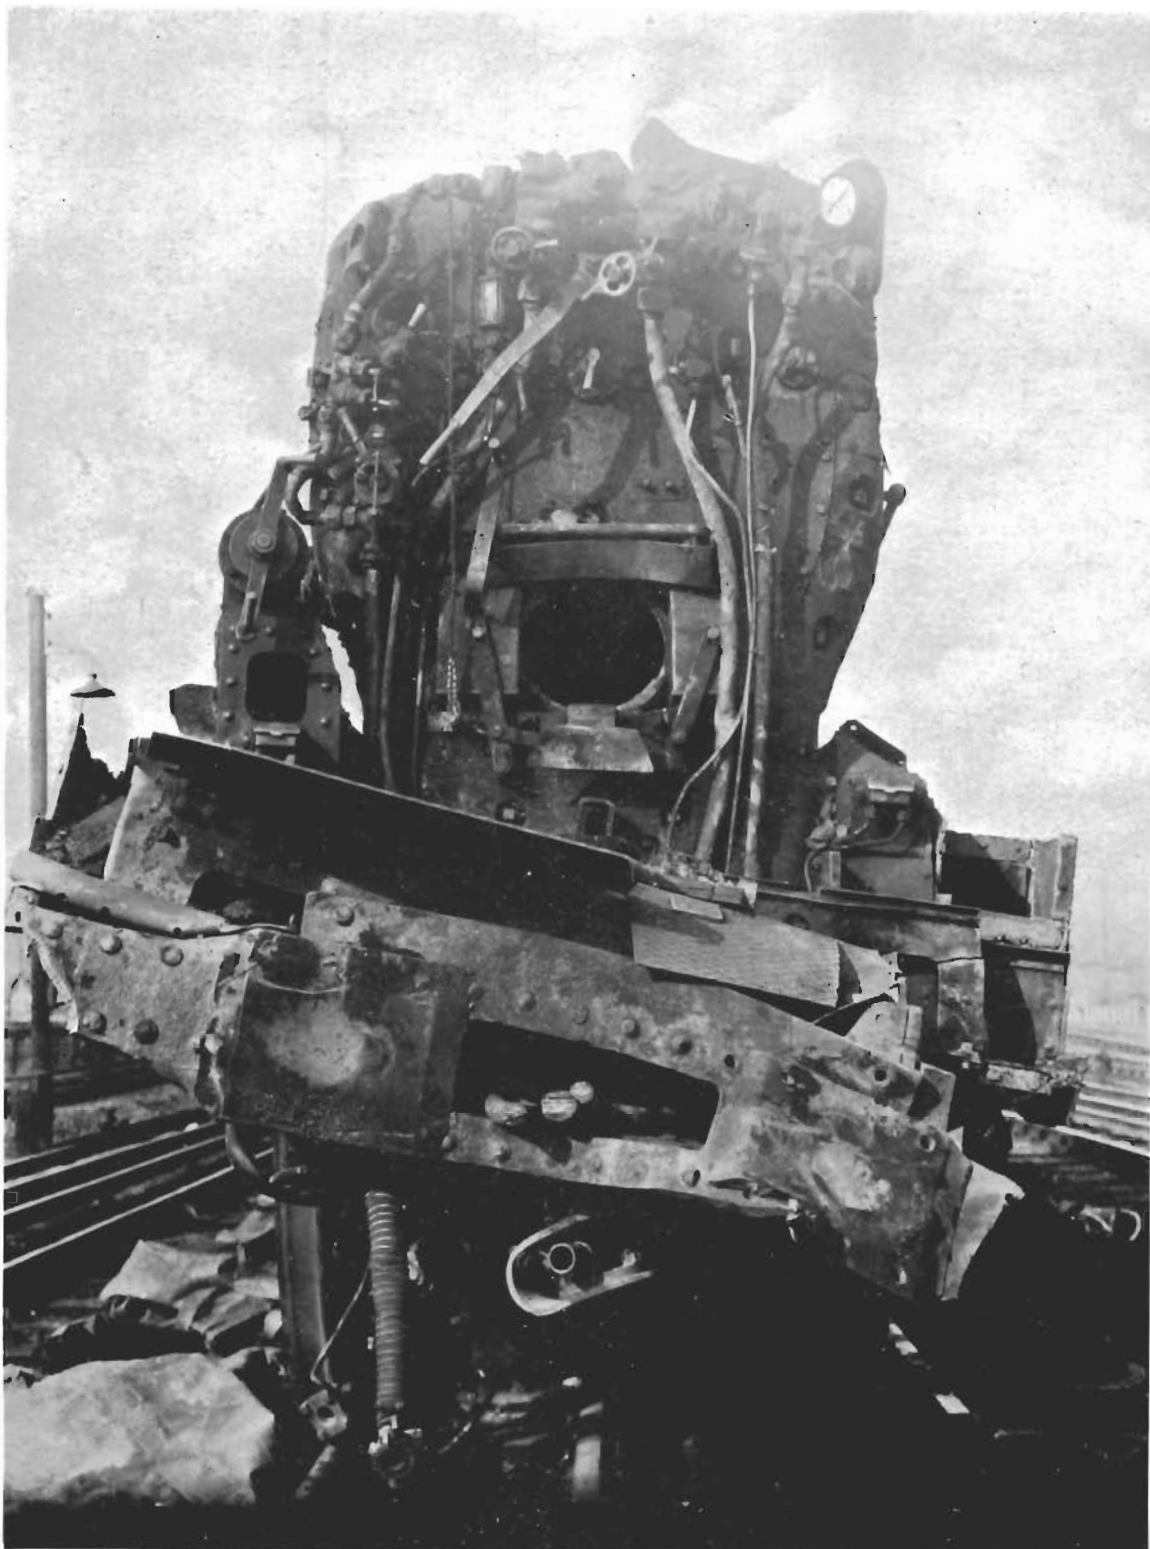
4. ENGINE NO. 45637. *Class 6.P. Leading Engine of Liverpool Train (para. 7)*

Except for the boiler, Engine No. 45637 was practically reduced to scrap. The bogie was wrecked and its component parts scattered, and the buffer beam and the frames were folded back as far as the leading coupled wheels. All three cylinder castings were smashed, and the tyre was broken off the right hand leading coupled wheel centre, which itself was fractured in several places. There was also very heavy damage at the rear end as the tender was driven into it, as is shown by photograph 4. Photograph 5 shows the remains of the engine as it was eventually recovered after the twisted framing at the front end had been cut away. The tender tank was torn from the main framing and turned upside down, and one of the distorted side frame plates was found underneath engine No. 46202 as it lay on its side, see photograph 9.

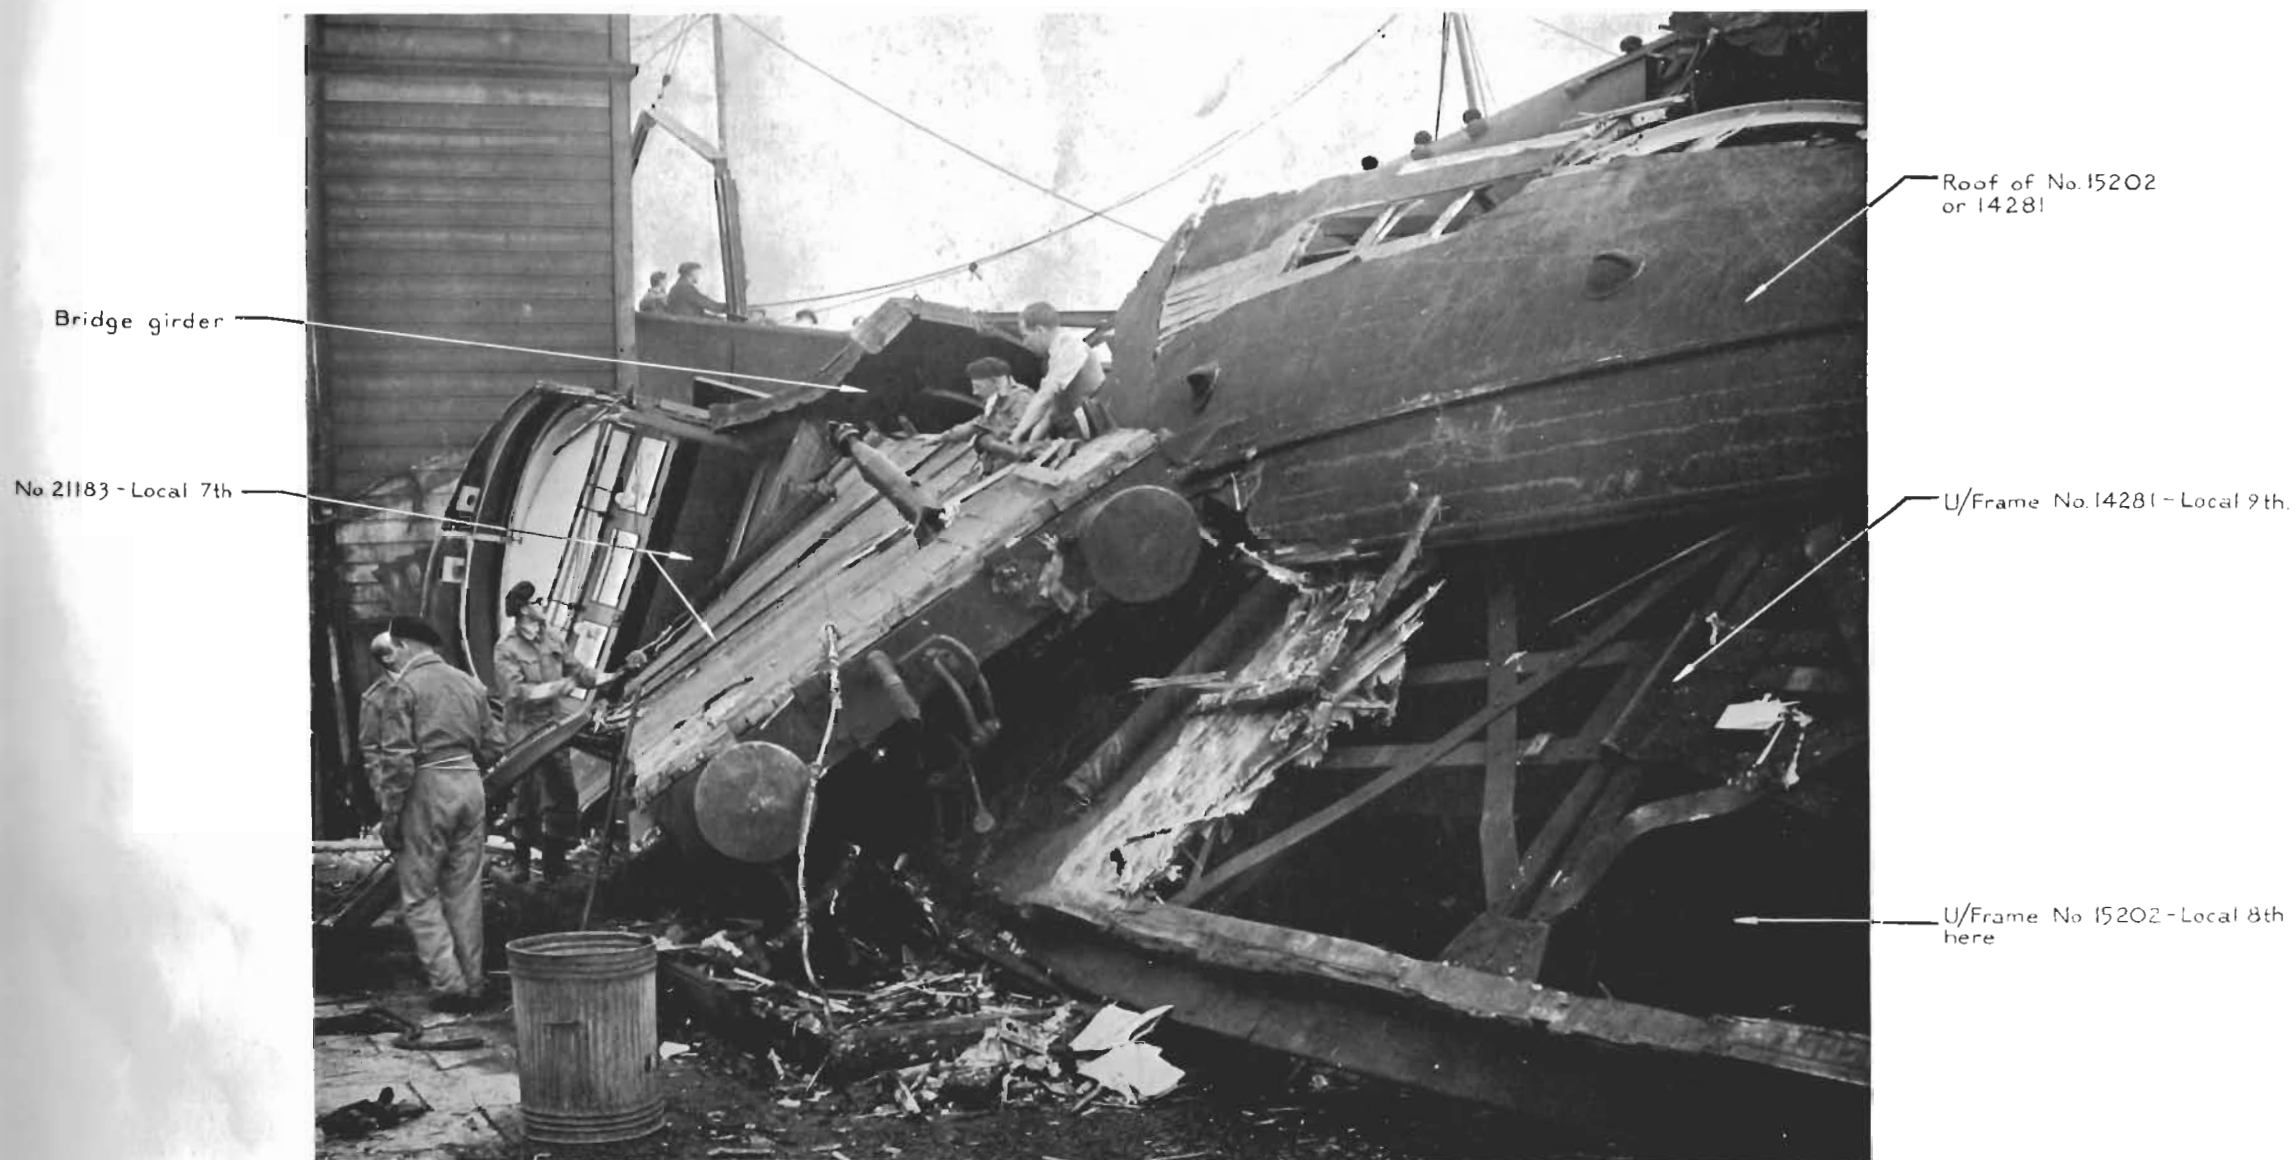
6. Last Three Vehicles of Local Train (para. 4)

although this part of the body was torn from the underframe as a whole and overturned to the left on to the platform. The leading end of this coach came to rest under the station footbridge and abreast of the Perth train engine, which was found to be standing on the alignment of the *Down Fast* line after the overlying wreckage had been cleared.

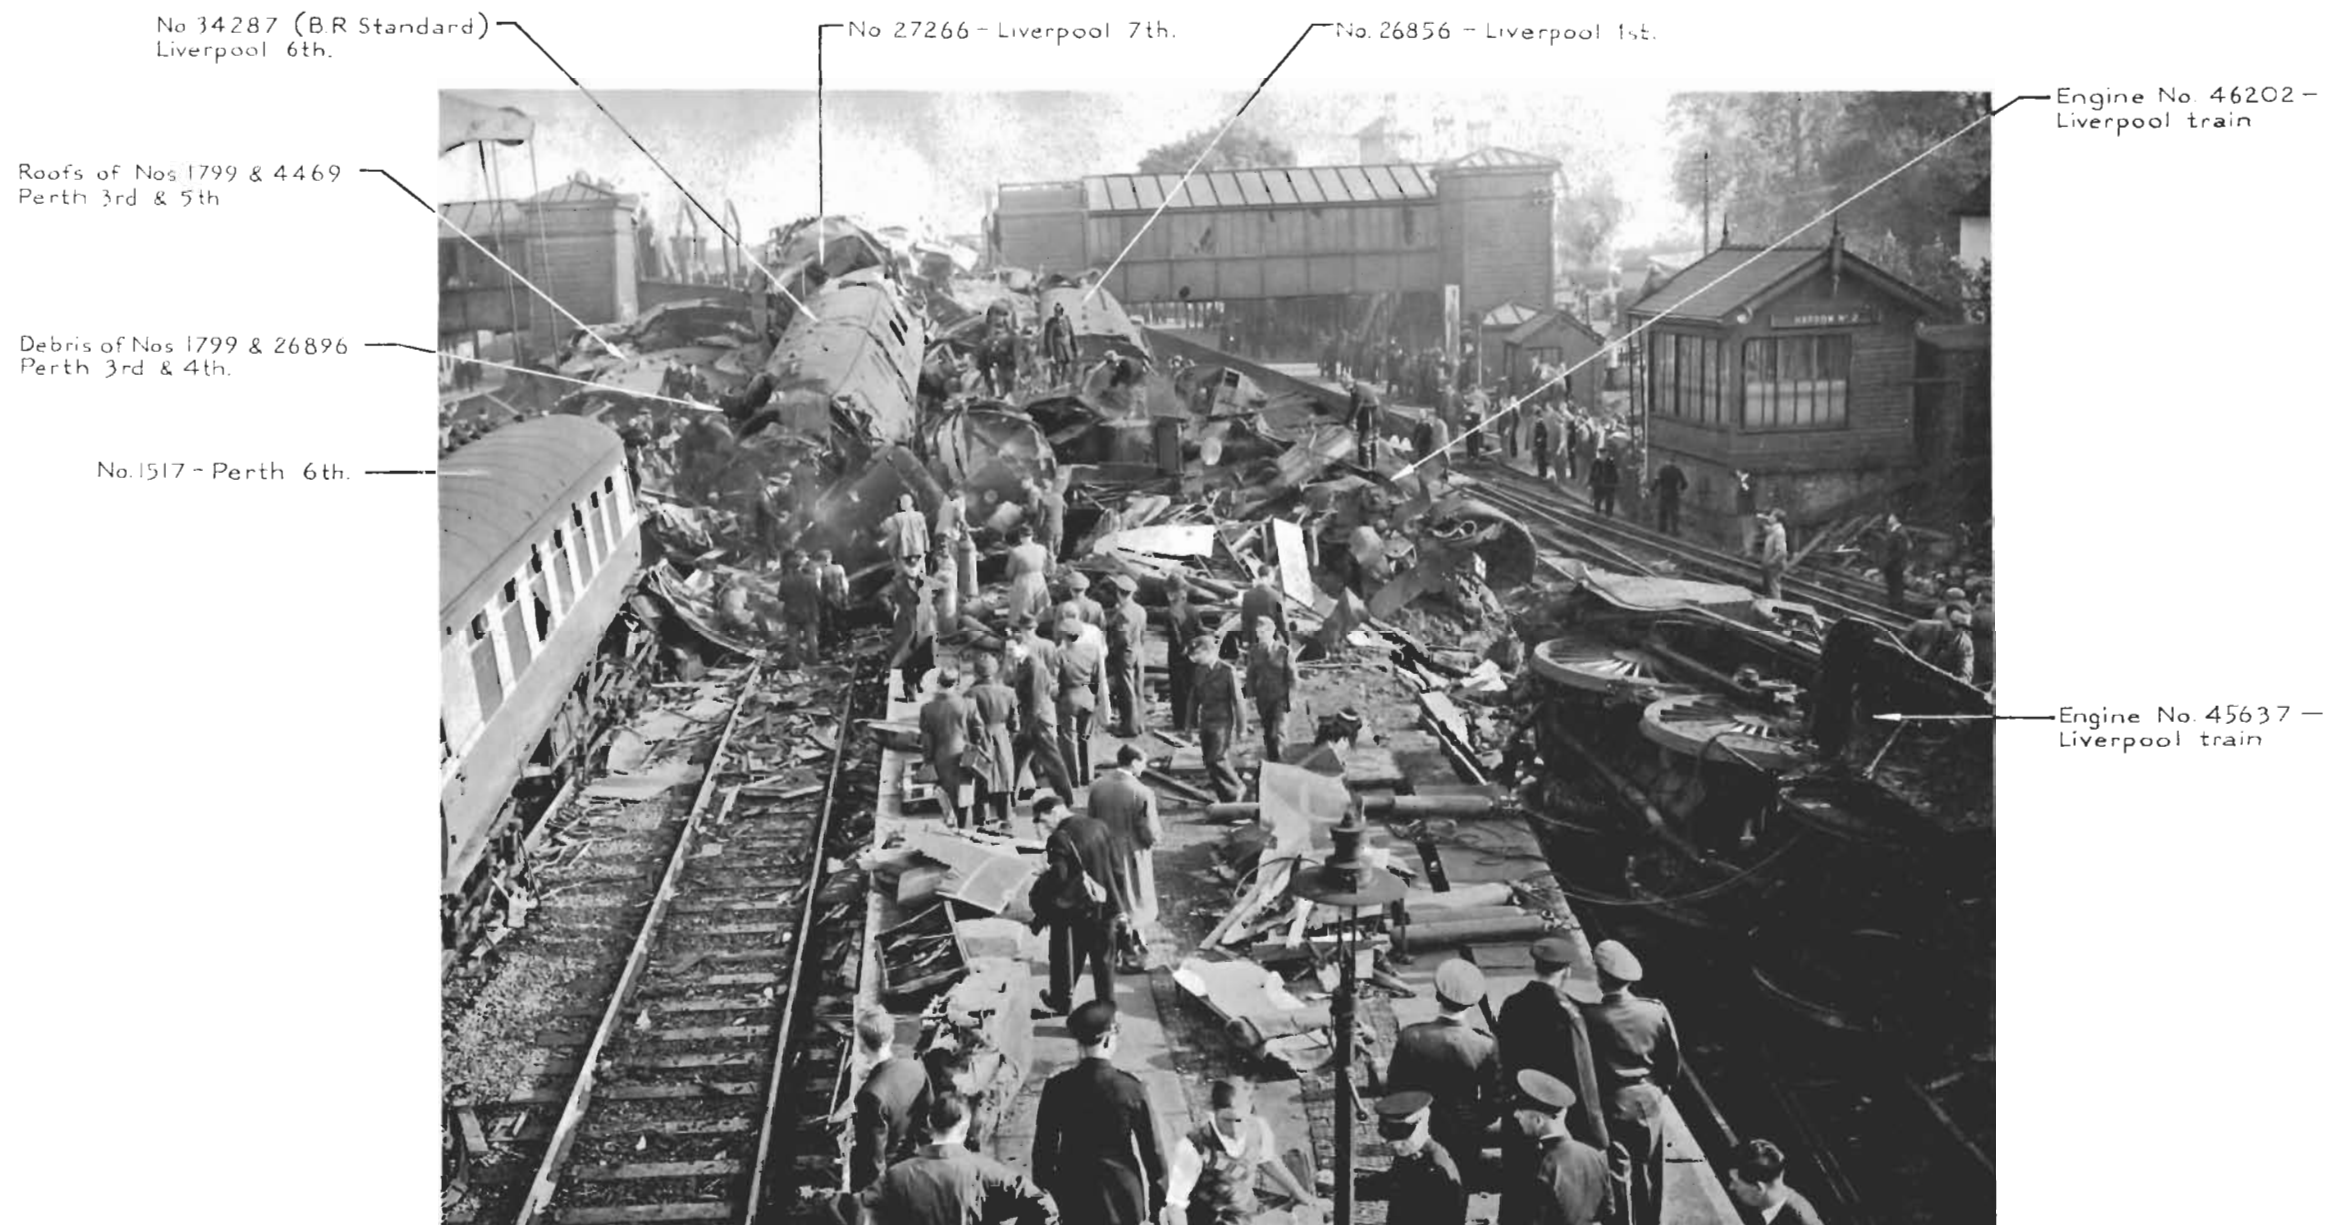
7. General View of Wreckage from North (paras. 6, 7 and 8)

The destruction and damage to the 5th, 6th, 7th and 8th vehicles of the Liverpool train is shown by photographs 7, 8, 9, 10, 11 and 12. The steel body shell of the 5th coach, No. 24683, was demolished and its twisted underframe lay on the pile of bogies close to the footbridge, but the next two, Nos. 34287 (6th) and 27266 (7th) were carried beyond it on a straight course and mounted the engine of the Perth train and the other wreckage on the alignment of the Down Fast line. No. 34287, like No. 34108, was an all-steel coach of the new standard design, and it suffered a good deal less than the others; its underframe kept its shape well, as did the body shell, and all the compartments could be identified, although there was a good deal of internal damage. The body sides of No. 27266 behind it were torn from the underframe and it lay directly above the buried engine of the Perth train, with its roof about 30 ft. above the level of the rails.

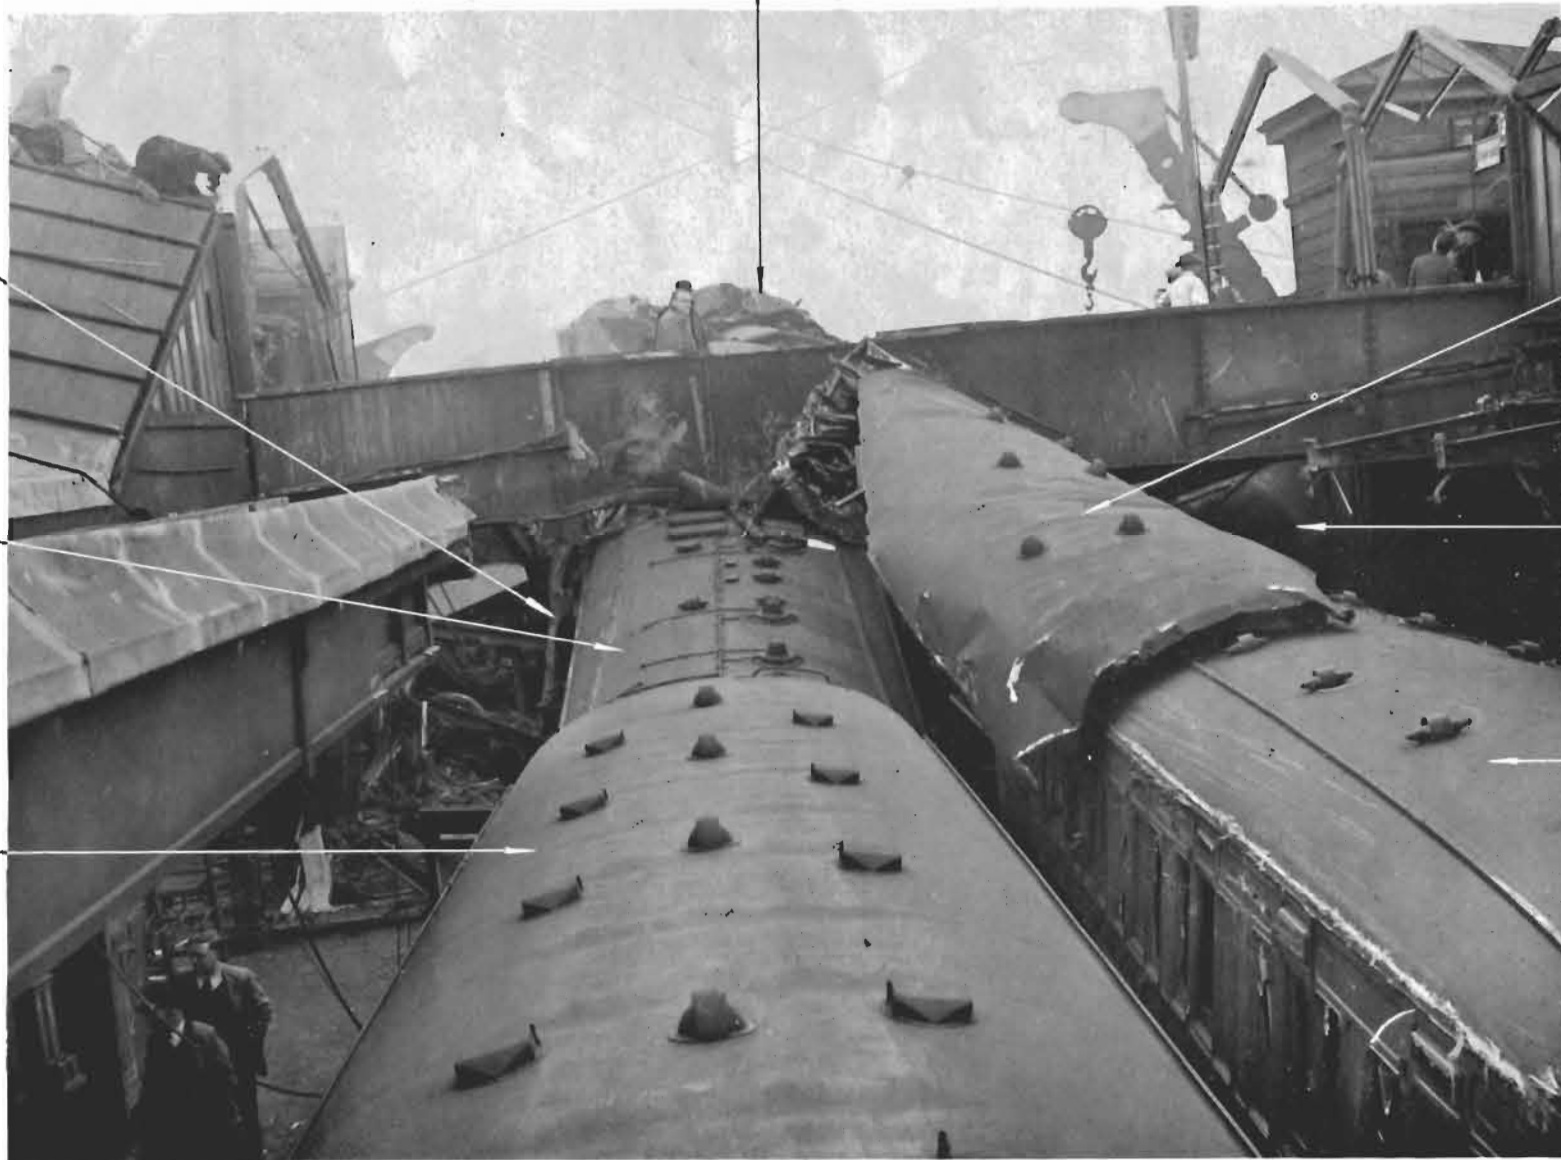
10. View from South of Footbridge (paras. 4 and 8)

Except for the two rear compartments of the next coach ahead, No. 11254 (photograph 10), the six leading coaches of the local train sustained no severe structural damage and were eventually drawn forward on the *Up Fast* line by the undamaged tank engine, after a pair of wheels of No. 11254 had been rerailed. The panels on the right hand side of No. 11254 were scraped and broken by some of the coaches of the Liverpool train as they became derailed, and Mr. Williams, who was in this coach (see page 2), told me that this scraping took place a second or two after the last of three distinct shocks from the rear, which he suggested were caused by the successive destruction of the three coaches behind him by the engine of the Perth train.

The next coach was the kitchen car, No. 30049, marshalled 8th in the train. It was wedged under the footbridge (see photograph 10) with its leading end resting on a heap of five or six bogies and other debris, but its trailing bogie was still on the rails. The front end of its body was driven in (photograph 12), but structural damage to the underframe was not very severe; all the gas was discharged as the reservoirs were broken, but it did not take fire. It is impossible to say which of the four or five coaches which struck the underside of the footbridge were responsible for the breakage and doubling back of the main girder on its country side. There was no serious structural damage to the undergear or bodywork of any of the seven vehicles behind the kitchen car; except for the leading bogie of the 9th coach, none of their wheels was derailed.
