RAILWAY ACCIDENT

Report on the Derailment that occurred on 20th May 1965 at Hest Bank

IN THE
LONDON MIDLAND REGION
BRITISH RAILWAYS

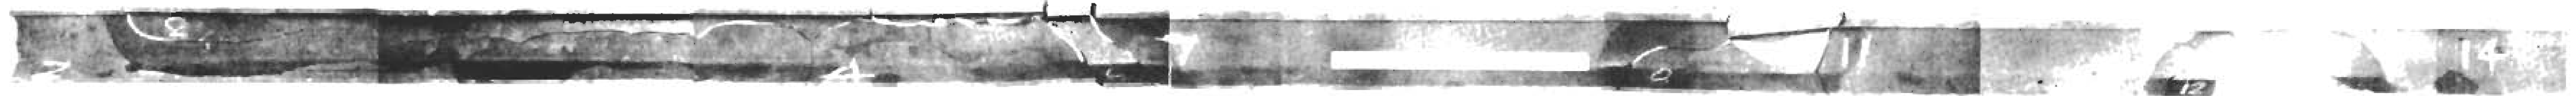
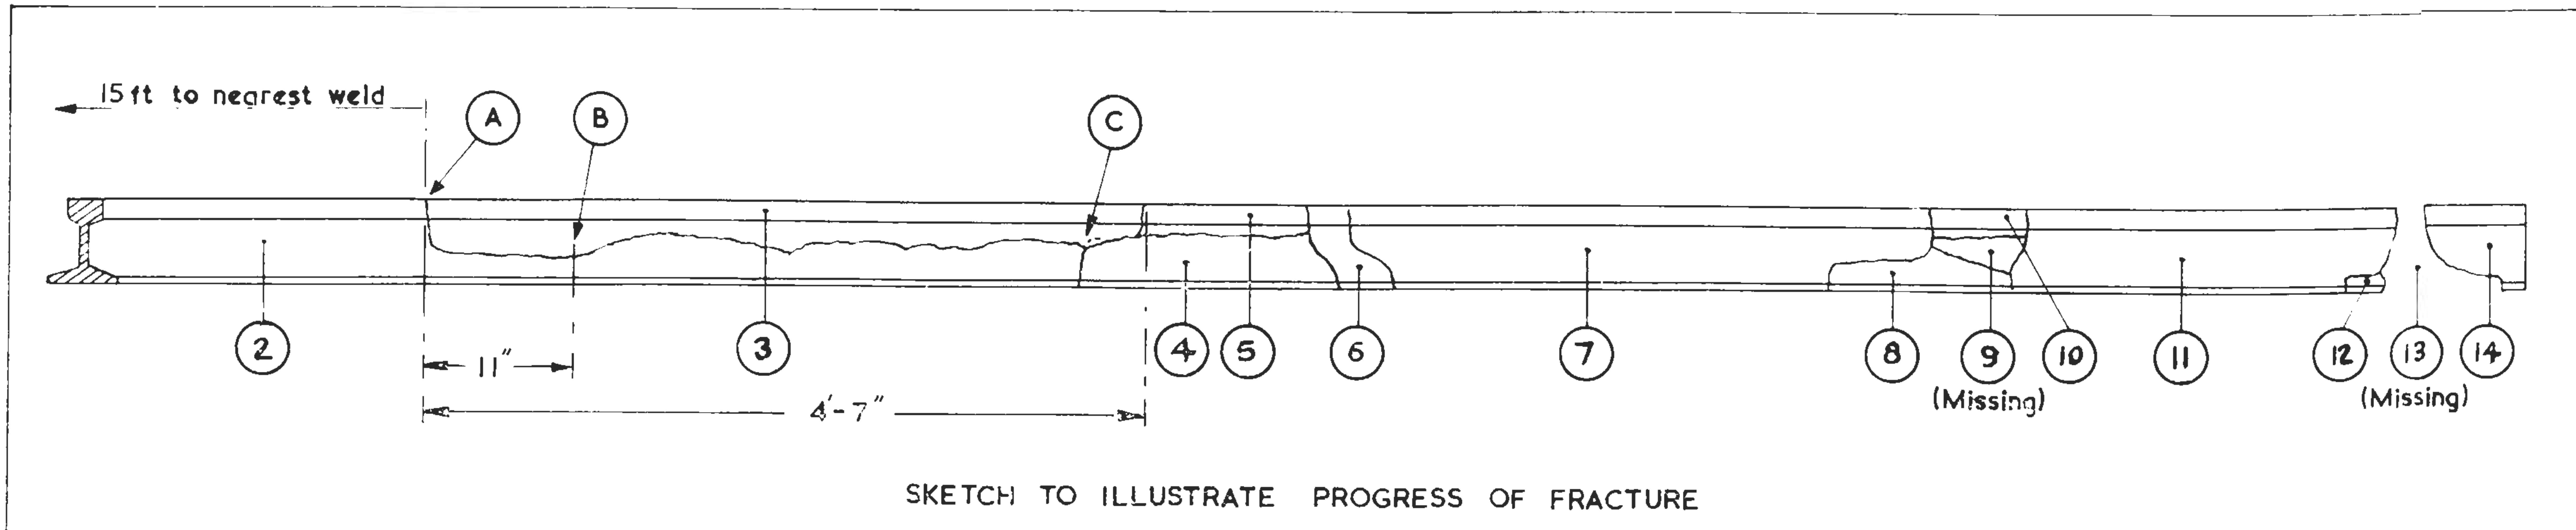
BROKEN 109LB FB RAIL - UP LINE HEST BANK WATER TROUGHS - 20th MAY 1965

33. "When assembled, the broken rail fitted together as shown in the sketch.

- (i) A transverse fatigue flaw in the head, which had reached the outer corner of the rail head but not the gauge corner, and which was 1½" deep at its maximum. (At point "A" in the sketch).

- (ii) A brittle fracture, lightly rusted, which had extended in several stages vertically down through the head when it had turned longitudinally in the direction of traffic along the web, and which had been battered under traffic before final severance, reaching a distance of 11 inches horizontally from the fatigue flaw. (Point "B" in the sketch).
- (iii) A new brittle fracture covering the remainder of the fracture, reaching a fork where it turned down to the foot and up to the running surface, continuing further on, but now leaving a piece of rail head 4' 7" long detached. (Numbered "3" in the sketch.)

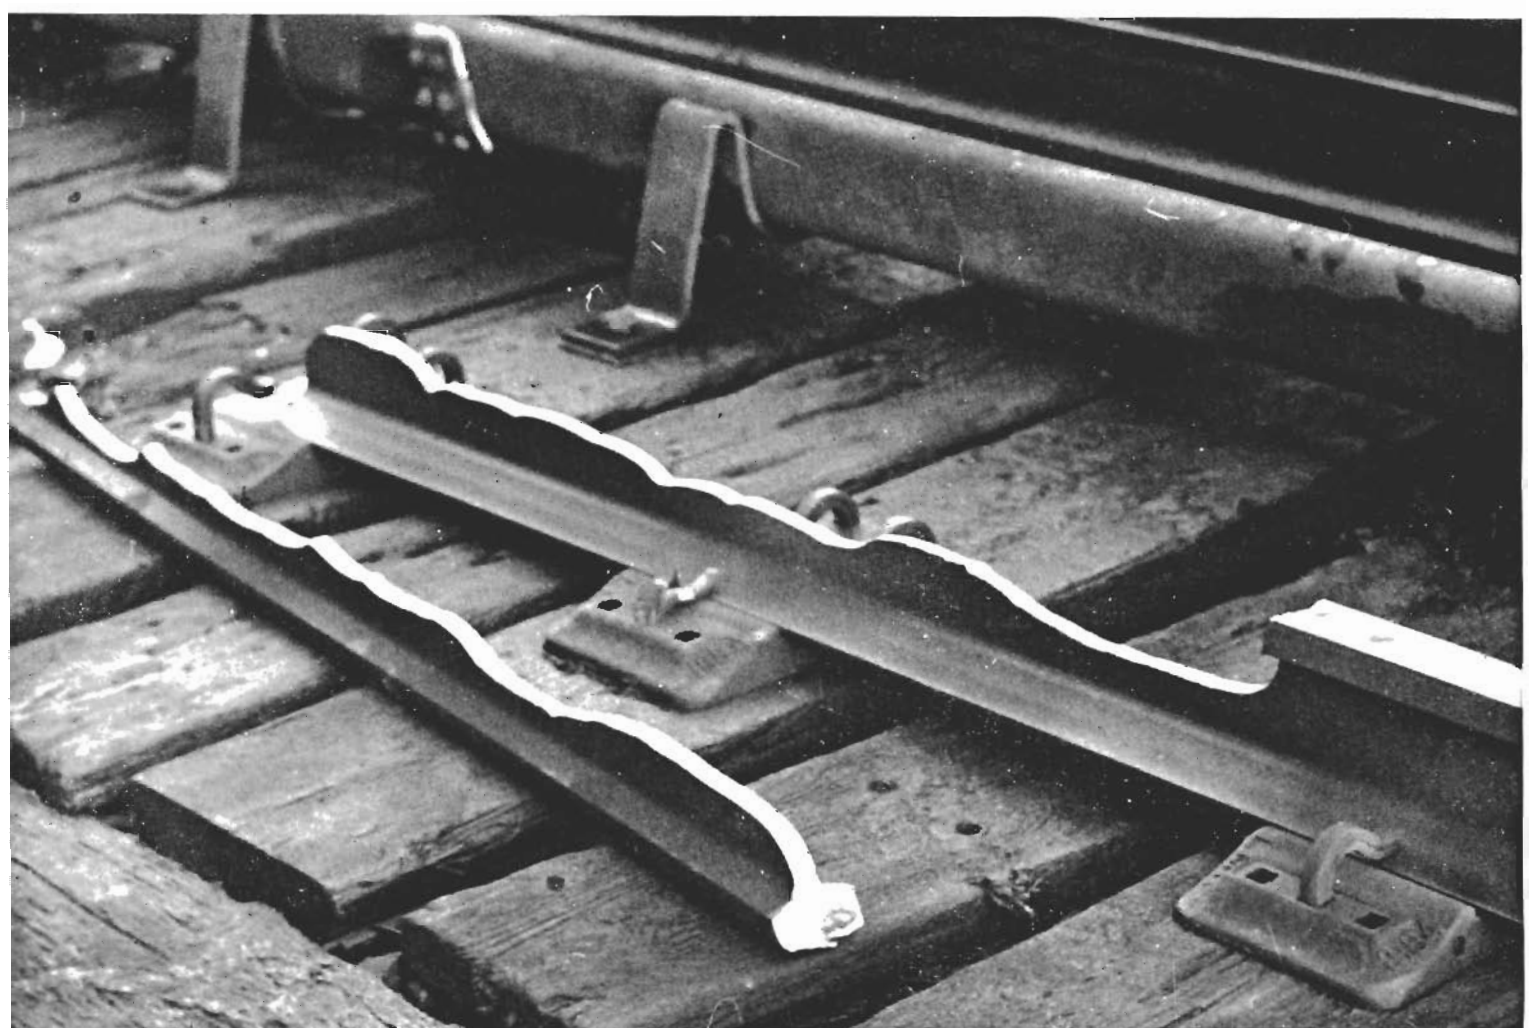
6. It was at once apparent to the railway officers when they reached the scene of the accident that the immediate cause of the derailment was a broken rail, a portion of the cess rail of the Up line about 13 feet long having broken away at the point at which the first marks of derailment were visible, adjacent to the more southerly of the two water tanks that feed the troughs. The initial fracture had occurred 15 feet from the nearest weld and had apparently started as a transverse crack through the rail head, underneath an old wheelburn, subsequently turning horizontally in the direction of travel along the web until it had turned down to the foot and up to the head leaving a piece of rail head 4 foot 7 inches long detached. A further 9 feet of rail had been broken into several pieces, probably as a result of the derailment, and was scattered over a considerable area. Almost all the pieces were subsequently recovered and reassembled as shown in the accompanying photographs and diagrams, in the British Railways Engineering Research Laboratory at Derby, where they were taken for a detailed metallurgical examination.

Broken rail before removal from track with detached portion of head lying alongside.
