MINISTRY OF WAR TRANSPORT.

REPORT ON THE ACCIDENT

which occurred on 7th September 1945, near

SUN BANK HALT, LLANGOLLEEN

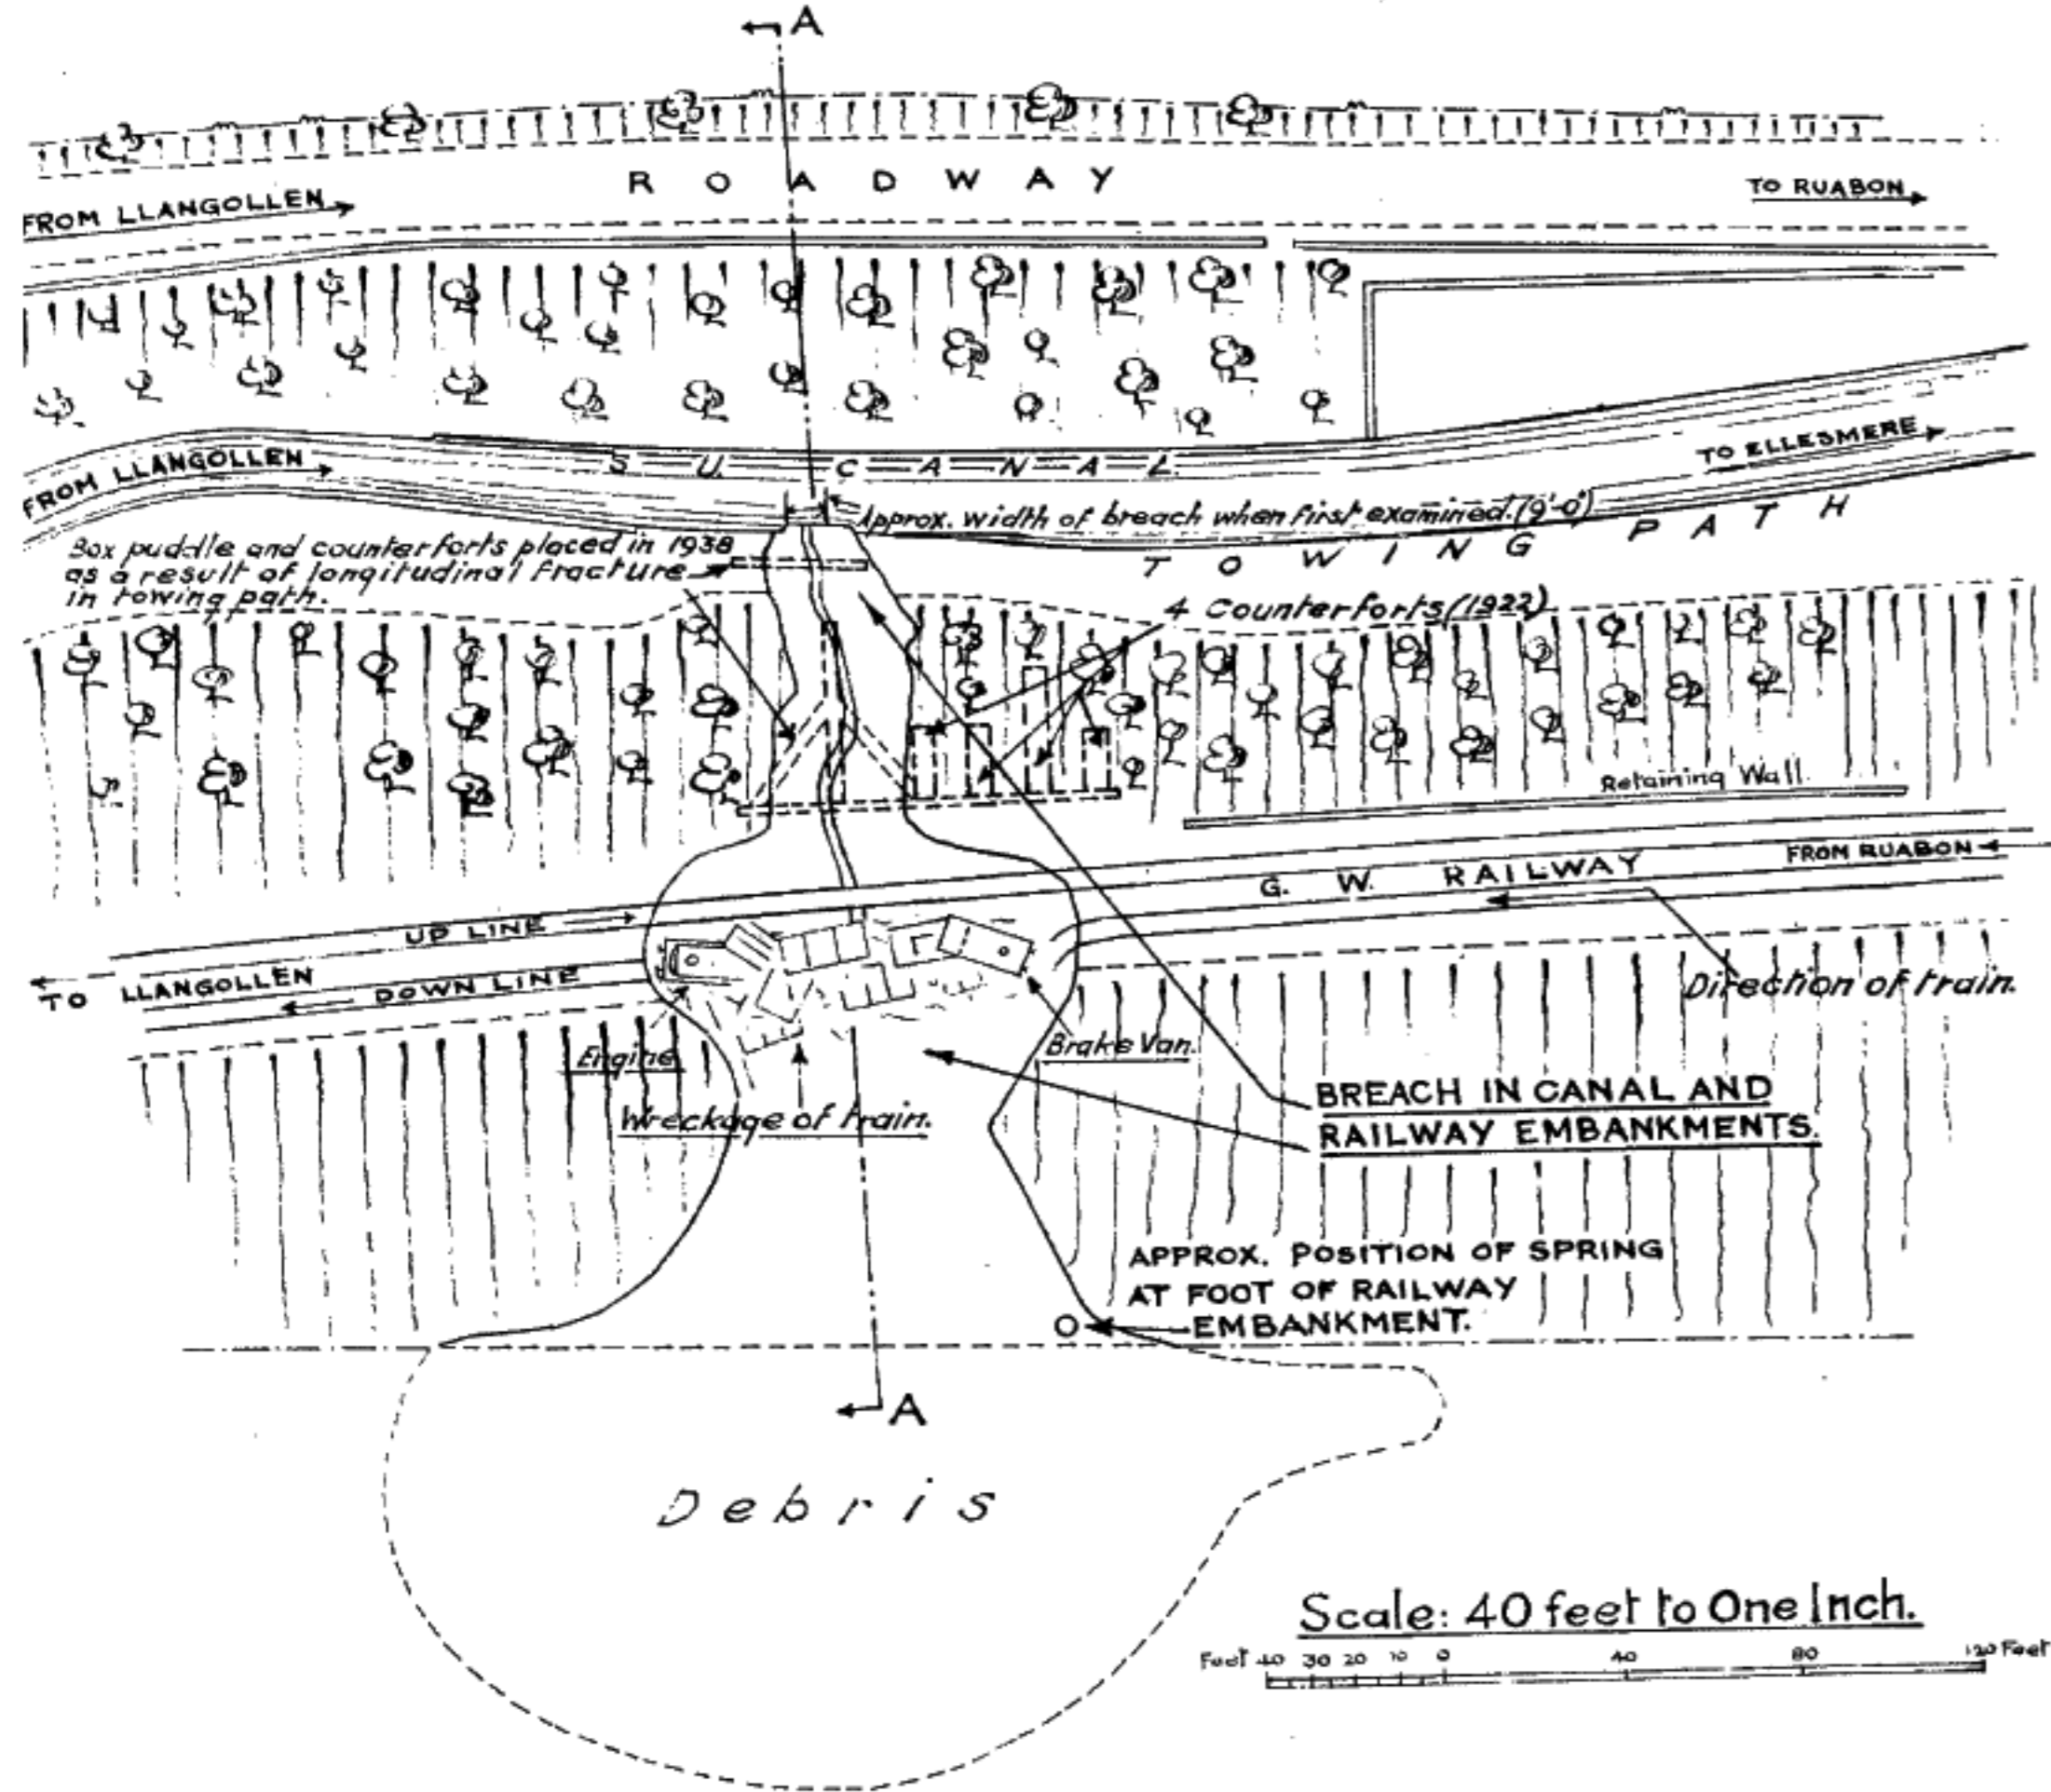
**FIG. 2.
ENLARGED SITE PLAN.**

For a short distance on the Ruabon side of the breach, the railway formation is partly cut into the hillside, which is supported by a rubble masonry retaining wall 160 ft. long, with a maximum height of 12 ft. (see Fig. 2). So far as can be determined, this wall, which has no weep holes, is the original one, and it appeared to be in first class condition.

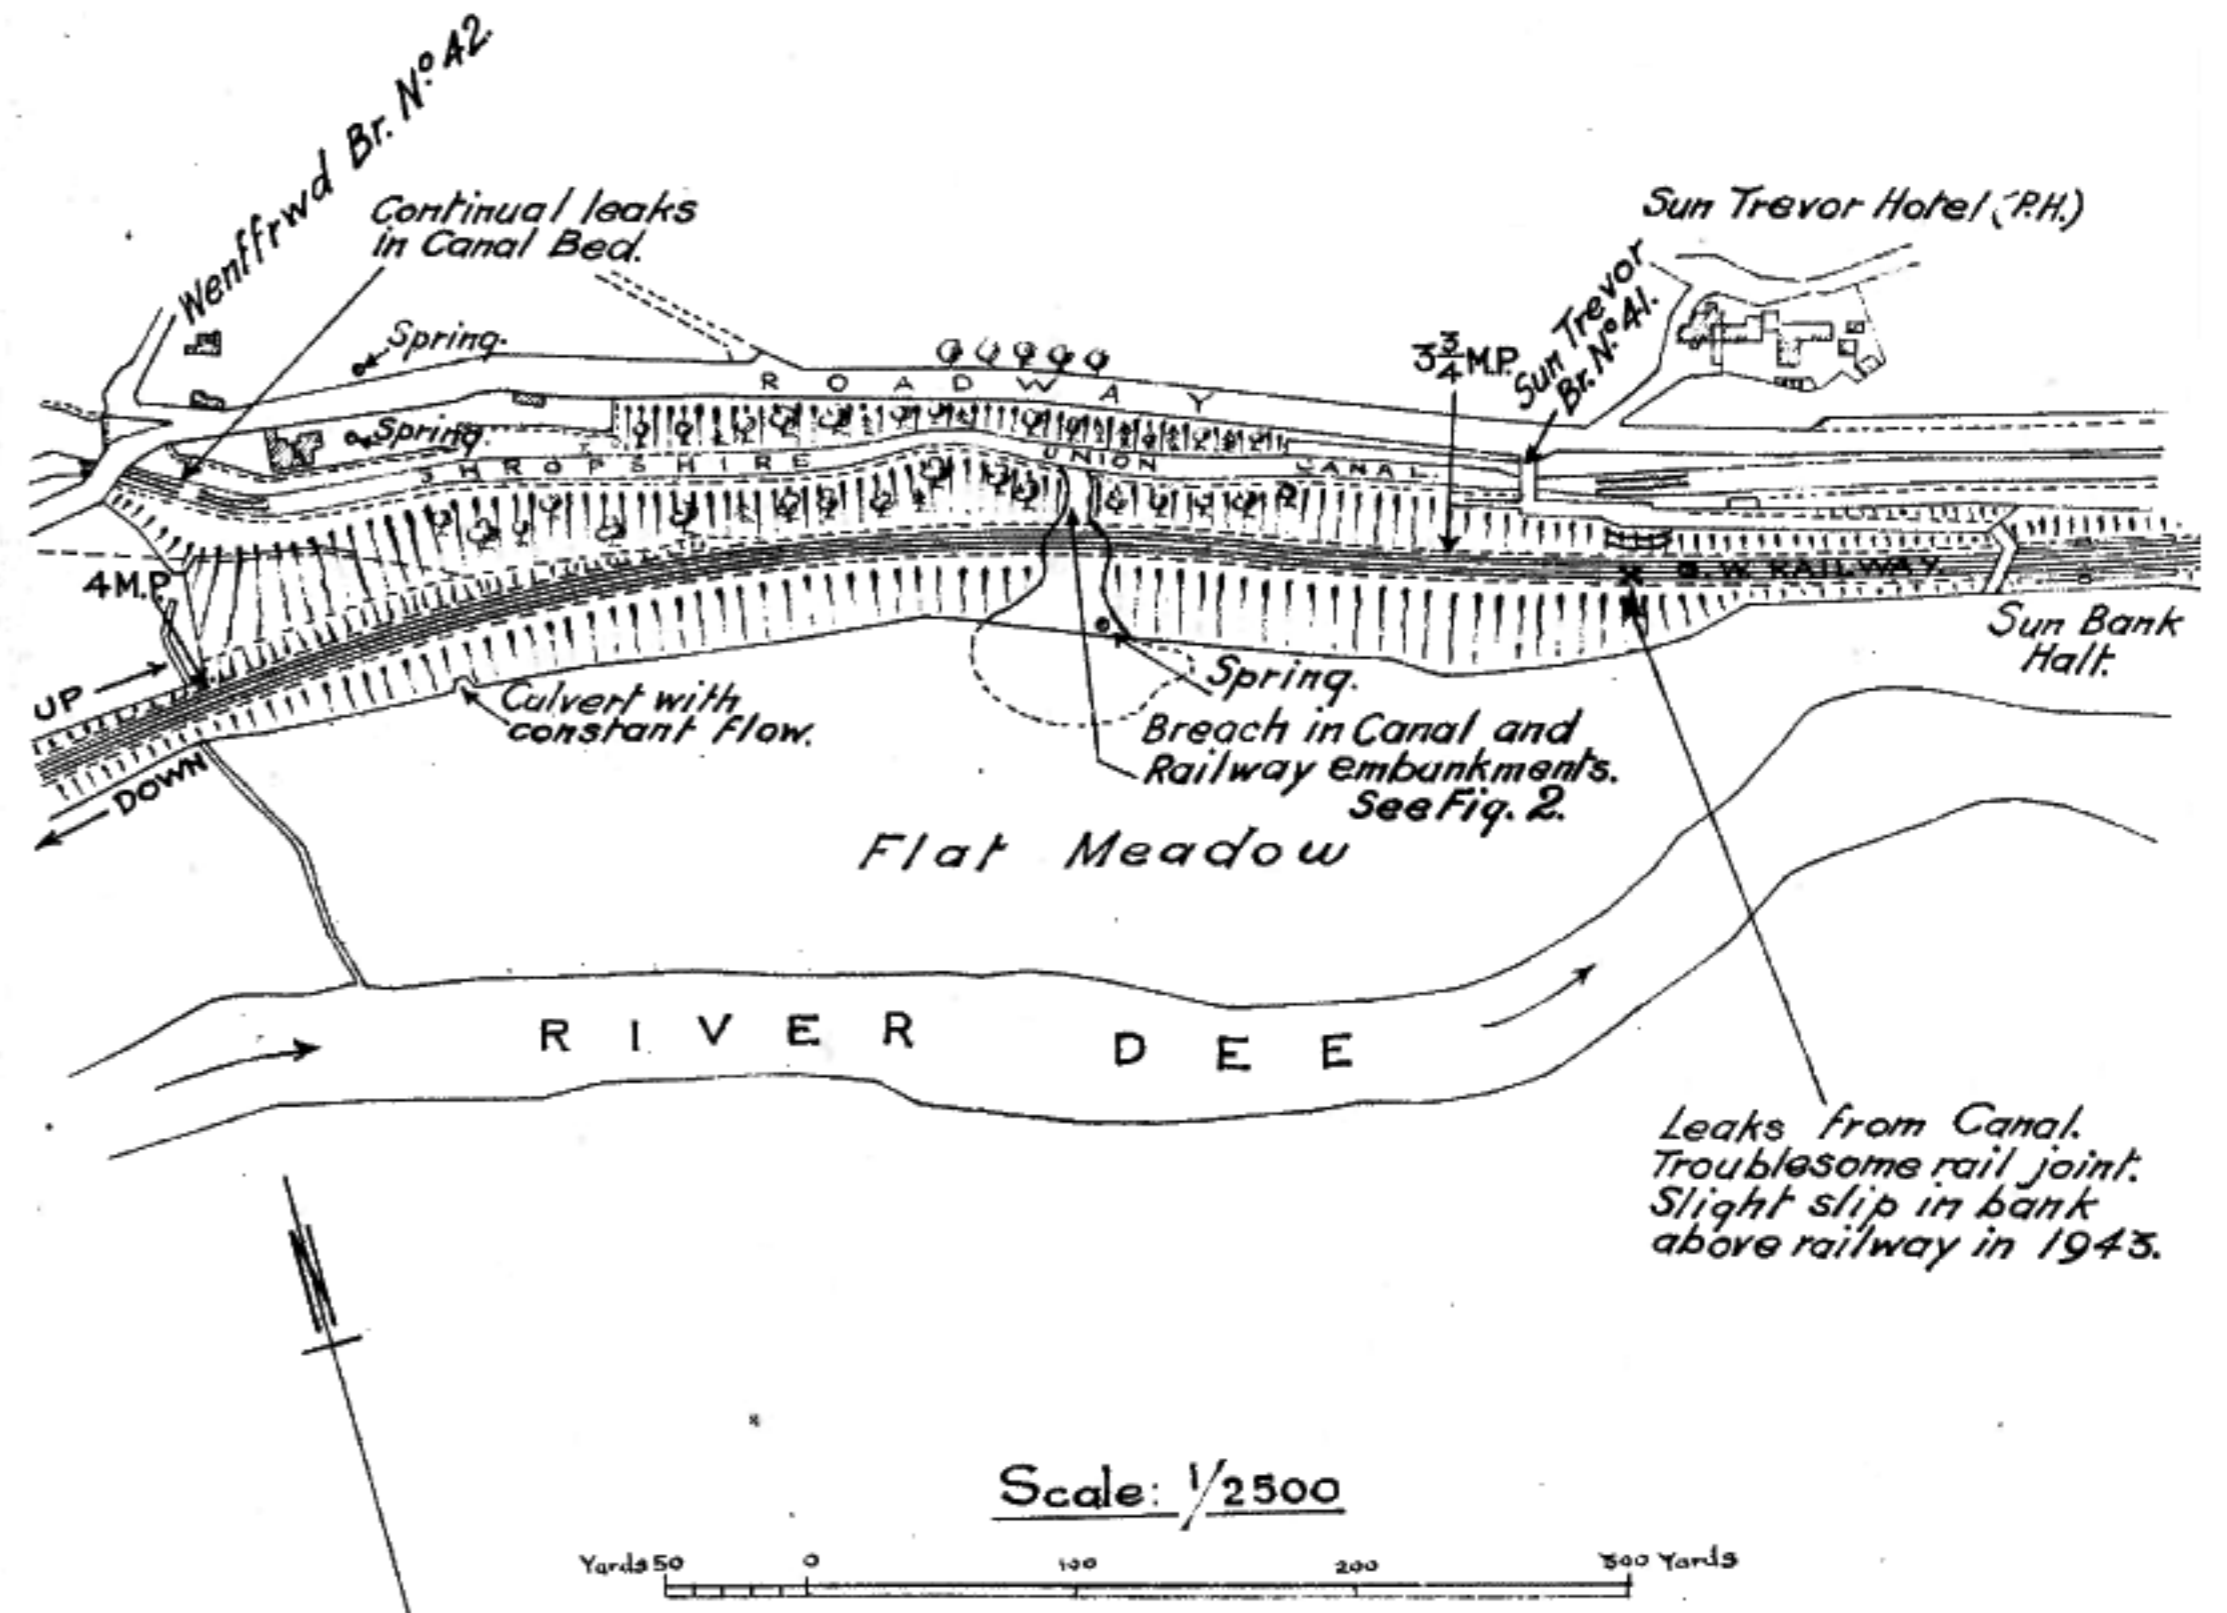
**FIG. 1.
GENERAL SITE PLAN.
*Ordnance Survey Sheet. DENBIGH. 34.16.***

(i) Serious leakage from the bed of the canal occurs from time to time for a length of about 50 yards East of Wenfirwd Bridge No. 42 (see Fig. 1). This length is 290-340 yards from the site of the breach, and, according to Chase, the leakage is sufficient to reveal itself by a swirl in the water and by waterlogging of the meadow below. A stock of some tons of clay is kept on the bank nearby for repairs, but after it is placed in the bed of the canal it gradually sinks and the leaks re-appear. Chase stated that the leaks were reduced for a time but not stopped altogether, when the bed of the canal at this point was lined with corrugated iron sheets in 1933. It was found in 1937 that the ground had subsided under the sheets.

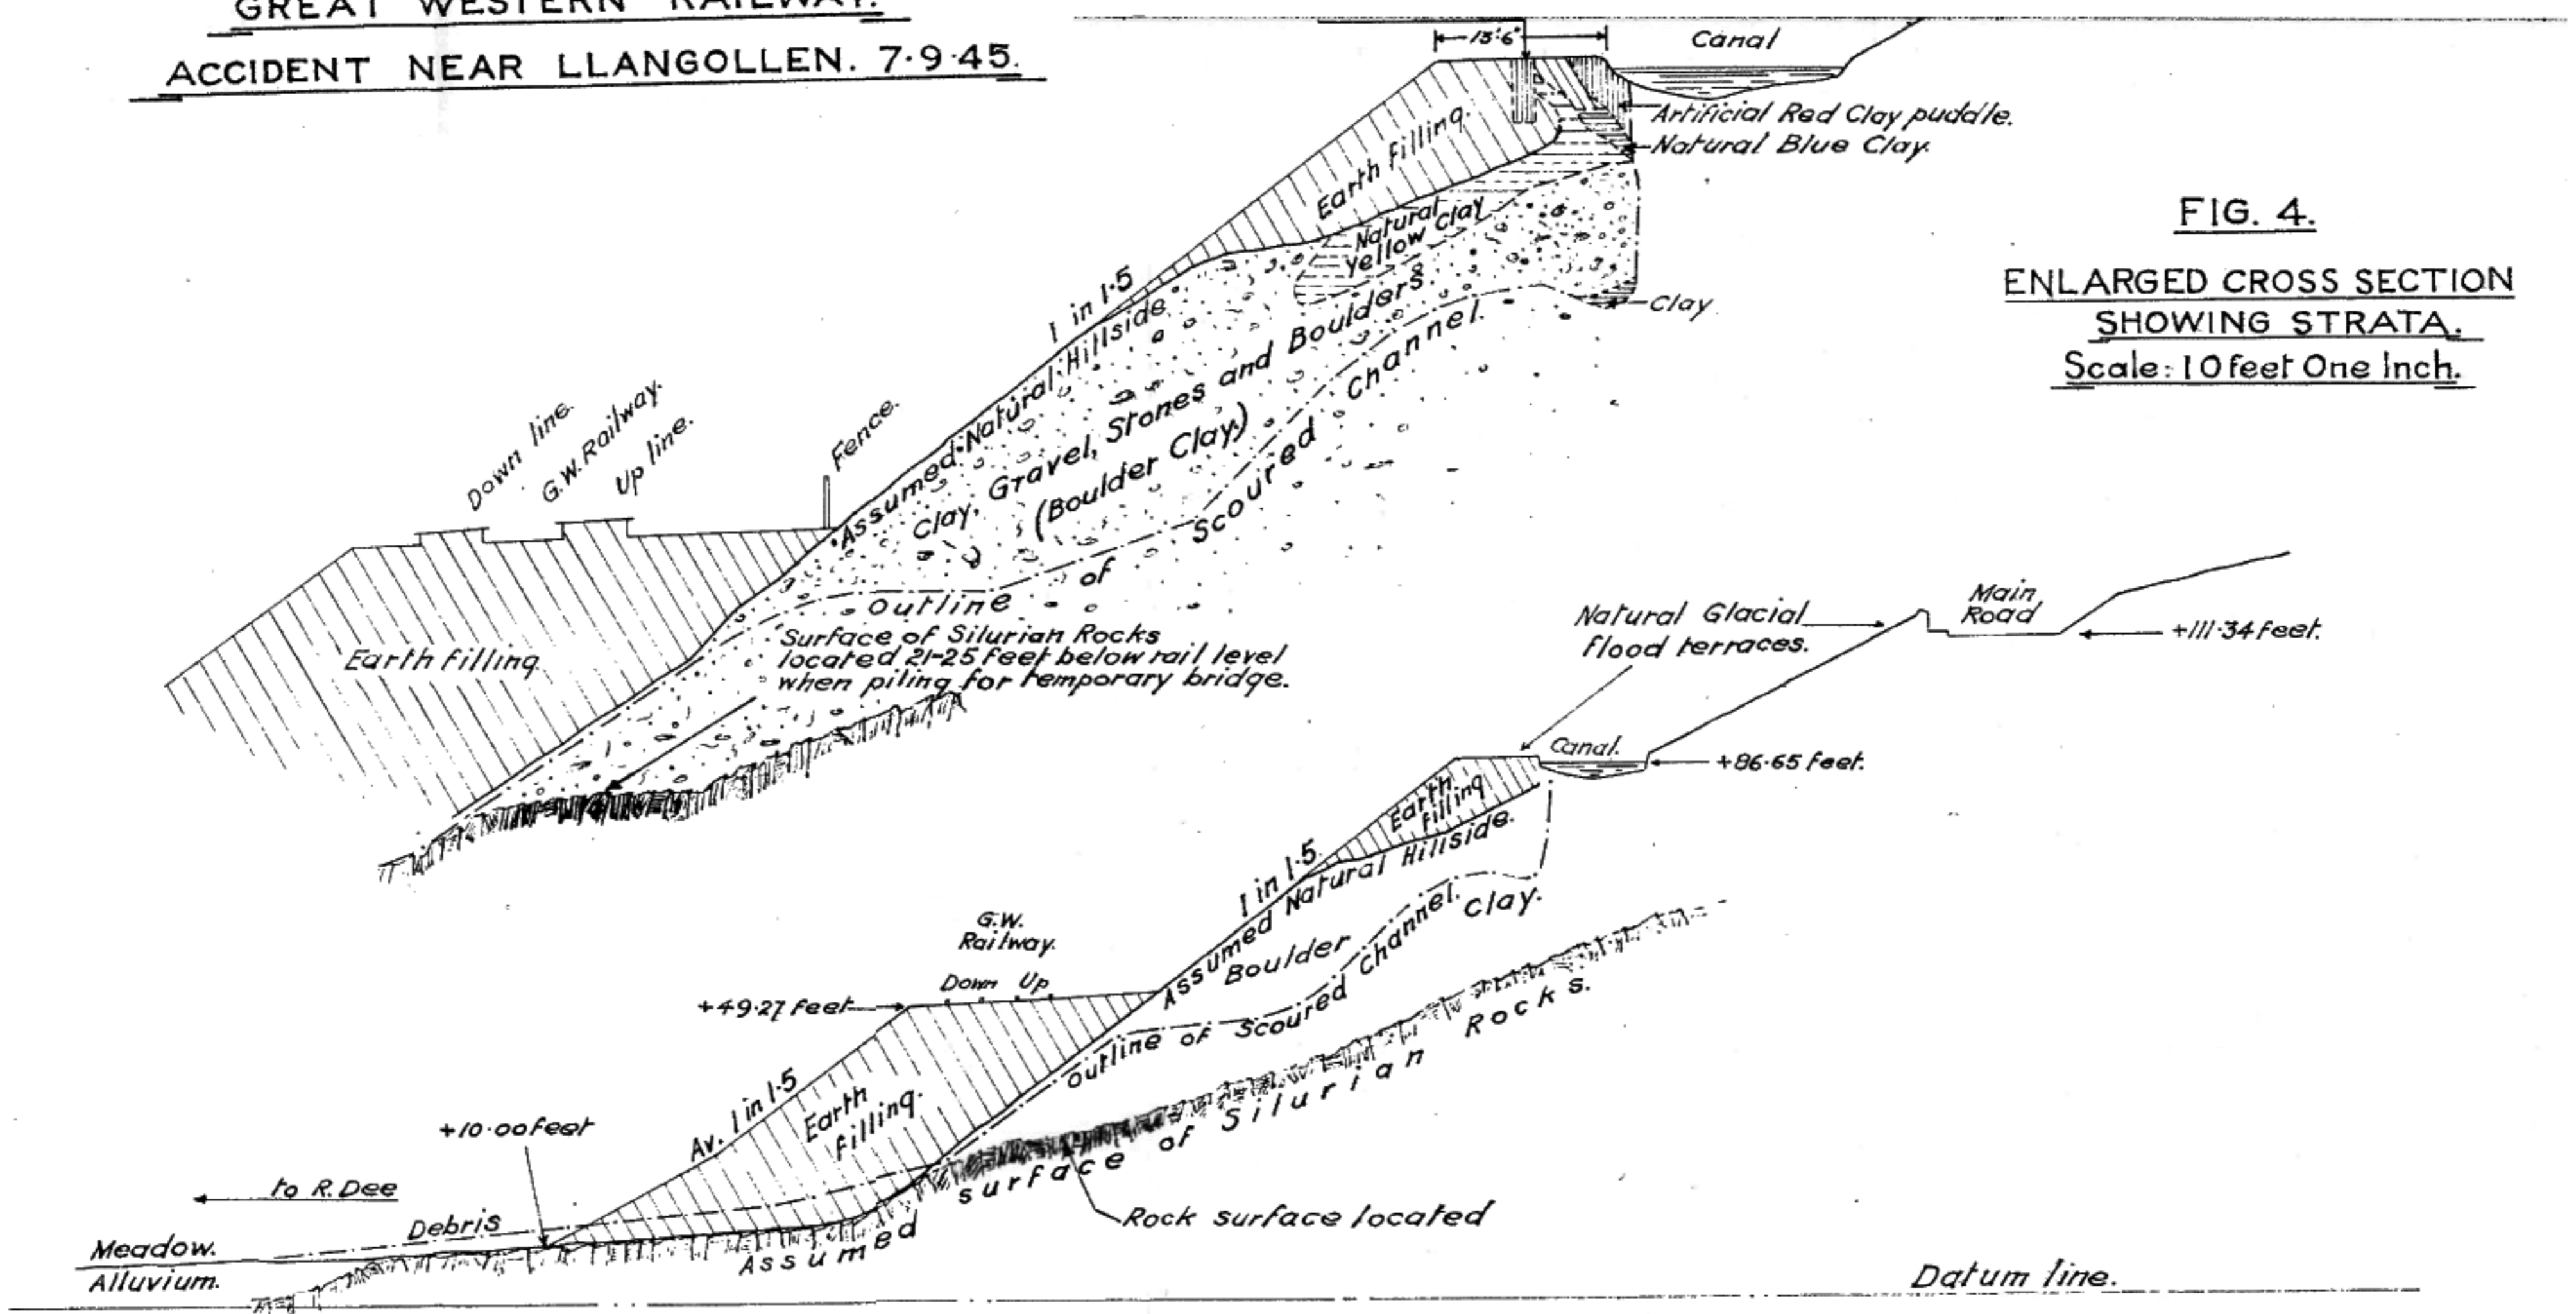
FIG. 4.
ENLARGED CROSS SECTION
SHOWING STRATA.
Scale: 10 feet One Inch.

15. Fig. 4 also gives some indication of the layers of strata exposed by the breach. The layer of artificial red clay puddle round the canal bed appeared to be homogeneous and about 1 ft. 6 ins. to 2 ft. 0 ins. thick, with its upper edge almost level with the towpath. It was washed away for about 2-3 ft. only from the outside edge of the canal and the remaining width of about 20 ft. appeared to be intact, as stated by Chase.

Alternatively, there is the possibility that sliding may have occurred at the damp surface between the layer of yellow clay shown in Fig. 4, and the gravelly boulder clay below it, but on the whole, I consider that erosion of the boulder clay itself by natural water channels is the more likely explanation of the two. I do not think that the continual trouble experienced with the one rail joint on the Ruabon side of the breach can be regarded as evidence of any tendency to general movement of the railway embankment; it is probably due to a local patch of soft formation, caused no doubt by leakage from the canal at this point, to which reference has been made.
