RAILWAY ACCIDENT

Report on the Derailment that occurred on 22nd May 1967 near Tyseley Station, Birmingham

IN THE
LONDON MIDLAND REGION
BRITISH RAILWAYS

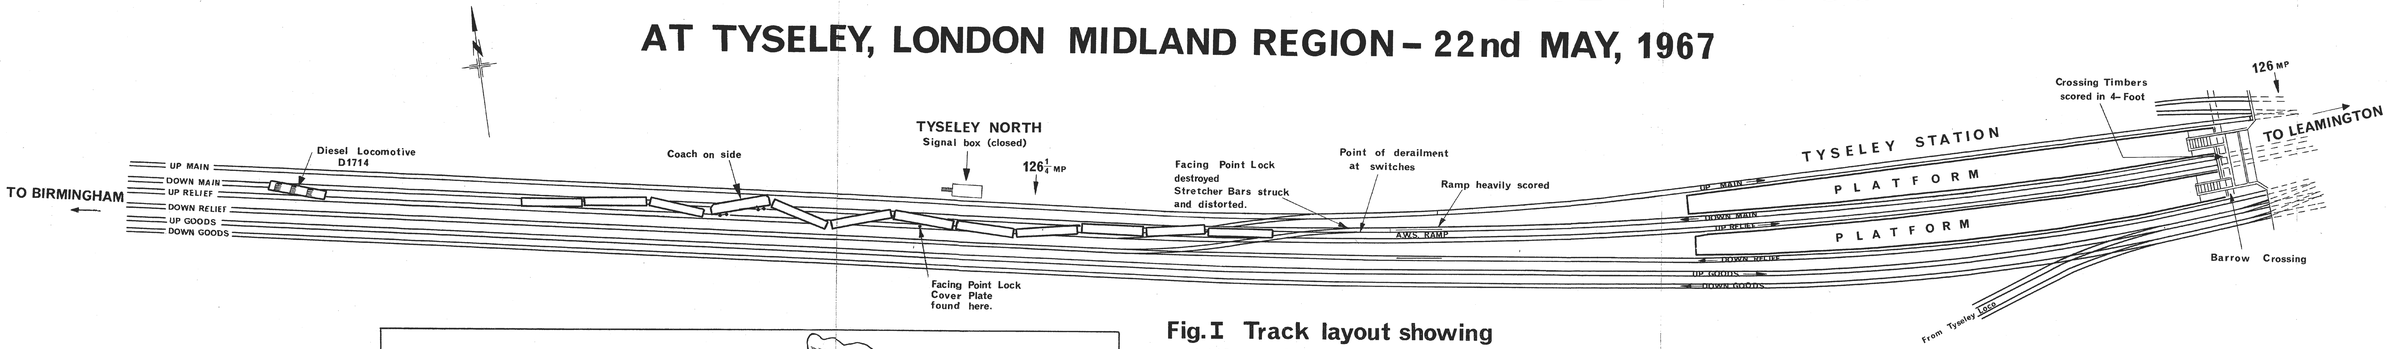
Fig. I Track layout showing positions in which coaches came to rest

12. On approaching Tyseley, the bracket securing the W.R. A.W.S. equipment, which was in advance of the No. 2 motor and axle in the direction of travel, evidently became sufficiently loose to cause the leading bottom edge of the equipment to scrape the tops of rails of two diamond crossings in the centre of the "four foot" of the Down Main line, and then to scrape the surface of the timber barrow crossing at the London end of the station. The leading edge of the equipment then struck the London end of the A.W.S. ramp for Small Heath South Down Main Distant signal, scoring it deeply until the W.R. A.W.S. shoe, located some 20 ins in the rear of the leading edge of the equipment, commenced to ride up the ramp, lifting the equipment clear of it. As the shoe cleared the Birmingham end of the ramp, which, as shown in Figure I, is only 14 ft 1 in.

from the stretcher bar of No. 13 facing points, the equipment dropped again and struck the ramp of the facing point lock cover. It ripped the cover up, destroyed the facing point lock and struck the stretcher bar so severely that it bent towards the heel of the turnout, pulling the closed and clamped switch blade away from the stock rail, so that there was a gap of some 2 ins. at the tip of the switch blade.

13. The wheels of the rear bogie of the locomotive and of the bogies of all 12 coaches then passed between both switches and stock rails and derailment occurred as the gauge widened, the wheels dropping down onto the sleepers and subsequently striking further points and crossings, with the result that the coaches were straddled across the Down Main line in zig-zag fashion, with the fourth coach, a corridor composite, turning onto its right-hand or non-corridor side.

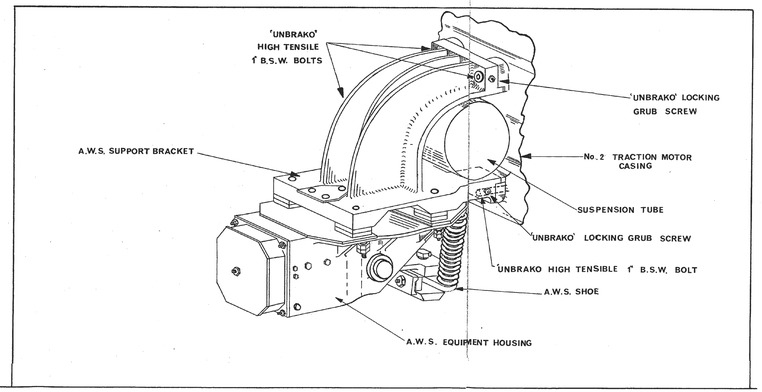
Fig. III Sketch showing general arrangement of Mark II Western Region A.W.S. Support Bracket fitted on Brush–Sulzer Type 4 locomotives.

6. Locomotive No. D.1714, allocated to the London Midland Region, is one of a number fitted with the W.R. A.W.S. equipment in addition to the standard British Railways inductor operated A.W.S. equipment, owing to its travelling regularly over lines fitted with W.R. A.W.S. ramps. The W.R. A.W.S. equipment, when fitted on this class of locomotive, is attached to No. 2 traction motor casing by means of a bracket. On locomotive No. D.1714 and the majority of locomotives of the class this is a Mark II bracket, which is secured to the traction motor casing by four high tensile bolts. A sketch showing the general arrangement of the equipment, including the shoe, the bracket and the motor casing is at Figure III at the end of the Report.

7. The Mark II bracket was developed after a number of the original Mark I brackets had become detached in 1964, and a further number had developed cracks in the welds. The fitting of the Mark II brackets to the Brush-Sulzer Type 4 locomotives in service was completed in 1965. It was found, however, that there was difficulty in obtaining an accurate interference fit on the spigot faces of the Mark II bracket because of slight variations in the spacing of the spigot registers in the motor casings, and it was necessary therefore to resort to selective fitting. In order to overcome this trouble on the later batches of this class of locomotive to be built, a completely new design of cast steel bracket was developed. A six-bolt fastening was adopted in order to provide greater rigidity than the Mark II brackets, in which a small number of bolts had fractured and which also had a tendency to "spring" between the spigots. At the same time the motor casing was redesigned with closely specified dimensions to eliminate the need for selective fitting. The replacing of Mark II brackets on the earlier locomotives by the new Mark III brackets was not considered justified, however, particularly as the latter had to be associated with the modified design of motor casing.

8. The four bolts securing the Mark II bracket are special 1 in. diameter B.S.W. high tensile steel "Unbrako" bolts, tightened to a torque of 400 lbs ft. A locking grub screw is tightened into the head of each "Unbrako" bolt and lock nuts are fitted on each grub screw. An extract from the Maintenance Circular issued by the Western Region, giving detailed instructions for the fitting of the Mark II brackets, will be found at Appendix A.

41. There is little doubt that the top right-hand bolt securing the Mark II W.R. A.W.S. support bracket had failed some considerable time before the accident and that this resulted in excessive fatigue loading on the remaining three bolts. On approaching Tyseley the top left-hand bolt almost certainly failed from fatigue and the W.R. A.W.S. equipment, cantilevered forward from the support bracket, commenced to drop down, the leading bottom edge scraping the heads of the rails of the two diamond crossings in the "four foot" of the Down Main line south of Tyseley Station, then scraping the timber barrow crossing at the south end of the station, and finally striking and digging into the south end of the A.W.S. ramp for Small Heath South Down Main Distant signal. This probably completed the fracture of the two bottom bolts, the equipment then being carried along the ramp by the A.W.S. shoe and finally falling and striking the facing point lock and stretcher bars of No. 13 facing points, the blow being particularly severe due to the equipment being jammed between the facing point lock equipment and the casing of No. 2 traction motor.

(i) The replacement of the bolts securing all W.R. A.W.S. brackets at regular intervals, say every 3,000 hours, which should ensure that their fatigue life does not expire.

(ii) An increase in fatigue life of the bolts by increasing the tightening torque of the "Unbrako" bolts in the Mark II brackets to the figure of 758 lbs ft, as recommended by the bolt manufacturers and the British Railways Research Department. This would increase the fatigue life at least four fold, and reduce the frequency of replacement of the bolts. (See paragraphs 38 and 39.)

(iii) The initiation of an immediate programme to replace all four bolt Mark II brackets by six bolt Mark III brackets.
