RAILWAY ACCIDENTS

REPORT ON THE COLLAPSE OF  
CLIFTON HALL TUNNEL

which occurred on  
28th April 1953 at  
SWINTON

LONDON MIDLAND REGION  
BRITISH RAILWAYS

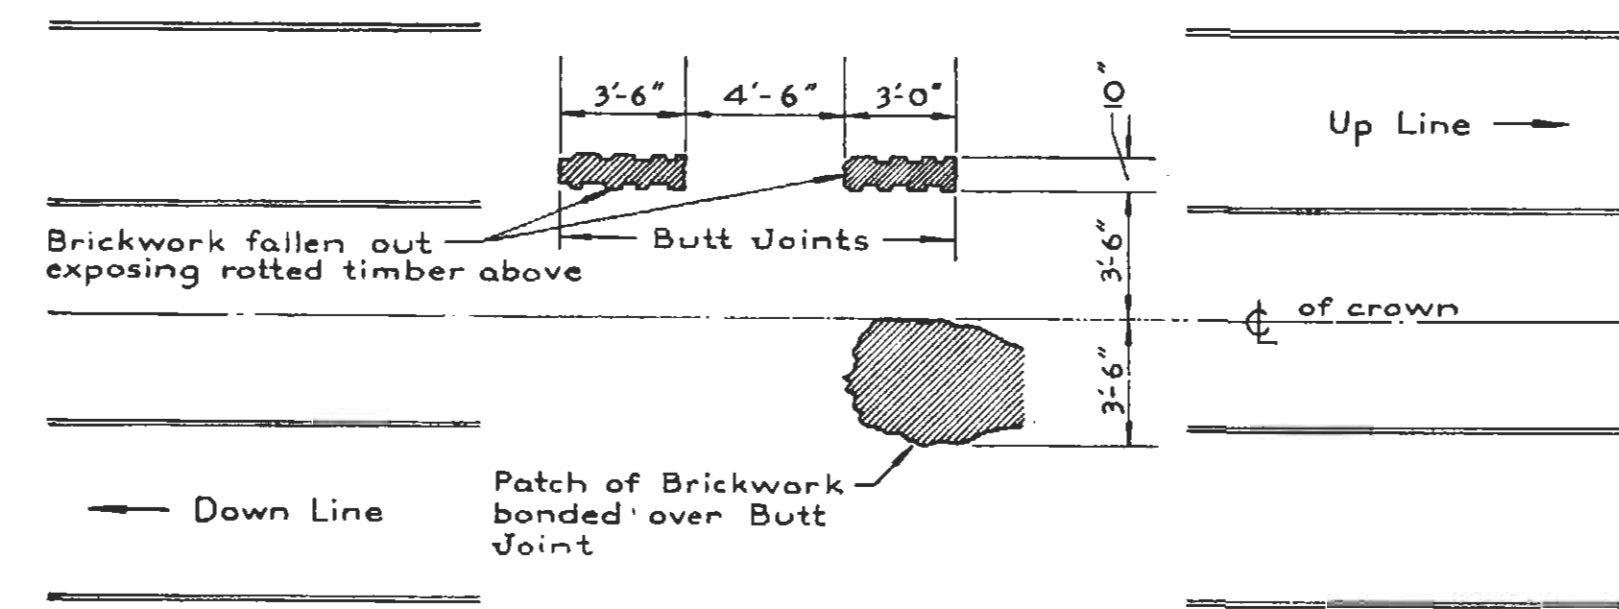
FIG. 6 SKETCH SHOWING DAMAGE TO TUNNEL ROOF UNDER SHAFT No.3

12. The next day on his return Mr. Owen, with Mr. Boivie and several members of their staff made a detailed examination from the top of an inspection wagon. Two blocks of brickwork had fallen from the roof of the tunnel directly over the Up line and had left gaps in the face ring each about 3 feet 6 inches long, with a length of about 4 feet 6 inches of brickwork between them (see Fig. 6). There were signs of butt joints across the crown of the arch at the ends of the damaged section and there was an area of patched brickwork at one end. The crown of the arch between the butt joints was about 2 inches lower than the general level of the tunnel.
