RAILWAY ACCIDENT

Report on the Derailment that occurred on 20th May 1965 at Hest Bank

IN THE
LONDON MIDLAND REGION
BRITISH RAILWAYS

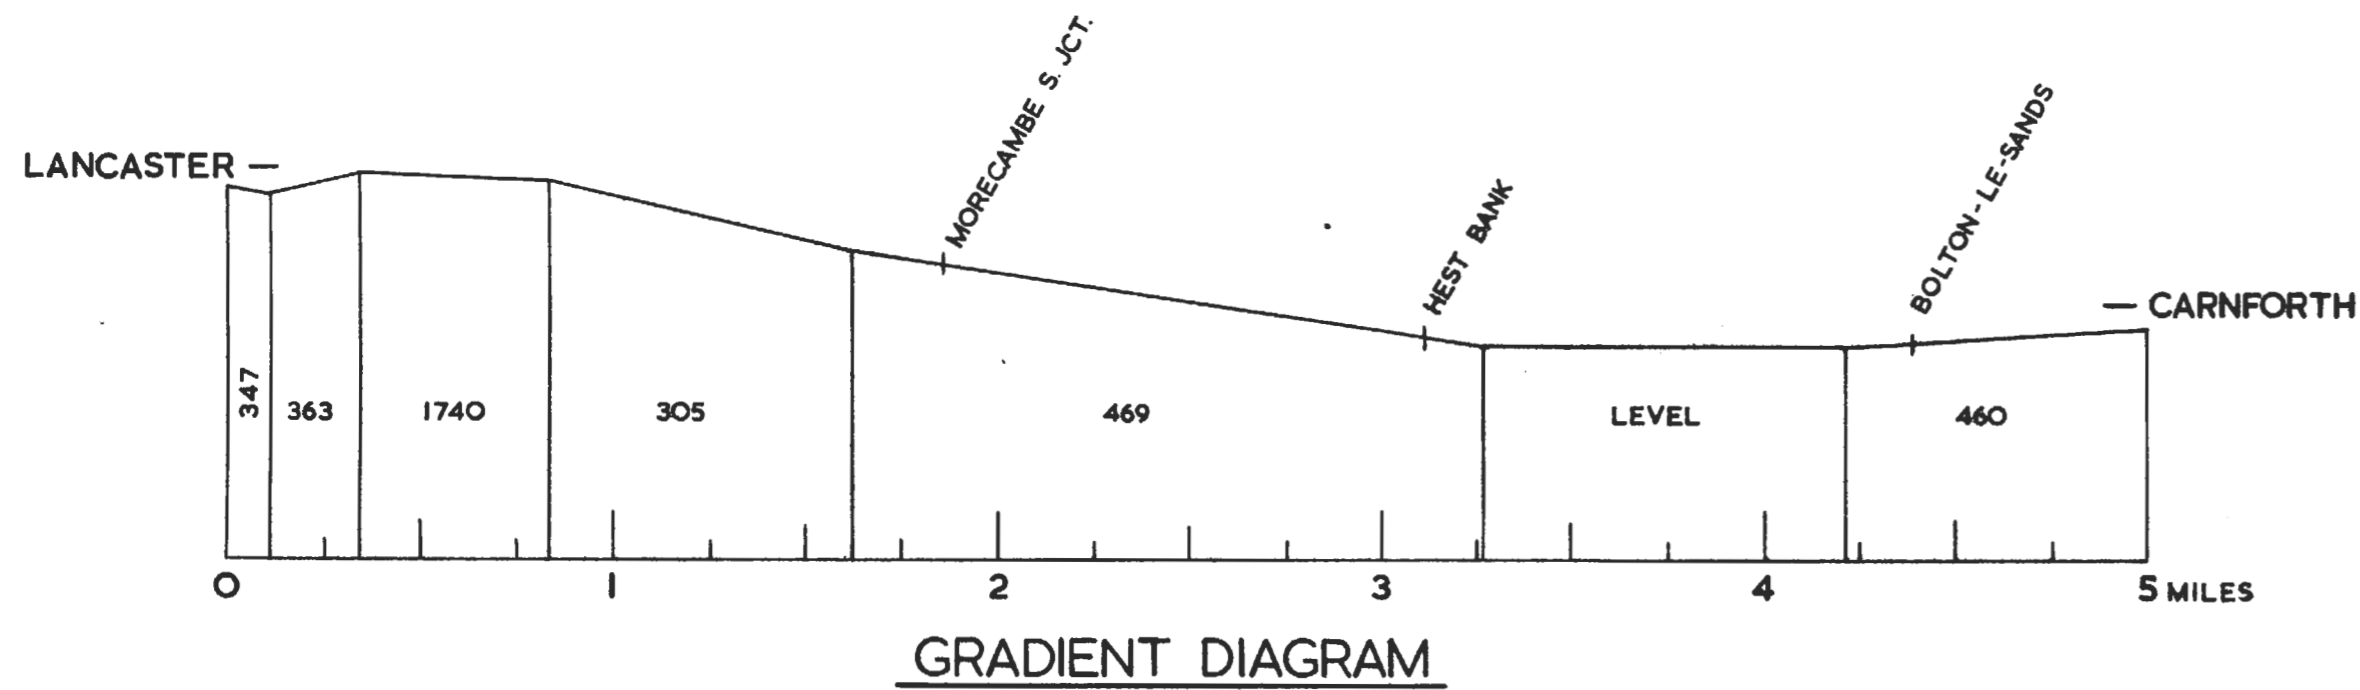
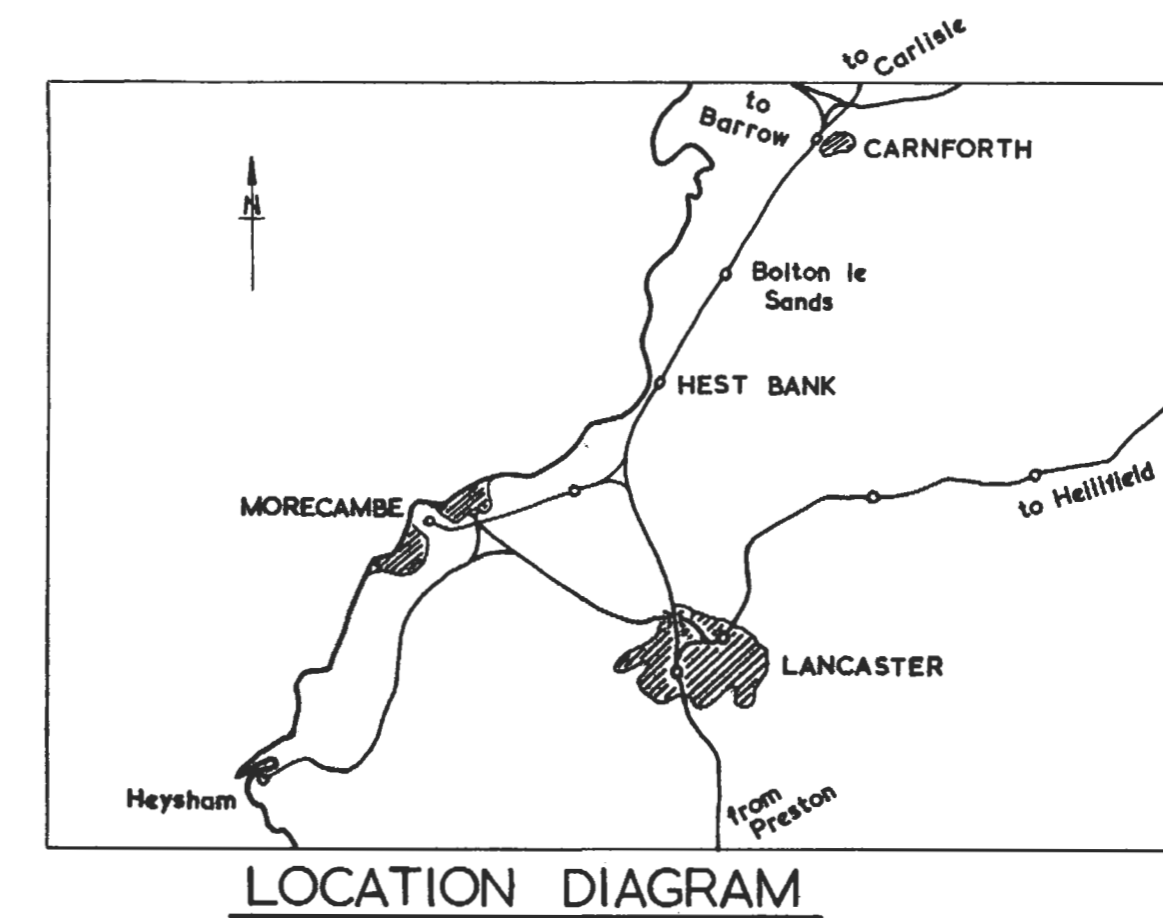
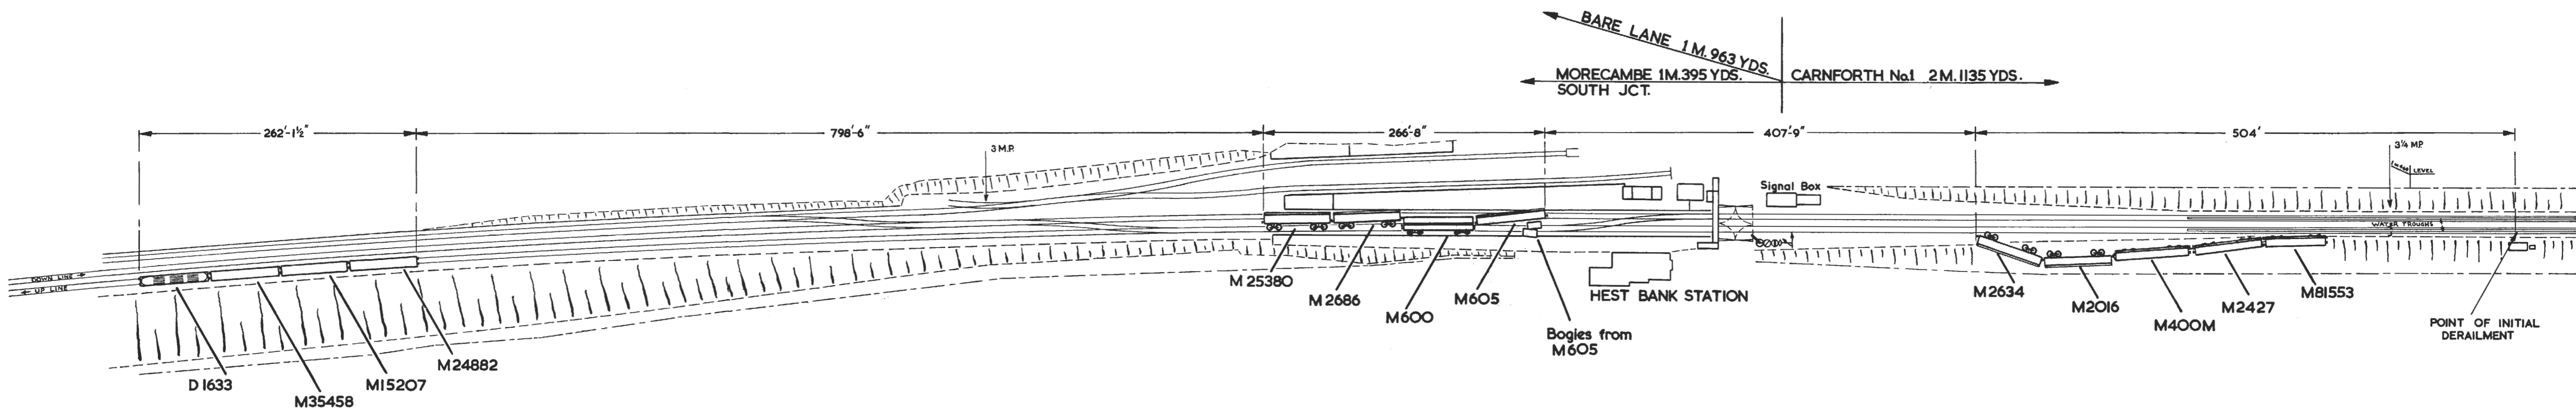
DERAILMENT AT HEST BANK — LONDON MIDLAND REGION 20th MAY 1965

6. It was at once apparent to the railway officers when they reached the scene of the accident that the immediate cause of the derailment was a broken rail, a portion of the cess rail of the Up line about 13 feet long having broken away at the point at which the first marks of derailment were visible, adjacent to the more southerly of the two water tanks that feed the troughs. The initial fracture had occurred 15 feet from the nearest weld and had apparently started as a transverse crack through the rail head, underneath an old wheelburn, subsequently turning horizontally in the direction of travel along the web until it had turned down to the foot and up to the head leaving a piece of rail head 4 foot 7 inches long detached. A further 9 feet of rail had been broken into several pieces, probably as a result of the derailment, and was scattered over a considerable area. Almost all the pieces were subsequently recovered and reassembled as shown in the accompanying photographs and diagrams, in the British Railways Engineering Research Laboratory at Derby, where they were taken for a detailed metallurgical examination.

9. It seems probable that the crack in the rail had already turned horizontally and was starting to advance along the web whilst the locomotive and leading coaches were passing over it, the portion of the head of the rail 4 feet 7 inches long finally becoming detached under the third coach which, however, was not derailed though it was found to have a bruised flange on the trailing left side wheel of the leading bogie, the right hand rocker bar of which had also been displaced by about 6 inches.

10. The gap in the rail must then have quickly lengthened as succeeding wheels struck the broken end causing further disintegration. From the fourth coach onwards each succeeding bogie was derailed to the left, but prevented from moving very far out of line by the heavy steel watertrough in the centre of the track, until the increasing damage to the latter finally allowed the right hand wheels to override it as the tail portion of the train started to diverge to the left. The increasing drag of the rear coaches as they ploughed along the edge of the formation caused the train to become divided between the 7th and 8th vehicles where the trunnion of the screw coupling burst and the thread stripped. The rear portion, consisting of 4 sleeping cars and the brake van then came to rest, still coupled together, on the low embankment on the Up side of the line at varying angles. With the division of the train and the consequent parting of the vacuum train pipe, the brakes were applied automatically as the front portion ran on with the 4th to 7th coaches derailed but still remaining upright, though displaced to the left sufficiently far to demolish the Up side level crossing gates and then, one by one, to mount the platform ramp and overturn towards the Down line.
