**Report on the Collision that
occurred on 11th September 1986
at Bridgeton**

IN THE
SCOTTISH REGION
OF BRITISH RAILWAYS

29th July 1988

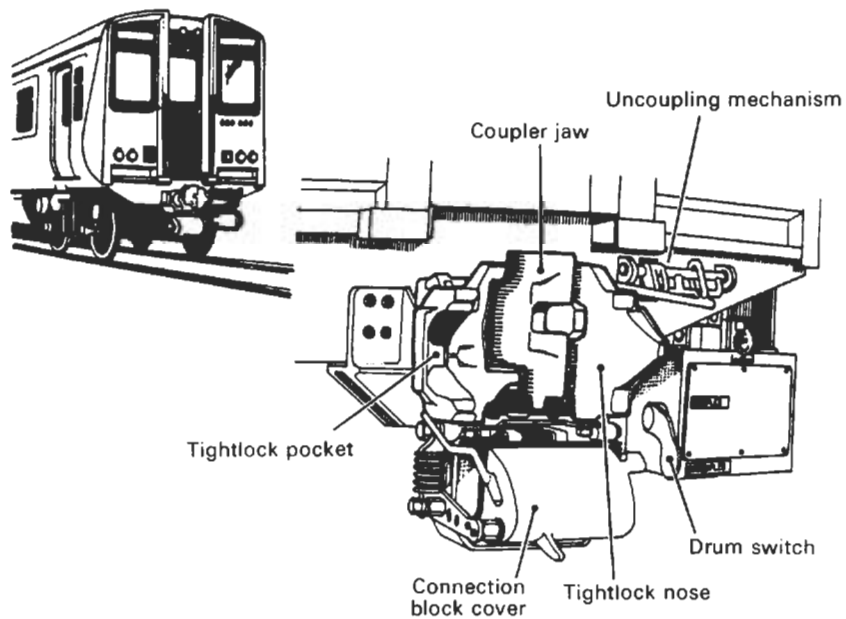
COUPLING OF UNITS

22.2.7 Press the 'COUPLE' push button on the driving compartment desk for 2 seconds, with the master switch in the NEUTRAL position.

22.2.8 Alight and check that both drum switches have moved to the 'coupled' position, that both butterfly indicators are visible and that there is clearance between the indicator and the coupler body.

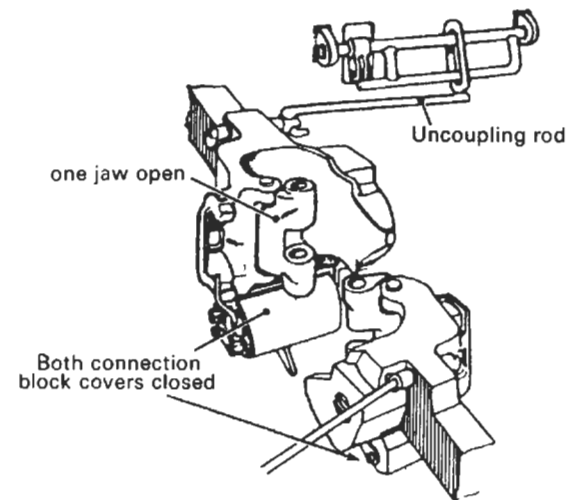
UNITS COUPLED
